# **Darwin River Cabomba Eradication Program Interim Report December 2017**

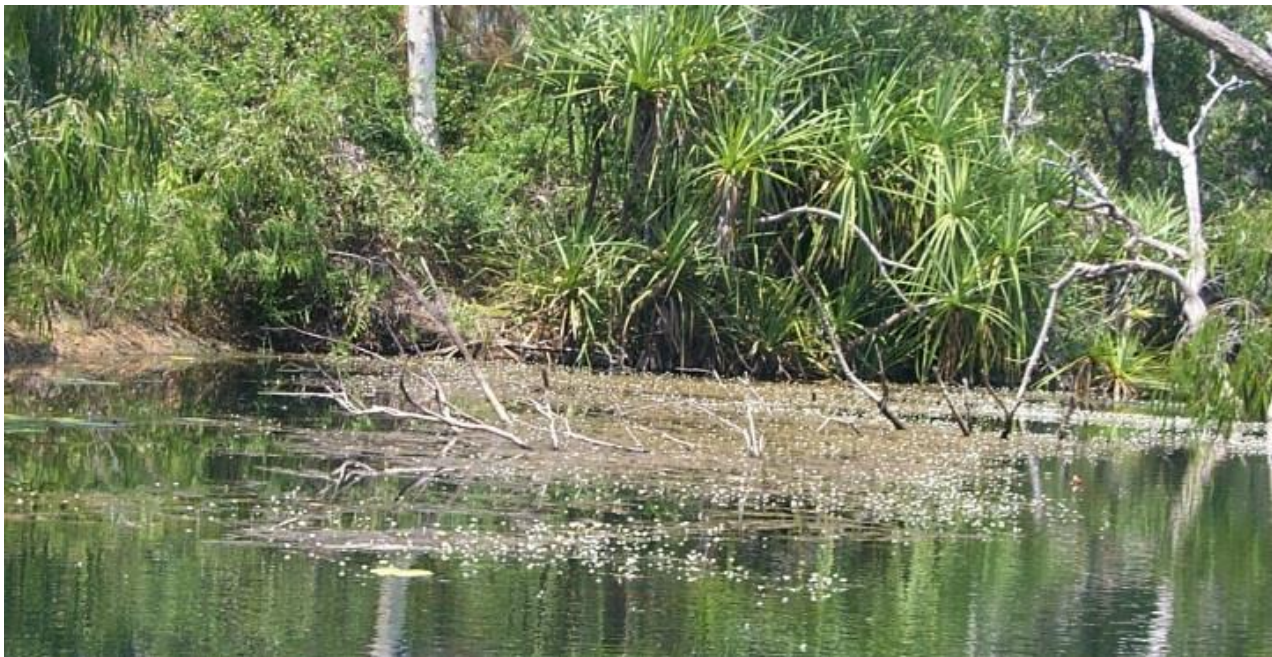
Plate 2: Cabomba infestation in Lok Landji 2004.

When it was discovered in 2004, the Darwin River cabomba infestation spanned over 10 kilometers (Plate 2). Immediate eradication efforts were made by the Weed Management Branch (WMB). As no registered herbicides were available for use in Australia to control cabomba, an off-label permit was issued by the Australian Pesticides and Veterinary Medicines Authority (APVMA) for the use of an aquatic herbicide (2,4-D ester). This herbicide was used successfully as part of the Eradication Program (Plate 3) for over 10 years; however it is now deregistered for use in Australia and is no longer available for purchase.

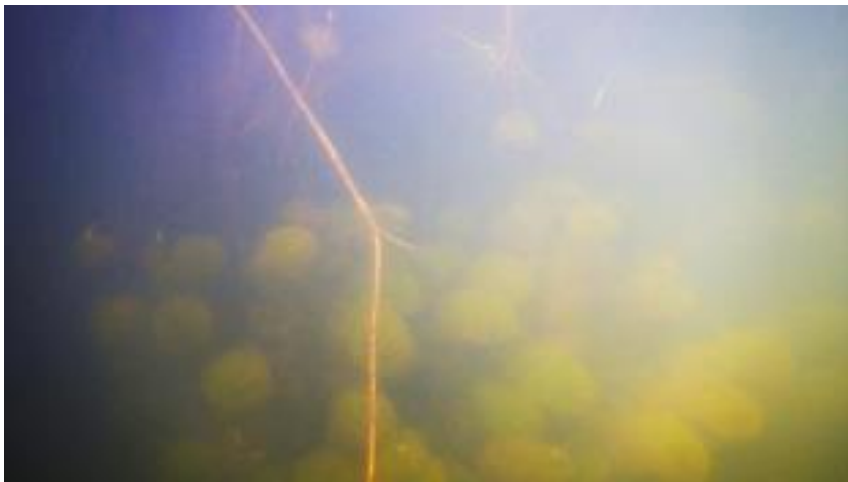
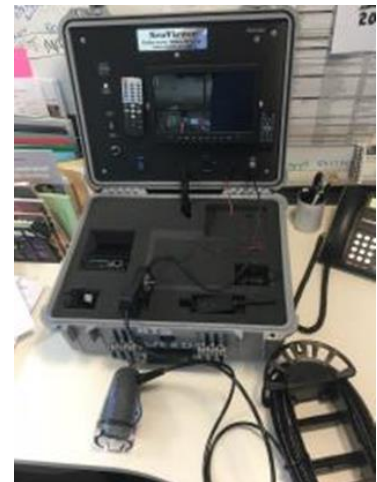
Plate 7: Detection of cabomba using underwater camera

An underwater camera with live feed back to the surface was purchased in December 2015. This camera was used extensively during 2016 to observe the riverbed in real-time to identify cabomba. The camera revealed cabomba growing at depths and locations within Lok Landji that it had previously not been known to occur (Plate 7).

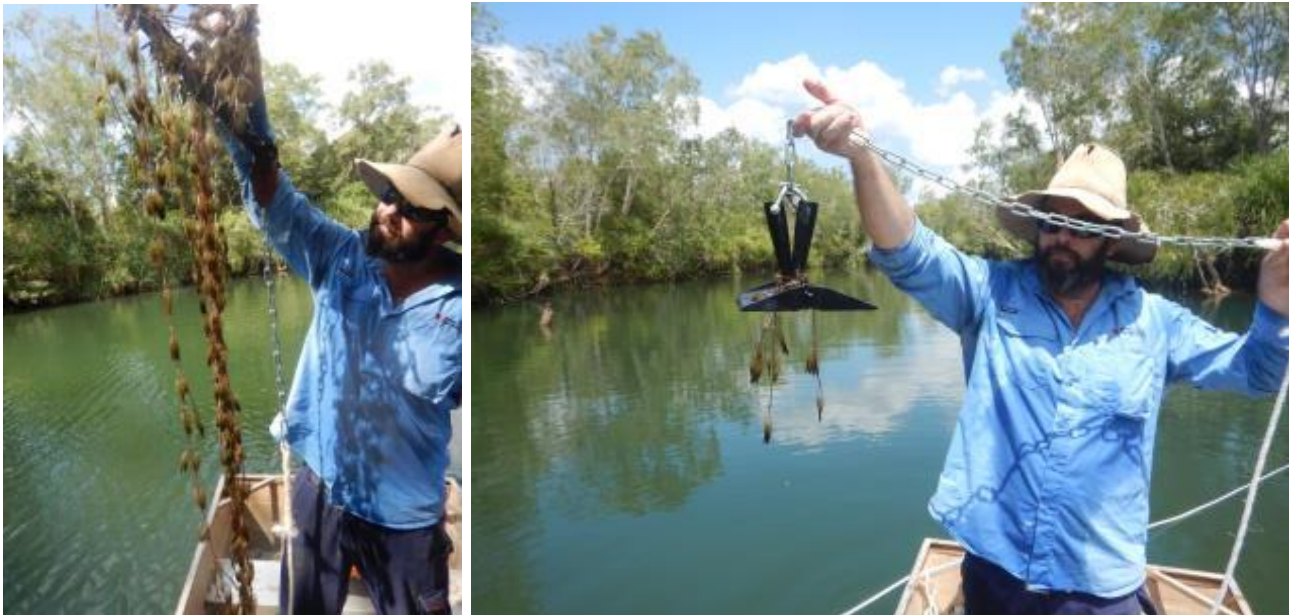
Plate 8: Physical sampling and monitoring of cabomba at depth using a grapnel.

retrieved with cabomba fragments attached. Weed officers could visually inspect treated cabomba to determine the level of health post-herbicide application (Plate 8).

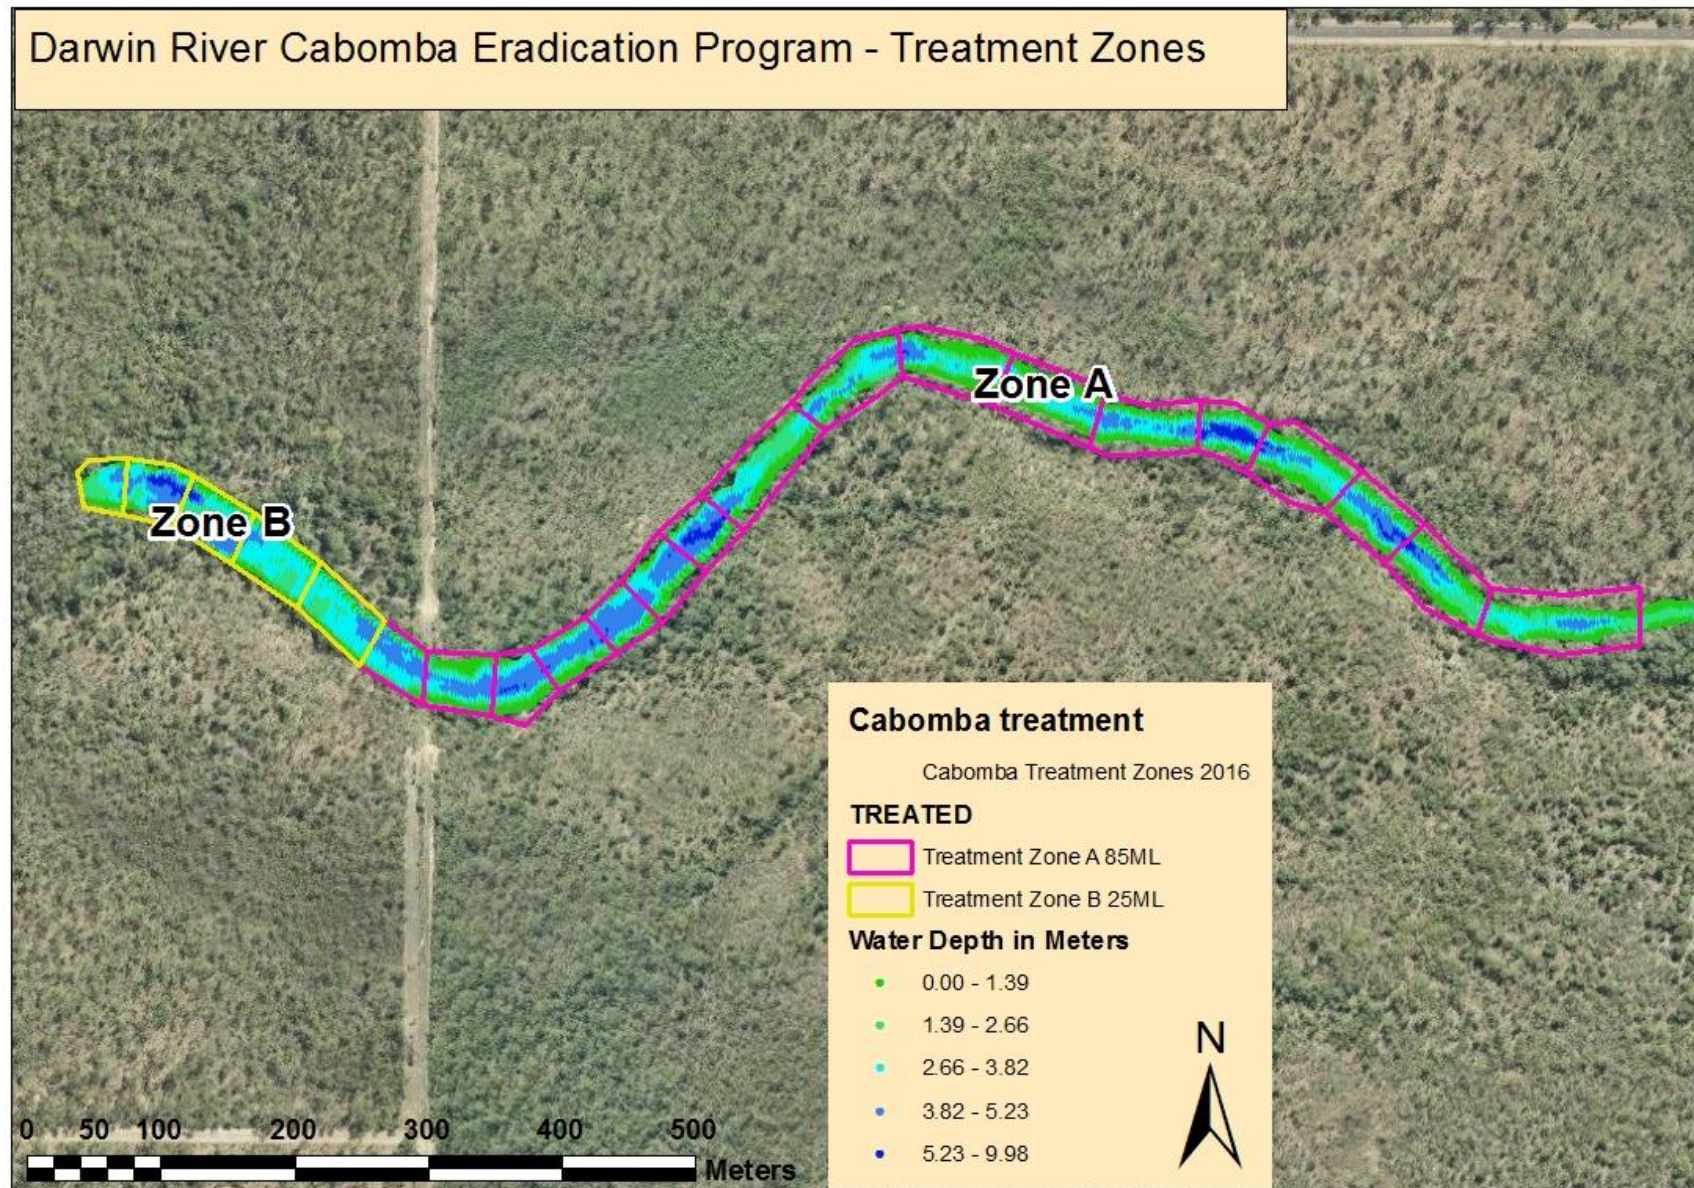
Map 2: Cabomba treatment zones, Lok Landji Darwin River

The ideal treatment schedule, as shown in Table 1, incorporates six half-billabong treatments over three years. Herbicide application is timed to coincide with ideal treatment conditions, those being healthy and actively-growing cabomba and high sunlight penetration in to the water. Best results from the herbicide are achieved under high light conditions with clear water and low water flow through the billabong. Upstream areas (Zone A as shown in Map 2) are treated first to completely remove the risk of upstream reestablishment.

Treatment Zone B will require treatment in 2018 and again in 2019 if needed (herbicide drift from the A Zone has already had an effect). Cabomba surveys, river flow and turbidity levels in the 2018 dry season will determine when this herbicide can be applied and whether a follow-up treatment will be required.

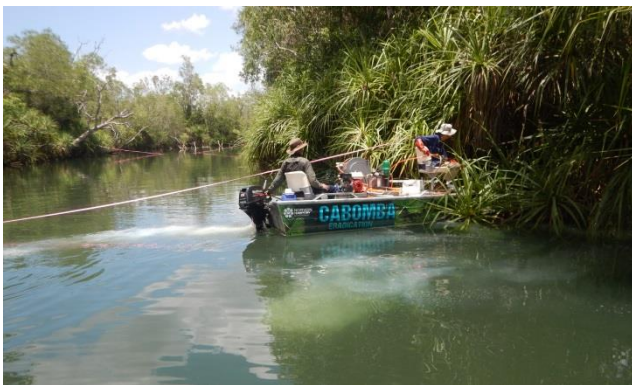
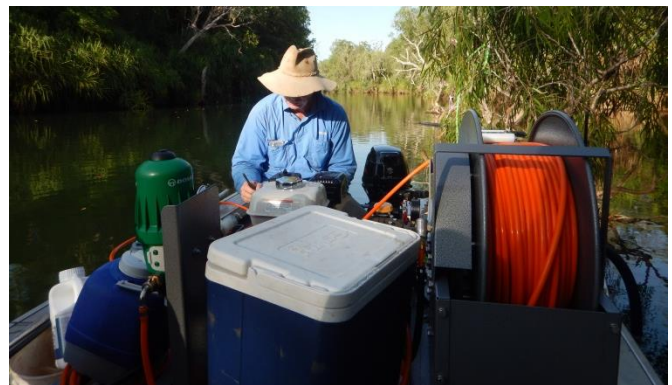
Plate 12: Half billabong treatment and associated monitoring, October 2016

In total, it took four Weed Management Branch Officers six days to treat 85 mega litres of the billabong, using two boats to subsurface inject over 700 litres of herbicide along a linear distance of just over one kilometre (refer to Plates 12 and 13 and Map 3).

Before the first half billabong treatment, cabomba fragments were readily found floating on the surface throughout the infested zone. Cabomba infestations growing from the riverbed were also reaching the surface in at least ten sites. Three months post-treatment; not a single cabomba fragment was found in the treated zone. One healthy fragment was found in the untreated zone downstream of where the herbicide was used.

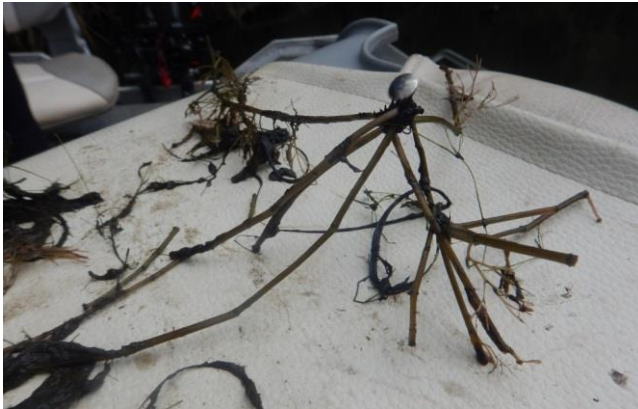
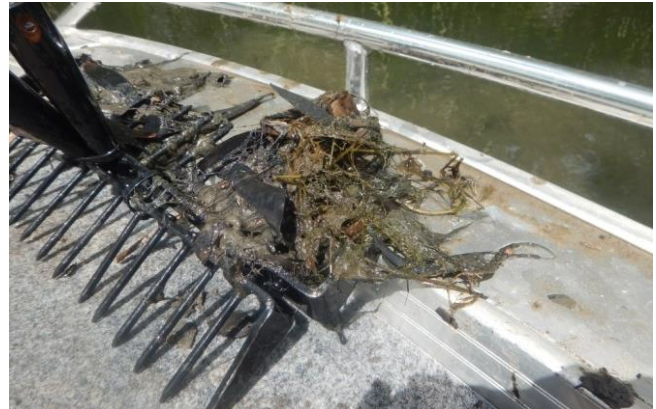
Plate 14: No healthy cabomba eight weeks post-treatment

- No floating fragments were found in the treated zone or downstream in the untreated zone.
- No healthy cabomba was able to be found on the riverbed in either the treated or untreated zone (Plate 14).

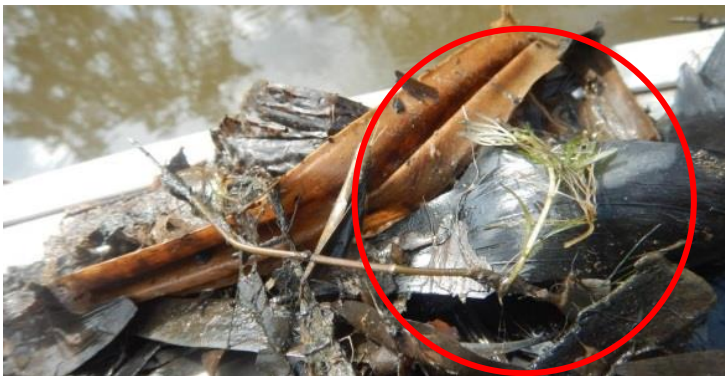
Plate 15: First sign of healthy cabomba three months post-treatment – only in untreated zone

- No floating fragments could be located in either the treated or untreated zone.
- Surveillance techniques used in the treated zone could not locate any cabomba on the riverbed in any of the previously known infestation sites.
- In the untreated zone a single small, but healthy fragment was located on the riverbed (Plate 15). This healthy stem indicates that while some herbicide effect was observed in the untreated zone, targeted management would be required once the river stopped flowing in the 2017 dry season.
