# Appendices

Ecology report  
2019 exploration program  
Santos

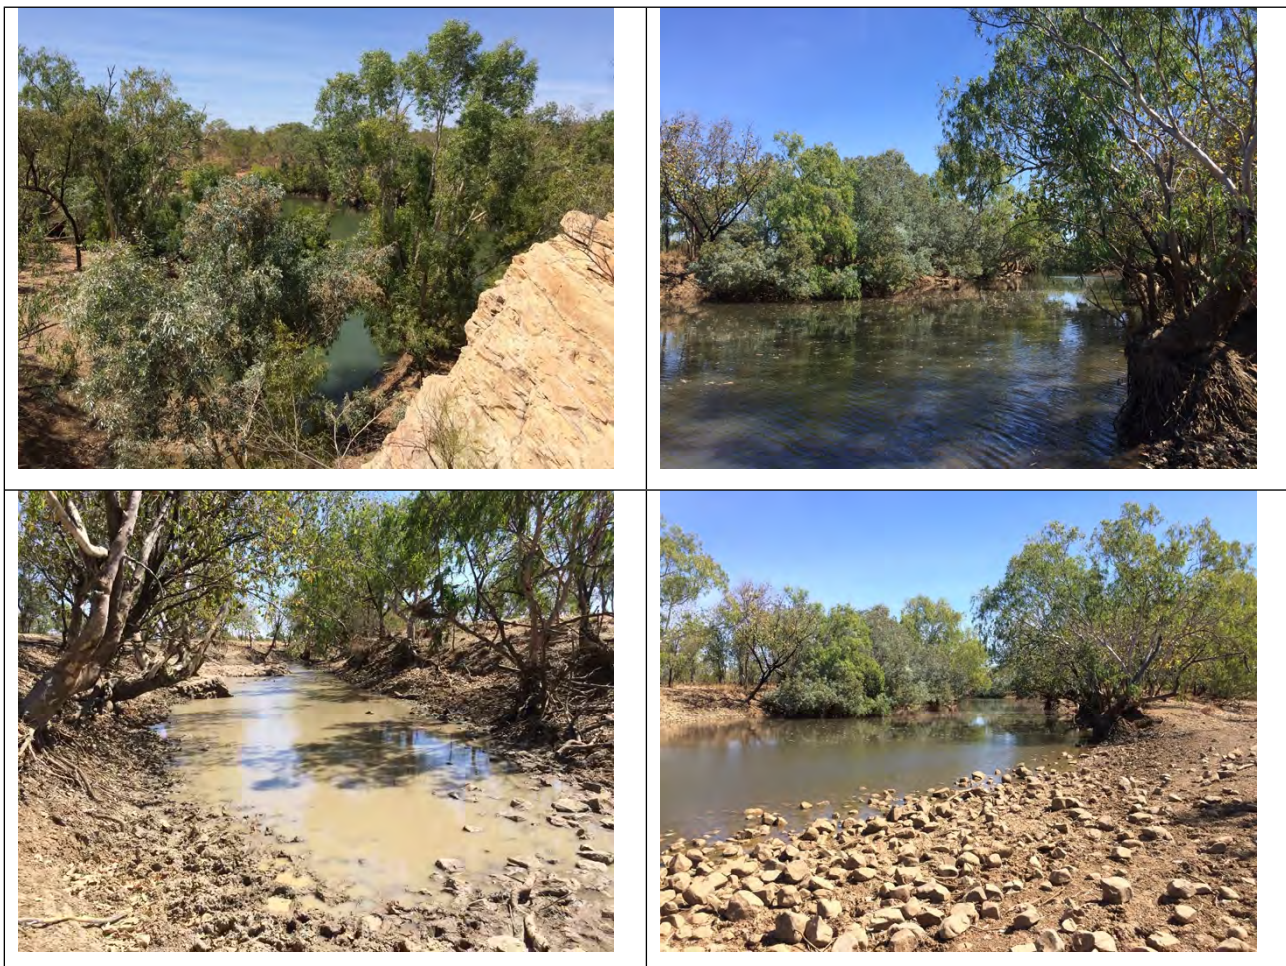
Like other areas within the survey area, riparian vegetation exhibited impacts from cattle. Erosion from cattle trampling was evident on the banks of all watercourses visited. Understorey grass species showed extensive impact from cattle grazing; this has likely exacerbated the erosion along the watercourse banks.

Figure 3-6. Photos showing typical riparian vegetation within the survey area

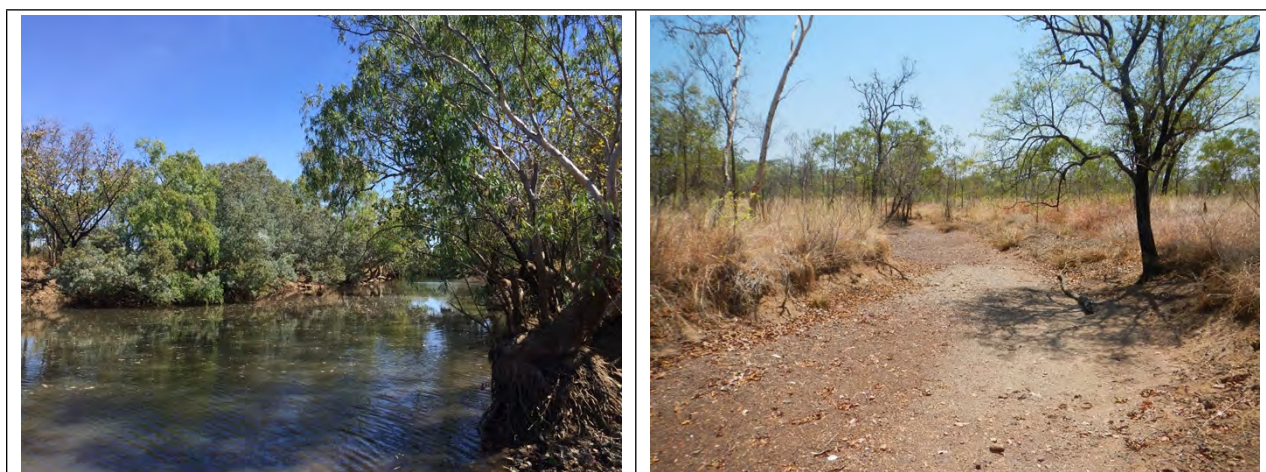
- Riparian vegetation – vegetation considered sensitive under the *NT Land Clearing Guidelines* (e.g. Figure 4-3 left).
- Drainage line vegetation – vegetation along a drainage line but not considered sensitive riparian vegetation under the *NT Land Clearing Guidelines* (e.g. Figure 4-3 right).

**Figure 4-3. Examples of sensitive riparian vegetation (left) and drainage line vegetation (right).**

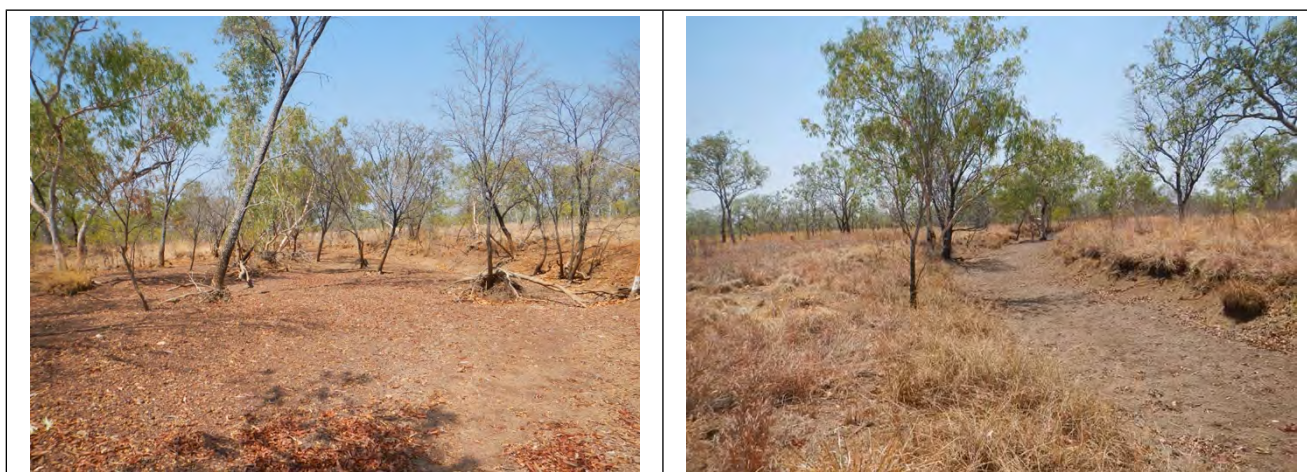
**Figure 4-4. Photos of riparian (left) and drainage line (right) vegetation within Inacumba-1 survey area**

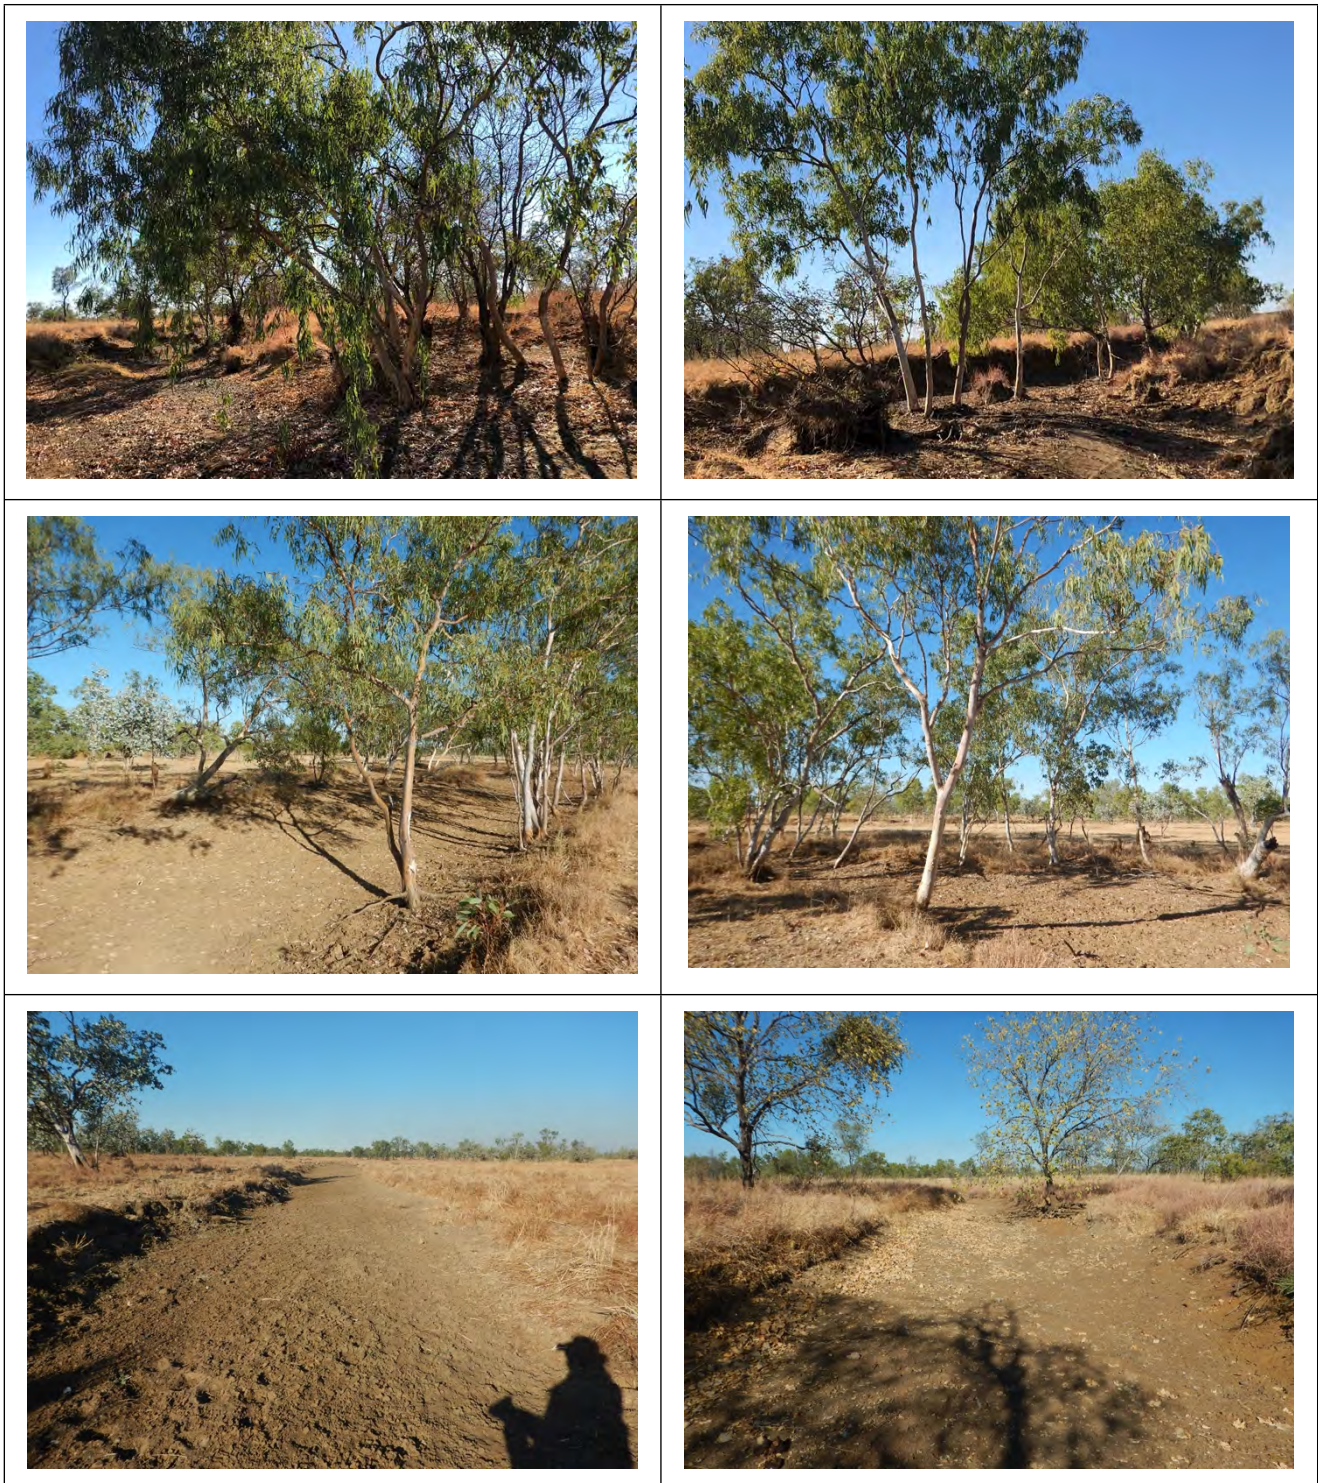
Figure 4-6. Photos of drainage line vegetation along transects radiating from Tanumbirini-2
