Appendices

Appendix A: Detailed Lease Layout Plan

Ecology report
2019 exploration program
Santos

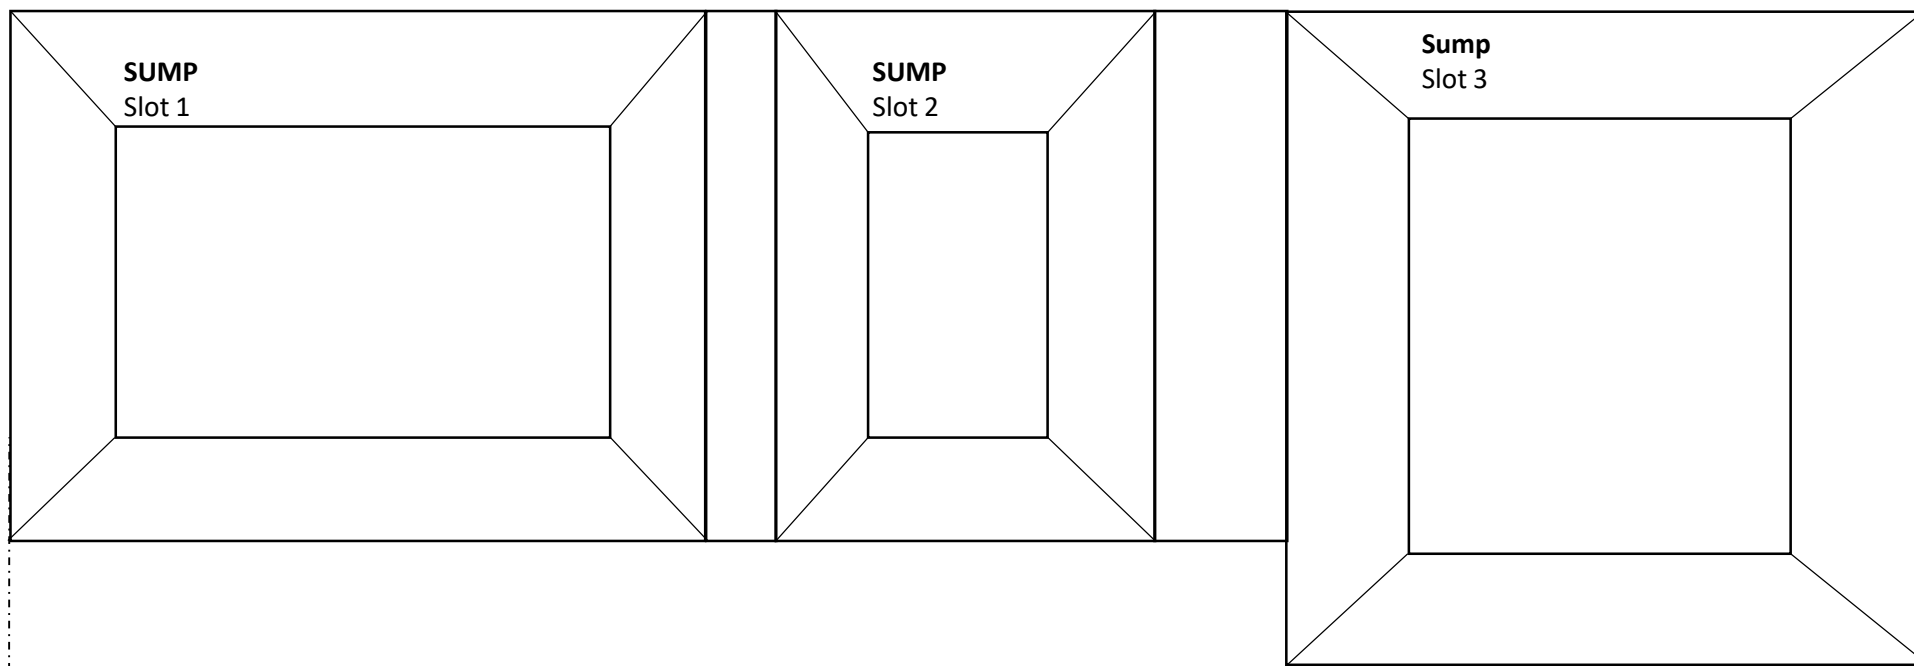
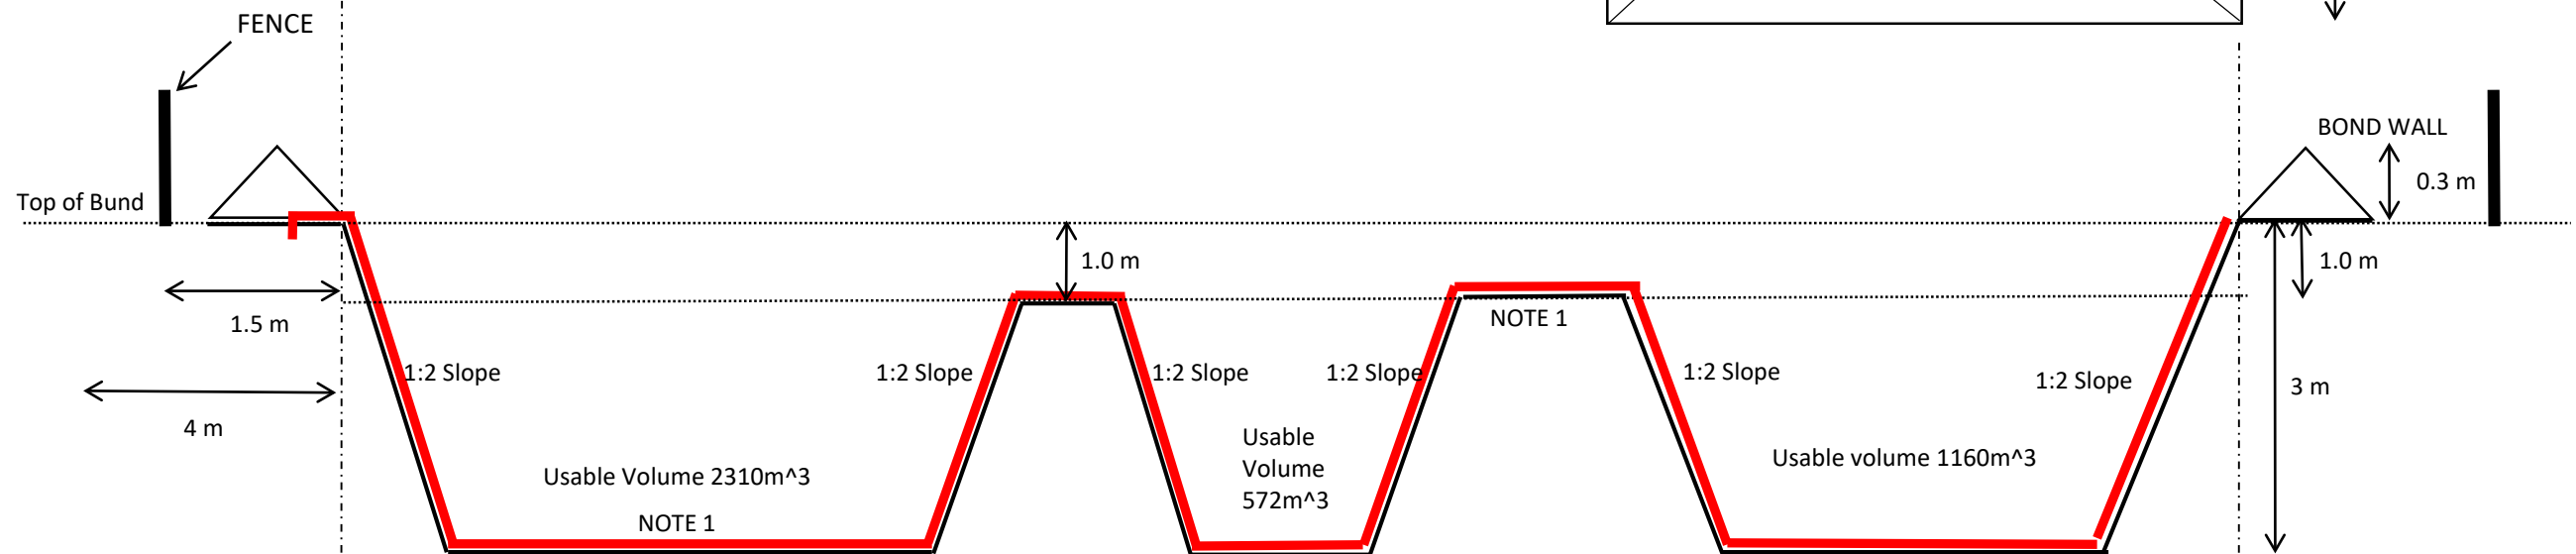
1. Sump (Slot 1, 2 & 3) to be lined as per permeability requirements
2. Liner installed as per specification
3. Weir system used to recycle drilling fluids & meet 1m freeboard requirements.
4. Useable volume excludes 1m freeboard

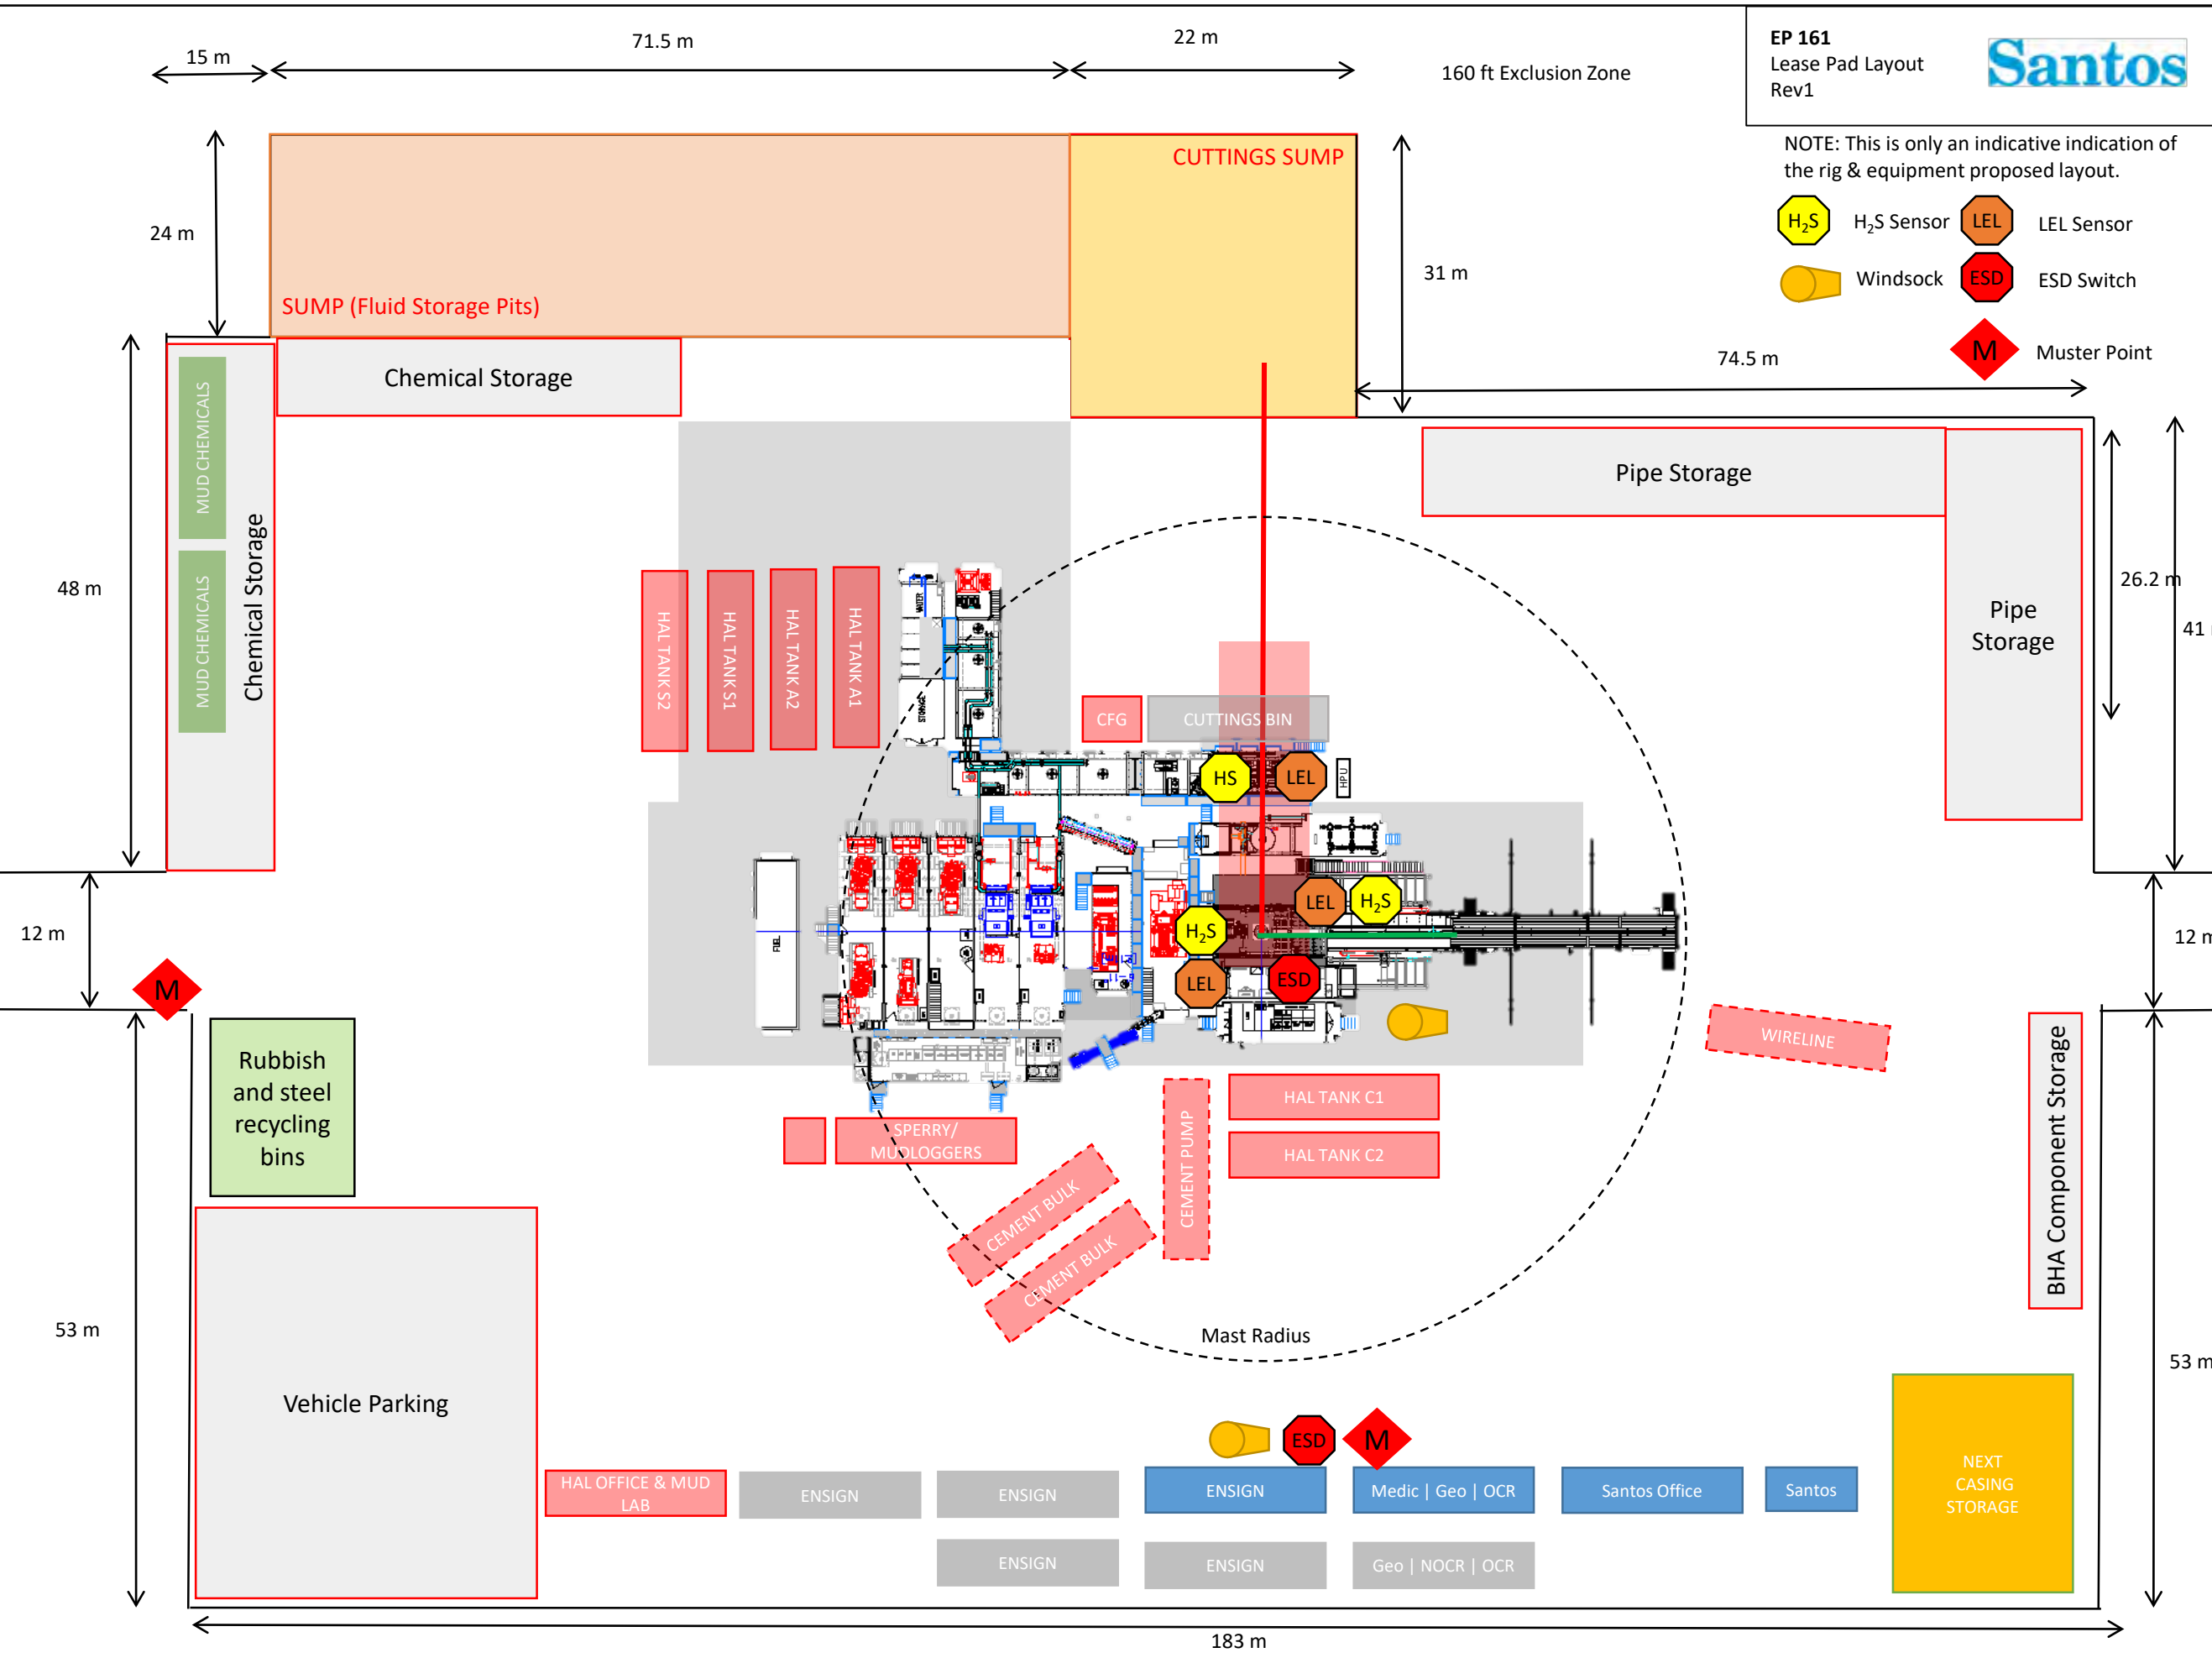
NOTE: This is only an indicative indication of the rig & equipment proposed layout.

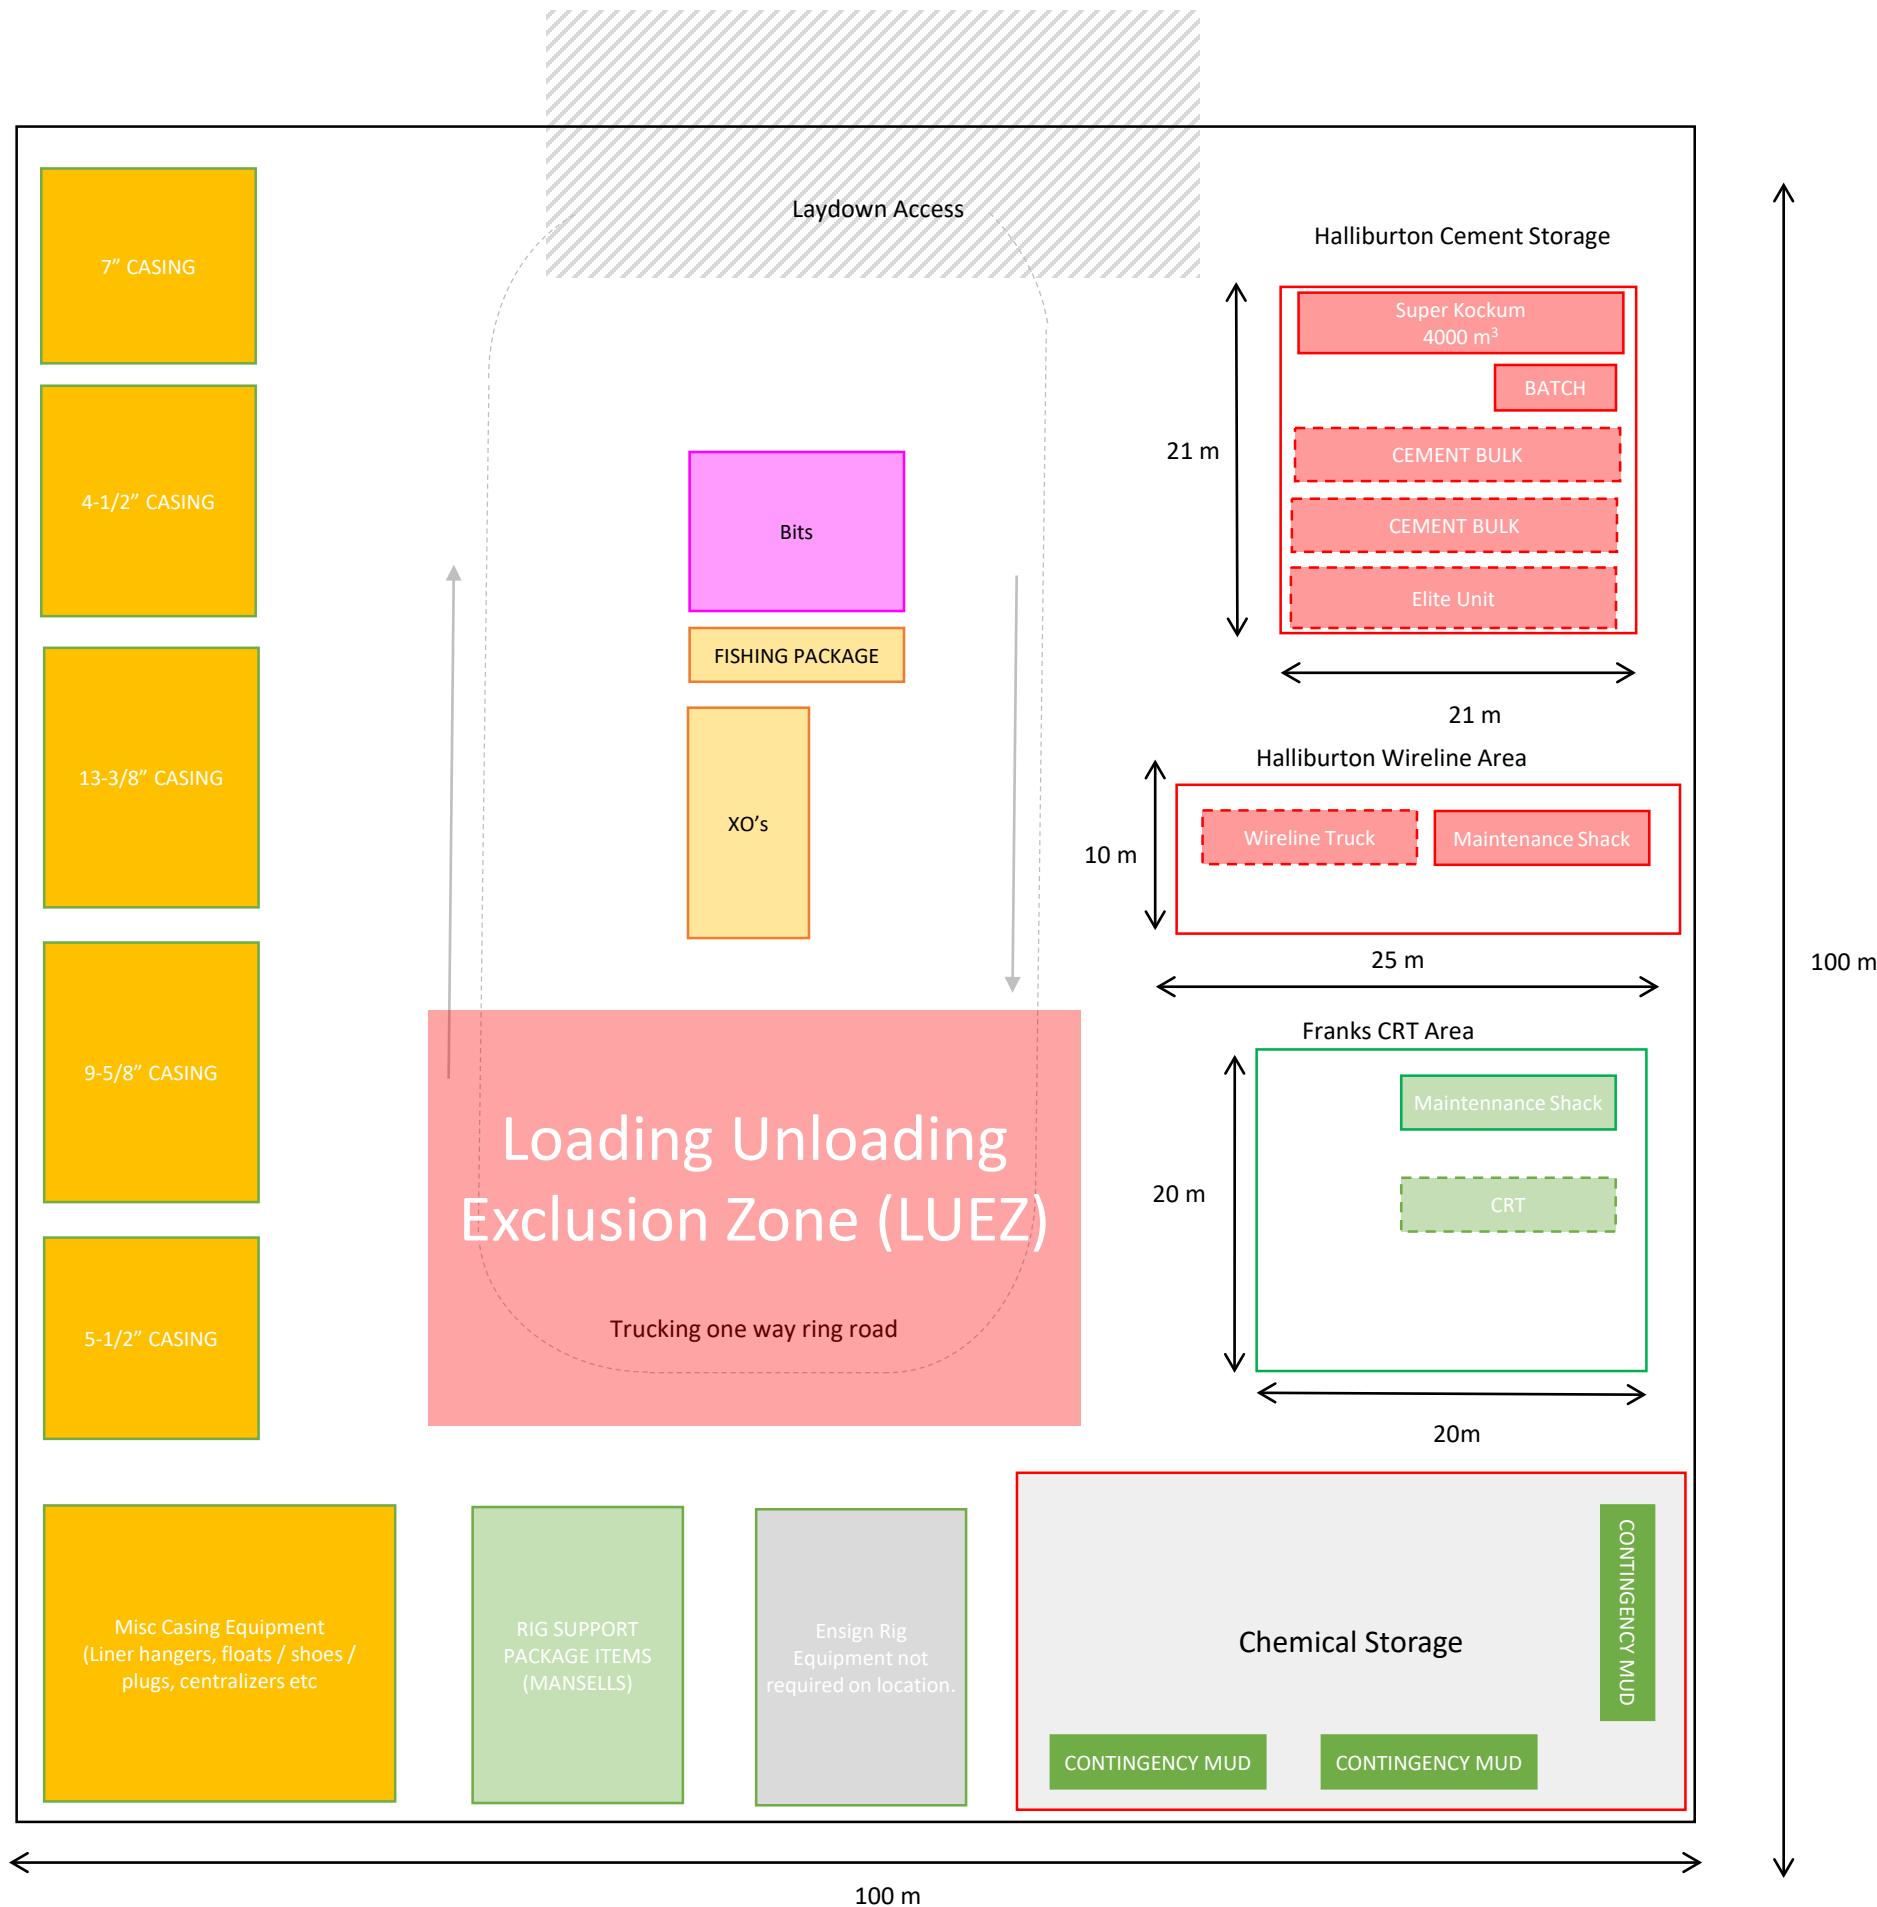
NOTE: This is only an indicative indication of the rig & equipment proposed layout.

- Laydown pad is aimed at minimising truck movements of infrequently utilised items or contingency items.
- Minimise unnecessary load movements between leases.
 - Utilise as a staging area as required
 - Lease will be fenced with grid access.

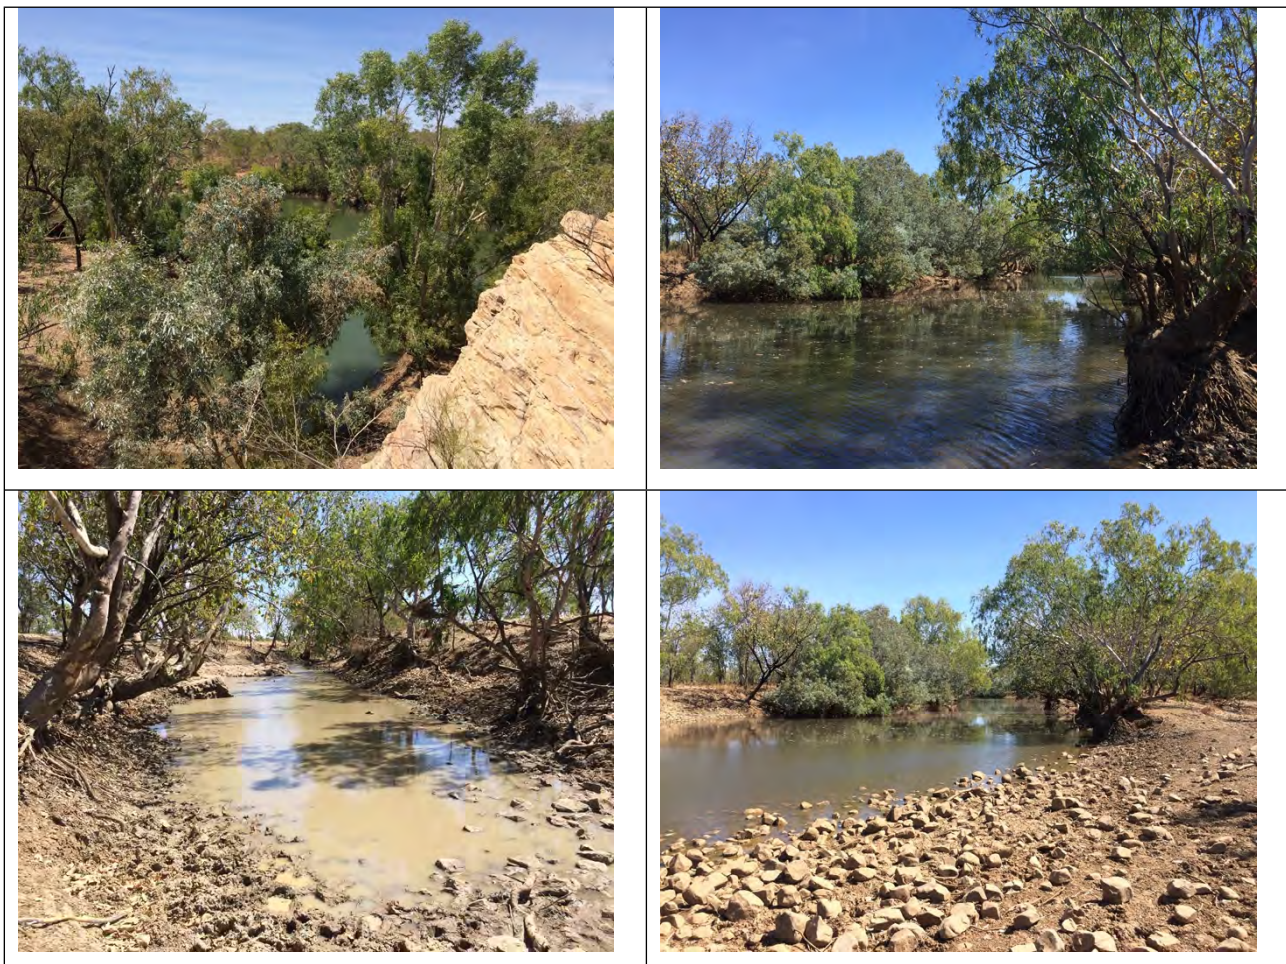
Figure 3-6. Photos showing typical riparian vegetation within the survey area

Six riparian sites were visited during field survey (this is a representative set of sites within the survey area). Typical riparian vegetation in the region consists of *Eucalyptus* and *Melaleuca* communities with tussock grass understoreys. Riparian vegetation within the survey area was confined to the banks of the watercourse and did not extend far into the surrounding country.

Like other areas within the survey area, riparian vegetation exhibited impacts from cattle. Erosion from cattle trampling was evident on the banks of all watercourses visited. Understorey grass species showed extensive impact from cattle grazing; this has likely exacerbated the erosion along the watercourse banks.

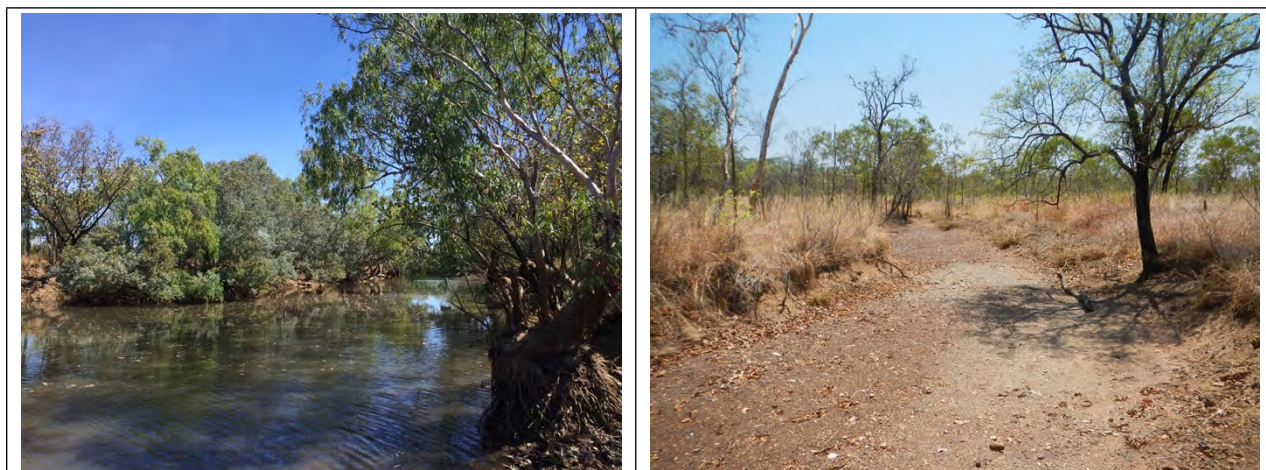
Figure 4-3. Examples of sensitive riparian vegetation (left) and drainage line vegetation (right).

Initial site visits determined that such closed forest community riparian vegetation was present within the survey area (Figure 4-3 left). Analysis of aerial imagery indicates the project area crosses ephemeral watercourses; however, not all the vegetation along these watercourses should be considered a sensitive riparian community. The majority of vegetation along the ephemeral watercourses in the area is an extension of the surrounding vegetation communities, or consists of species not found in the surrounding vegetation (e.g. *Eucalyptus camaldulensis*) but is sparse and does not provide the habitat characteristics or bank stabilising properties of sensitive riparian vegetation communities (Figure 4-3 right).

- Riparian vegetation – vegetation considered sensitive under the *NT Land Clearing Guidelines* (e.g. Figure 4-3 left).
- Drainage line vegetation – vegetation along a drainage line but not considered sensitive riparian vegetation under the *NT Land Clearing Guidelines* (e.g. Figure 4-3 right).

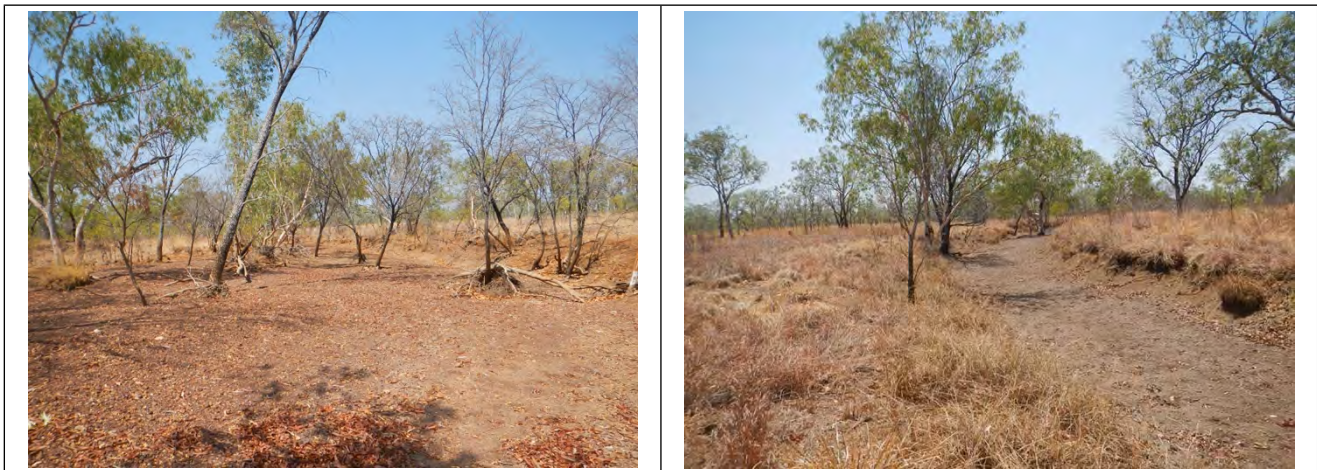
Figure 4-4. Photos of riparian (left) and drainage line (right) vegetation within Inacumba-1 survey area

There is a patch of riparian vegetation along the edge of drainage channels within the southern sections of the Inacumba-1 survey area. *Eucalyptus camaldulensis* and *Terminalia bursarina* are the dominant species in this open woodland community. This vegetation is associated with Inacumba Creek, a minor watercourse of stream order three. There is also a patch of drainage line vegetation extending from the north of the survey to the south east. This vegetation community consists of *Eucalyptus camaldulensis* and *Terminalia bursarina*, as well as *Eucalyptus pruinosa*, a species that dominates the surrounding open woodland within the Inacumba-1 survey area.

The location of riparian and drainage areas has been mapped for the Inacumba-1 survey area and is shown in Figure 4-5. Photos of riparian and drainage line vegetation within Inacumba-1 are shown in Figure 4-4.

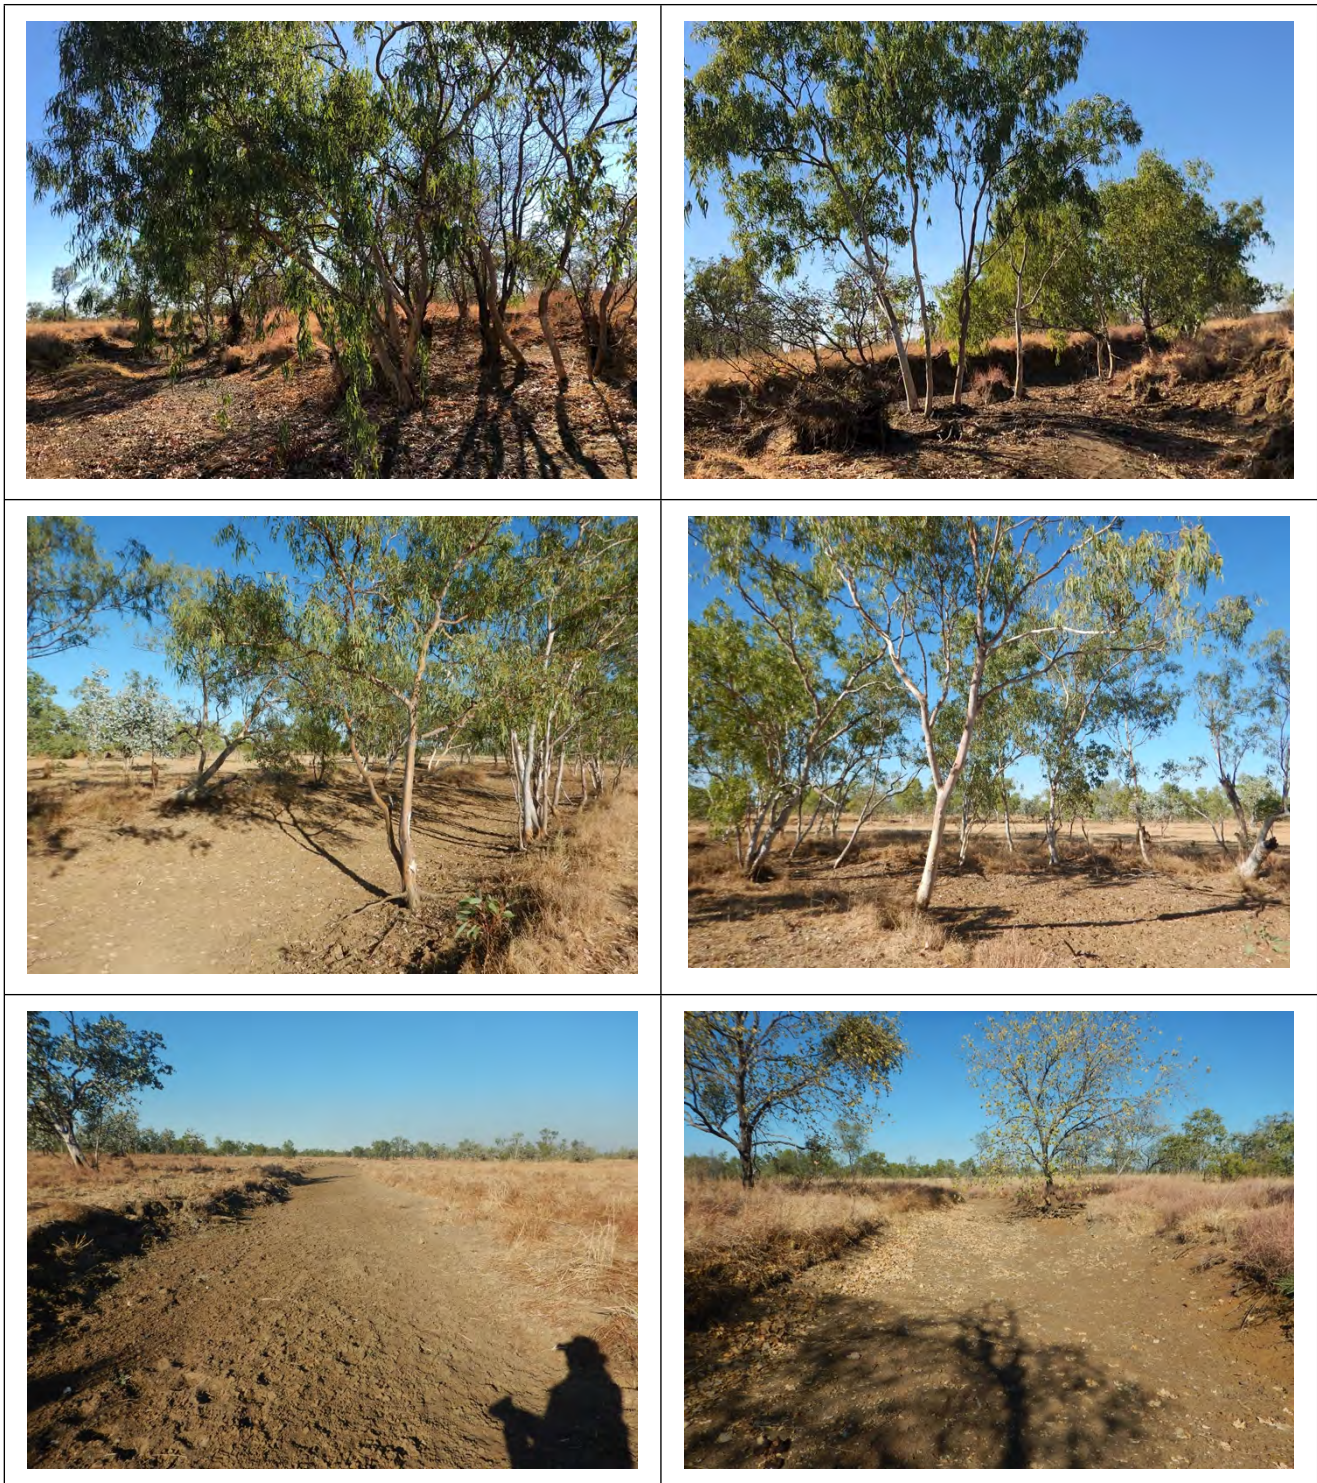
Figure 4-6. Photos of drainage line vegetation along transects radiating from Tanumbirini-2

The vegetation intersected by linear transects radiating out from Tanumbirini-2 at watercourse crossings comprised primarily a narrow strip of *Eucalyptus camaldulensis* in the upper-storey. Canopy cover along this strip is higher than the surrounding woodland and open plains; however, visual inspection did not indicate that canopy foliage cover was sufficiently dense for the vegetation to be classified as a forest community.

Height of upper-storey of riparian vegetation was between 5 and 10 metres. There was limited mid-storey vegetation at any of the watercourse crossing sites. Ground cover comprised tussock grasses consistent with the surrounding vegetation community. Vegetation at a number of drainage lines did not show any distinction between that of the surrounding landscape. Photos of vegetation at locations watercourses are shown in Figure 4-6.

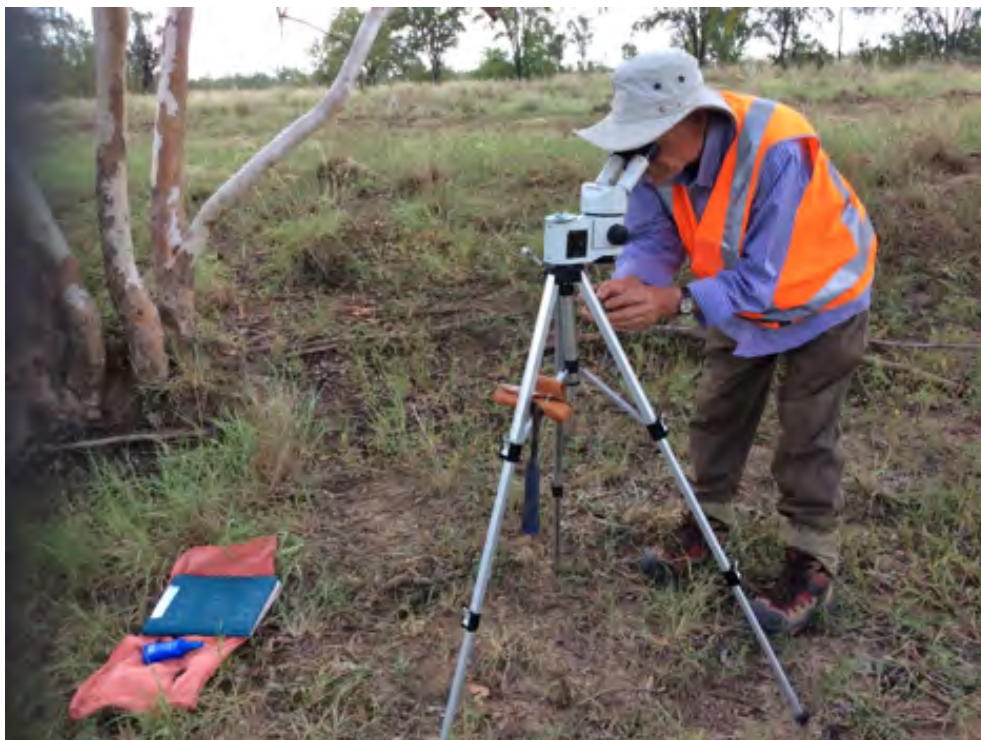
Plate 1. Low-magnification microscopic examination of natural stone occurring in a creek bank in the Tanumbirini North Area.

The field survey corroborates the background research finding that there appear to be no local sources of stone for stone-tool making. All stone, other than ironstone for red and yellow pigment, would have had to be brought in to the area; possibly from well beyond daily hunting and foraging distances from the encampment area. The potential distances of suitable stone sources are not known at this time, other than that sandstone possibly suitable for grinding stones and abraders, and brittle siliceous stone with conchoidal fracture properties (located approximately 30 km to the east), and also volcanic or metamorphic stone for ground-stone tools, may occur within the general region.

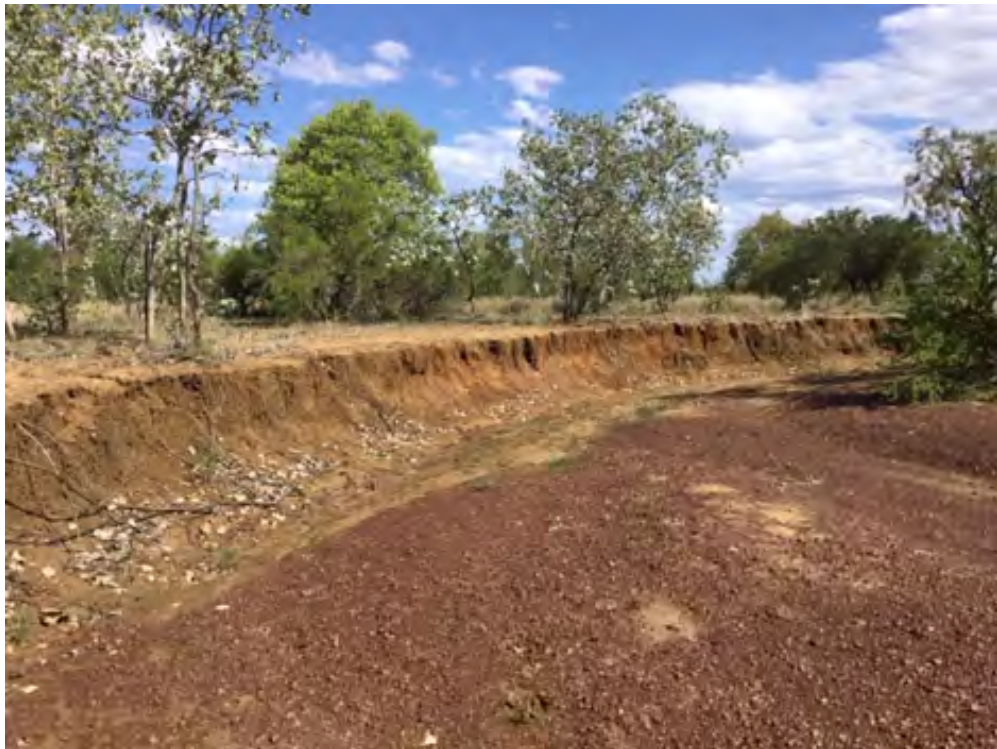
Plate 4. Meandering steep outer side of bend in a creek channel where ironstone lag has been concentrated on the more gently inclined inside slope of the channel. No Aboriginal stone artefacts were found in this location, despite the clear ground surface visibility on the ironstone gravel pavement.

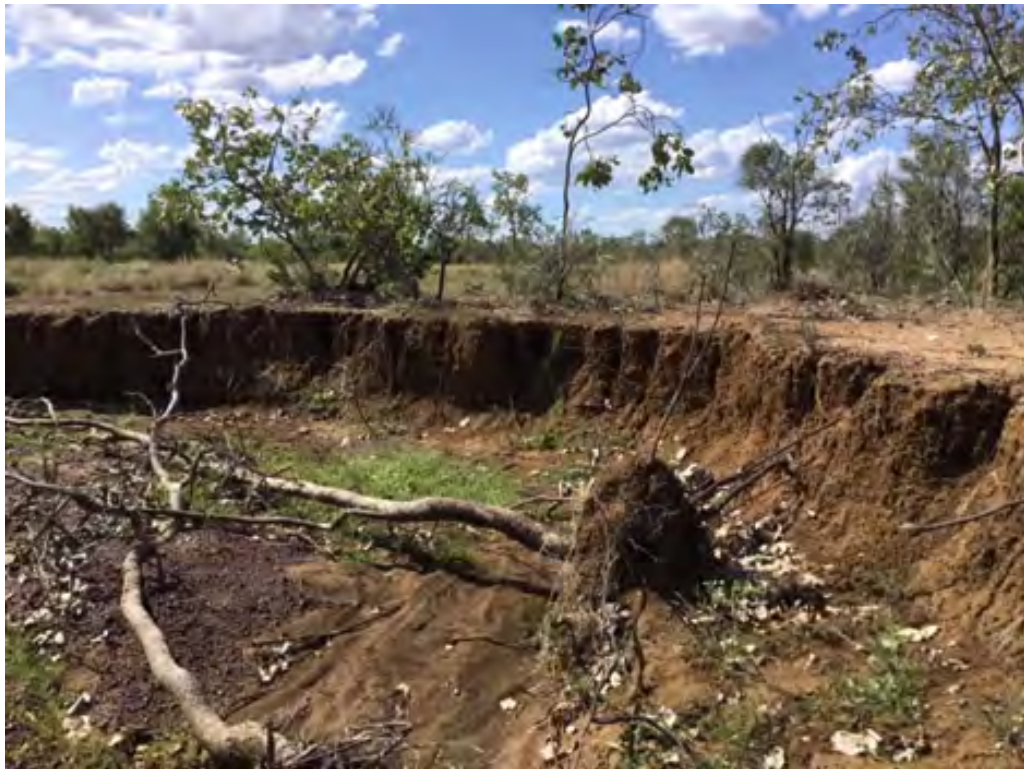
Plate 6. Actively migrating creek channel, exhibiting erosion causing tree fall and a steep outer channel margin exposing depth of loose clayey sand sediment. Located in the Tanumbirini North Area. Aboriginal stone artefacts are absent in the section along the channel bank or within the channel.

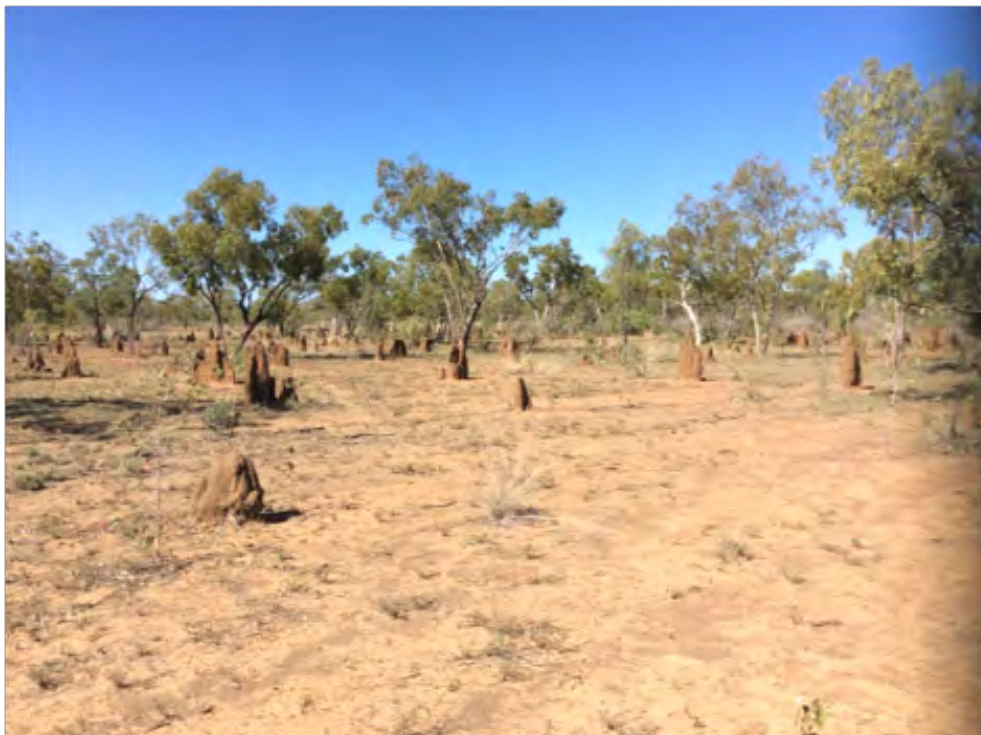
Plate 7. Termite mounds in the Ianumbirini North Area. Termite mounds are ubiquitous throughout this region.

Termite mounds and ant nests (Plate 7.) are ubiquitous throughout much of the survey area, indicating that intensive invertebrate bioturbation of the loose sediment of the biomantle has been occurring over thousands of years up to the present time (c.f. Cahen & Moeyerson 1977; Dean-Jones & Mitchell 1993:43, 46; Mitchell 1988:52; Moeyersons 1978; O'Connell *et al.* 2018). As a consequence of this ongoing low-intensity long-term invertebrate bioturbation, many or most Aboriginal artefacts are not likely to be in their original stratigraphic context (cf., O'Connell *et al.*

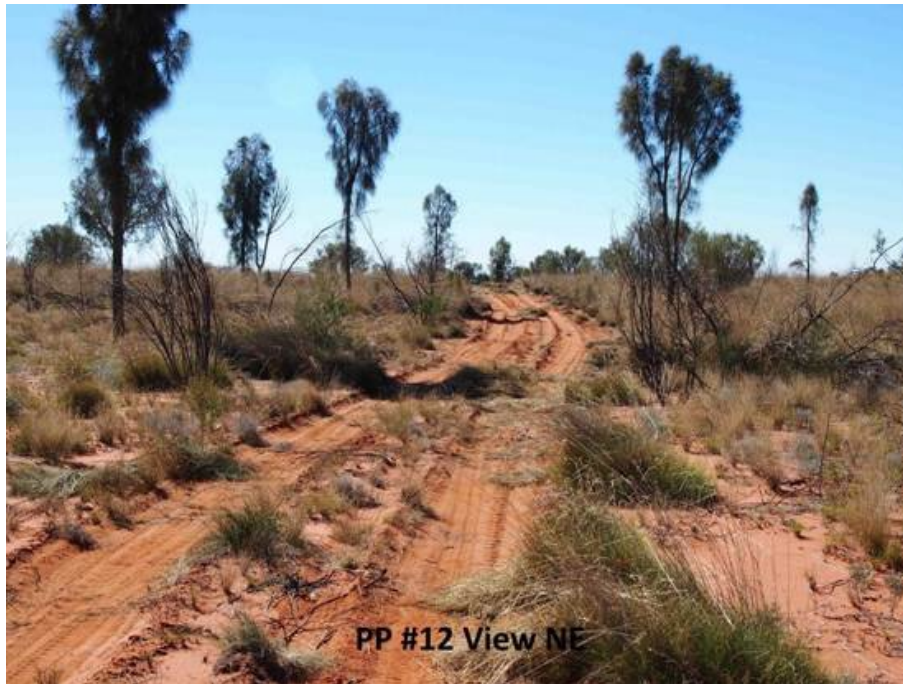
Figure: Example seismic line (Mereenie) after line Preparation

The line positions are pre-programmed into GPS units mounted in the dozers. These GPS units allow the dozer operators to get real time position updates. These are plotted on a display that also indicates the Cultural Heritage cleared corridor for the dozer operators.

The dozers weave around vegetation stands and on open ground the machines weave every 75-100m to reduce the visual impact. Other items such as roads, infrastructure, detours plus any exclusion zones or restricted work areas are also displayed on the dozer GPS units so the operator has a detailed project map shown in relation to their position at all times.

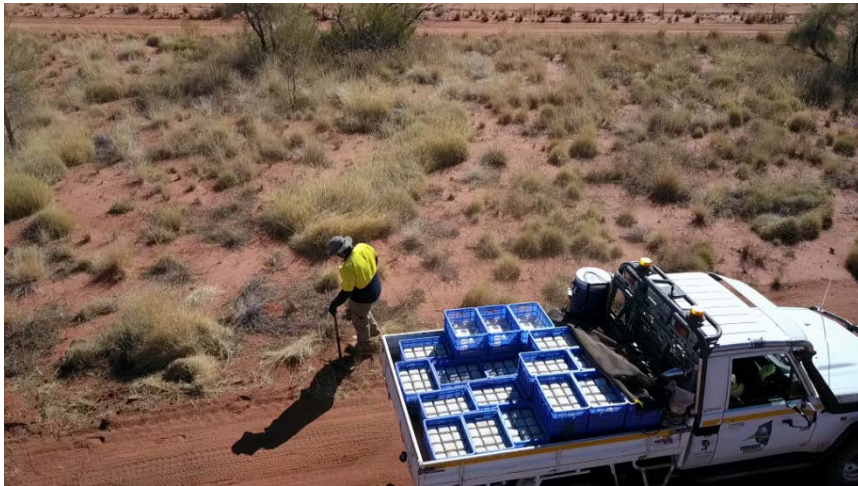
Work commences with the deployment of small seismic detectors (geophones) that contain the geophone element, a GPS receiver, hard disk storage and a battery. These are deployed along the line at a pre-determined interval, dependent on geophysical target, which can be between 2.5m and 25m increments.

Figure: Seismic line crew deploying geophones

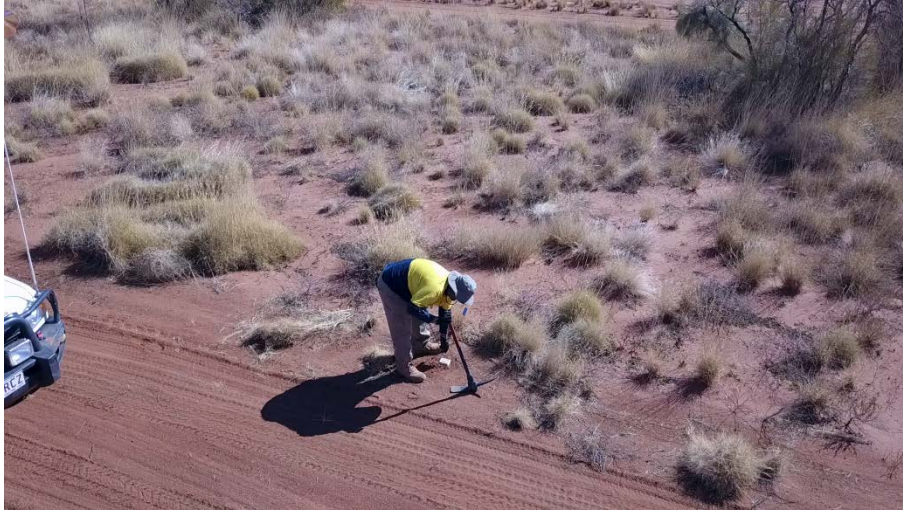
Figure: Seismic line crew planting geophones

Recording would normally commence when a sufficient number of geophones have been deployed. This layout is termed “the spread” and it picks up the acoustic energy transmitted from subsurface layers during the seismic surveying process, converts it to electrical energy and stores that information on a hard drive within the unit. Surveys may have up to 12km or more of spread live at any one time.

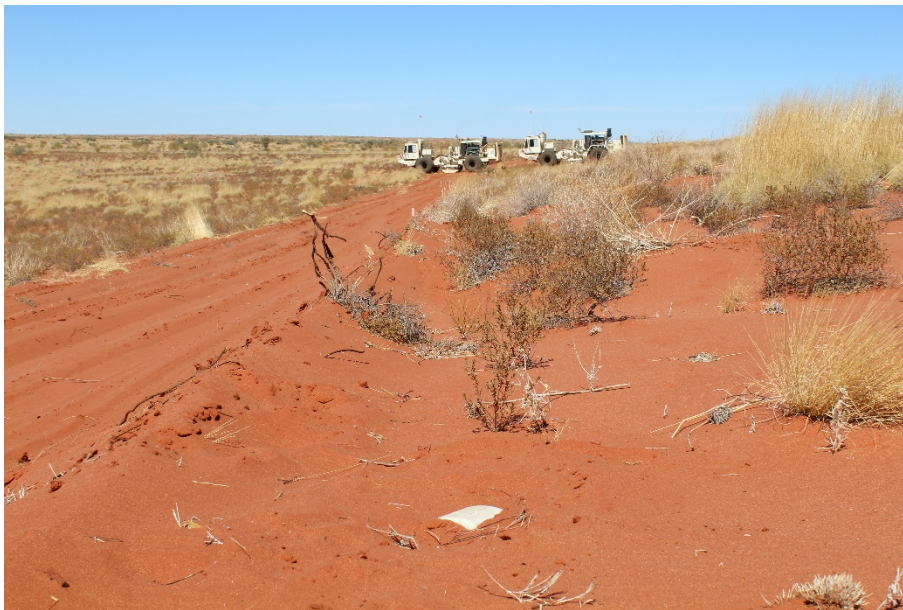
Figure: Geophone planted in the ground

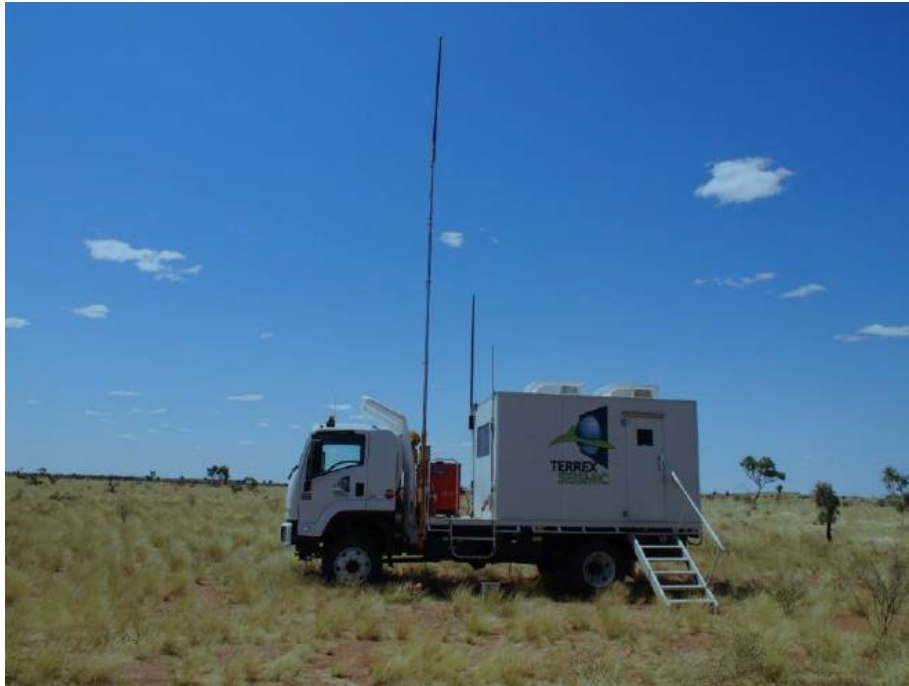
Figure: Seismic Recording Truck
