Appendices

Appendix A: Detailed Lease Layout Plan

Ecology report
2019 exploration program
Santos

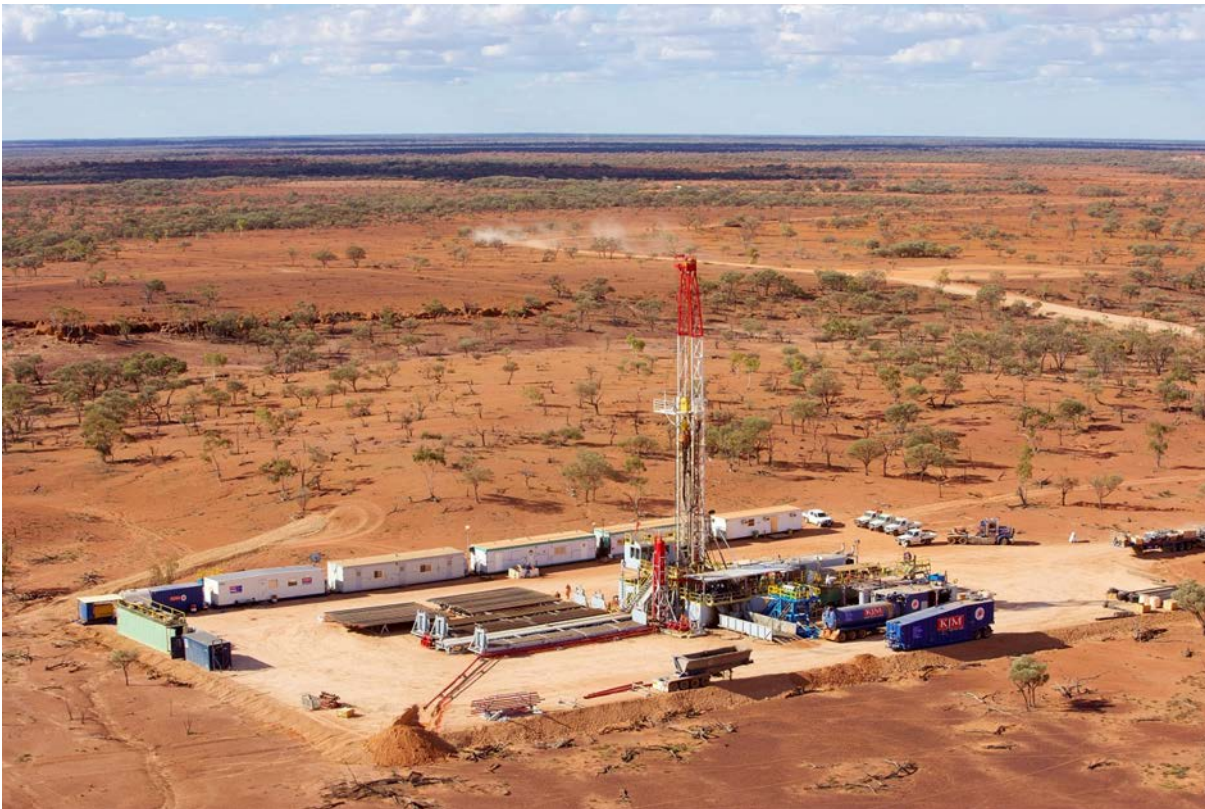
The figure below illustrates a typical drilling rig layout and lease and access roads required for a Cooper Basin drilling operation. The drilling rig along with specialised wellsite support services and camp are mobilised to the well location, comprising 100-150 truckloads. The drilling rig camp is either located adjacent to the wellsite or in a location central to multiple wellsites. It is designed to accommodate the crew working at the wellsite, and will expand and contract as required to meet personnel requirements.

Figure: Drilling rig in the Cooper Basin. (Source: Santos 2016)

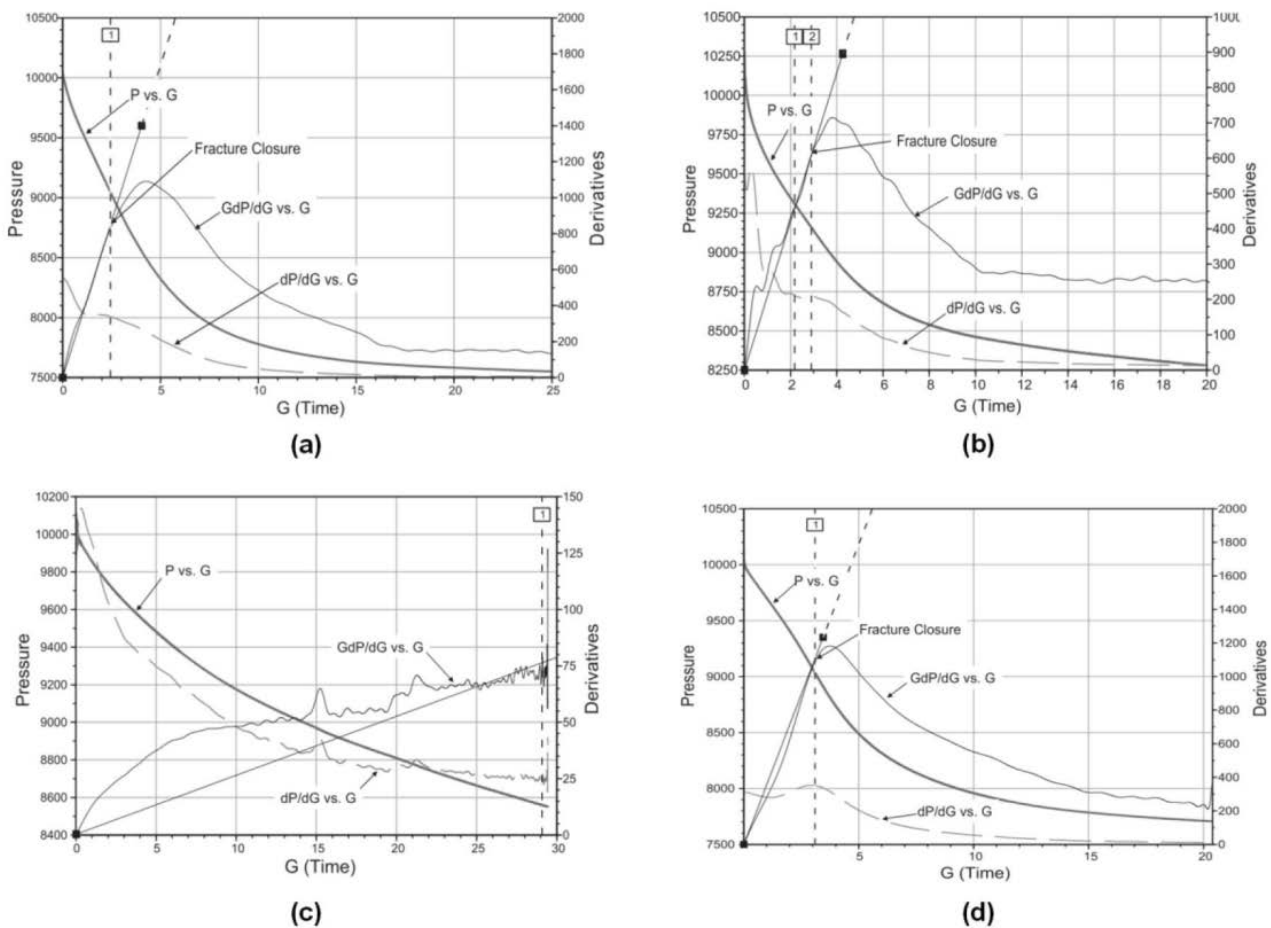
A Diagnostic Fracture Injection Test (DFIT) goes by many names: mini-frac, mini fall-off, datafrac, etc.; but all refer to the act of injecting small volumes of a clear fluid (usually with a small percentage of Potassium Chloride e.g. 2 to 3% KCl) at low pumping rates to create a fracture before the wellhead is shut-in and the pressure allowed to fall-off naturally. The fluid contains no proppant so that the fracture can relax and close naturally when pressure is released. The pressure changes are measured with high-accuracy gauges that are either placed deep in the wellbore or at surface on the wellhead. The analyses of fracturing pressure, during injection and after shut-in, provide powerful tools for understanding and improving the fracturing process. The importance of this DFIT analysis of fracture pressure was recognized in 1958 by Godbey, J.K. and Hodges, H.D. and pioneered by Nolte in 1979 who introduced the G-Function based on material balance and the Carter leak-off model. Barre et al. in 1996 recommended using the G-Function and its diagnostic derivatives to identify fracture closure and signatures of non-ideal leak-off behaviours such as tip extension, pressure dependant leak-off (PDL) and storage height recession signatures. These signatures help operators recognise fracture behaviours and design fracture stimulation programs accordingly to ensure that the targeted reservoirs are stimulated optimally. Below are examples of the signature behaviours that are commonly used in the industry to observe fracture injectivity responses:

Figure: (a) Normal leak-off; (b) pressure dependant leak-off (PDL); (c) tip extension; (d) storage/height recession signatures on G-function plots (Barre et al. 2009).

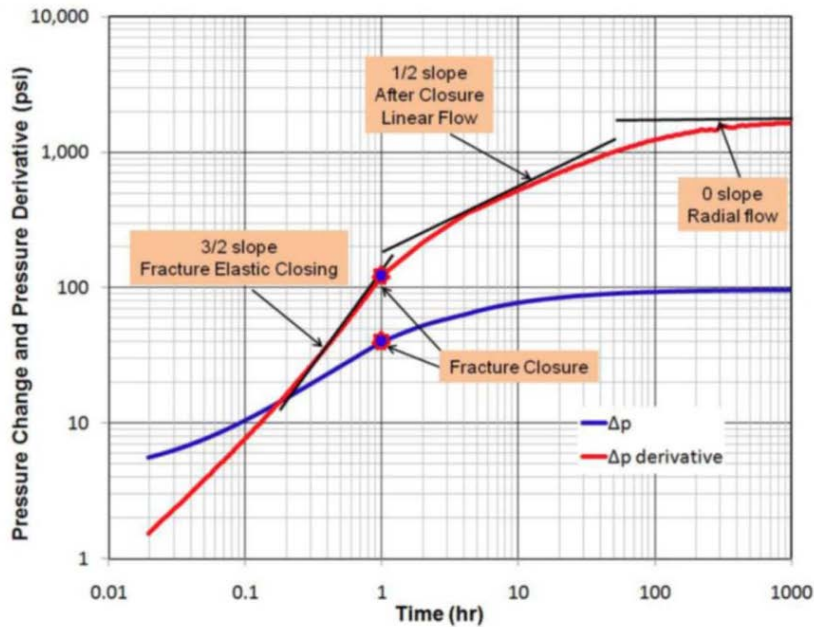
Figure: Log-log diagnostic plot of an idealised fracture-injection/fall-off test (Marongiu-Porcu et al. 2011).

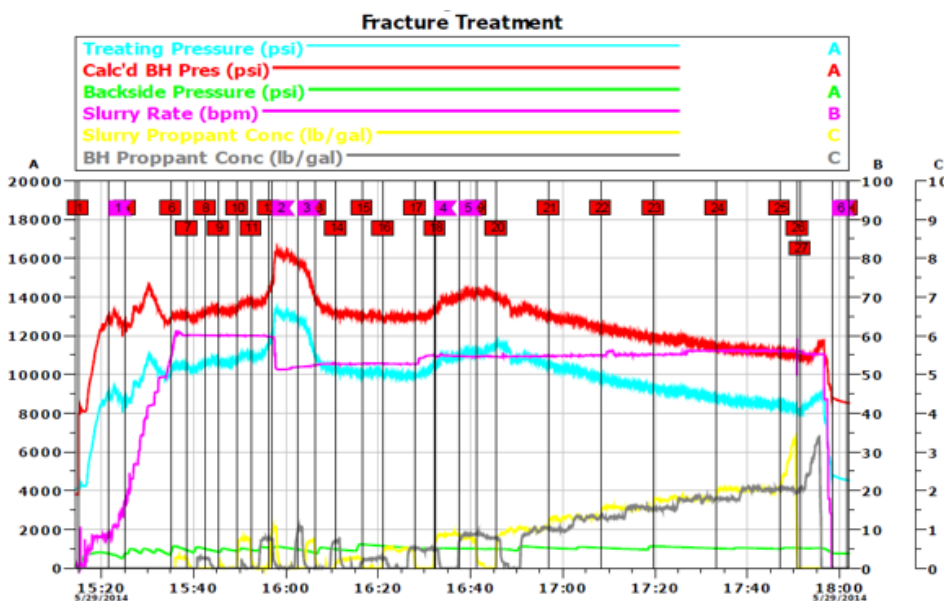
Figure: Real time monitoring of hydraulic fracture parameters (pressure, rate etc.) on a shale gas frac in the Cooper Basin (Santos 2014)

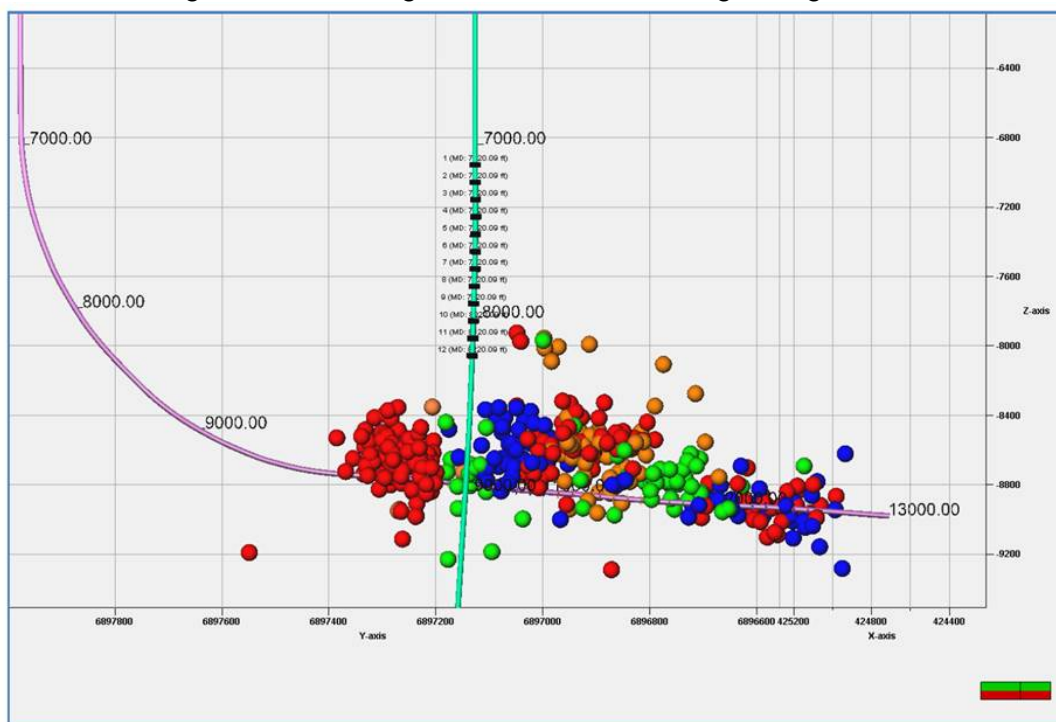
Figure: Microseismic events mapped during the 10 stage shale hydraulic fracture treatments pumped in the Cooper Basin. The different colours represent the different frac stages (Santos 2014).

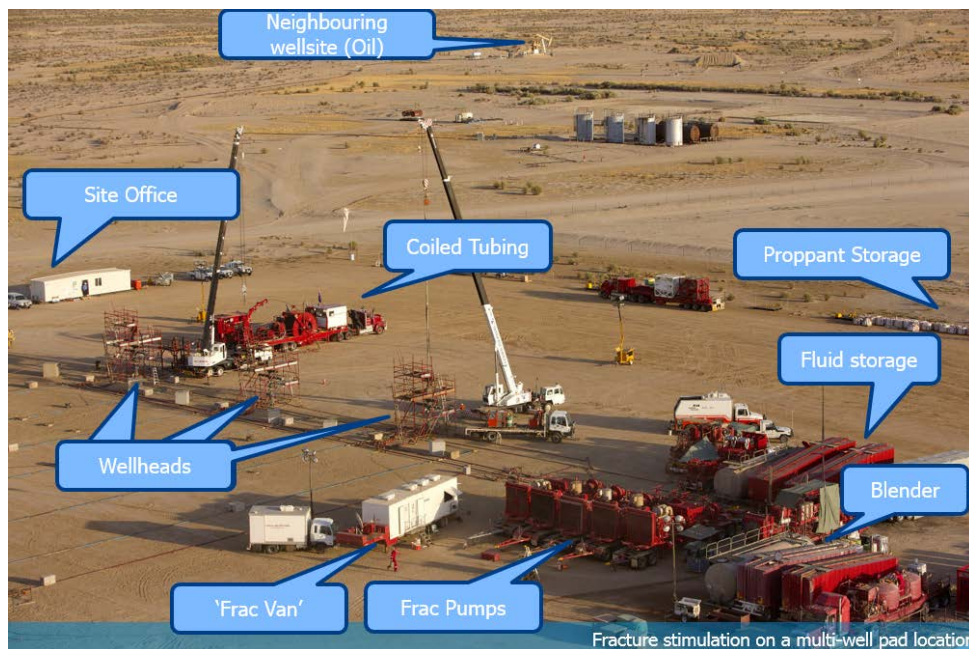
Figure: Fracture Stimulation spread rigged up on a 3-well pad in the Cooper Basin. (Source: Santos 2016)

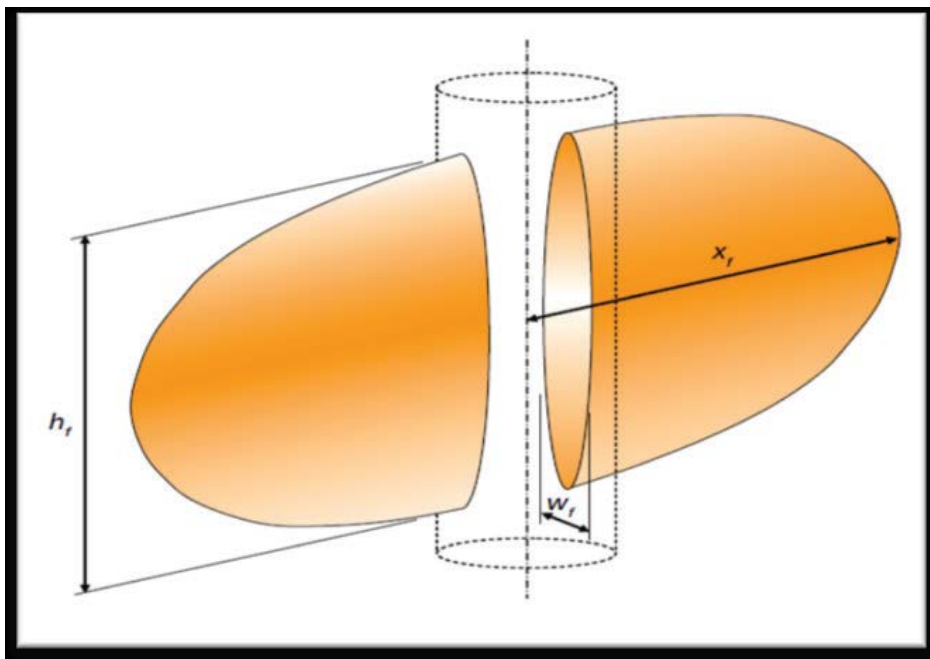
Figure: Conceptualised Shape of Hydraulic Stimulation Zone of Influence. (Source: Economides and Martin, 2007)

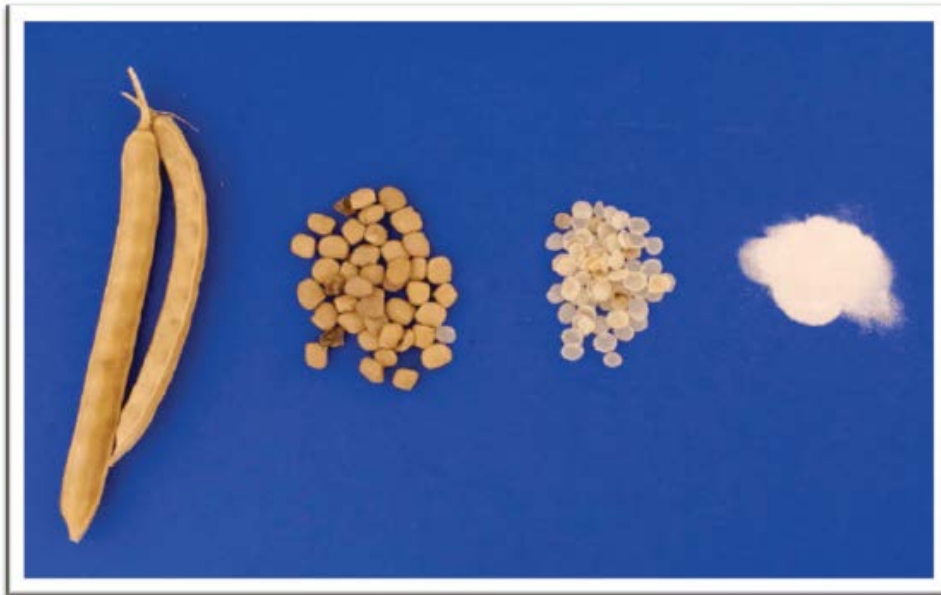
Figure: Example of a typical slurry gum constituent, guar gum – illustrating its native form, seed form, splits and powder.

*** Note: Guar gum is a vegetable product which is ground into a powder and used to create a viscous liquid for hydraulic fracturing. (Source: Economides and Martin, 2007)*

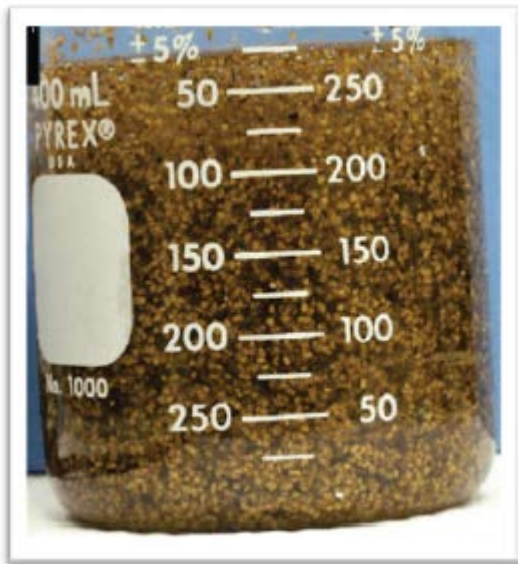
Figure: Typical sand - guar gum fluid mix. (Source Economides and Martin, 2007)

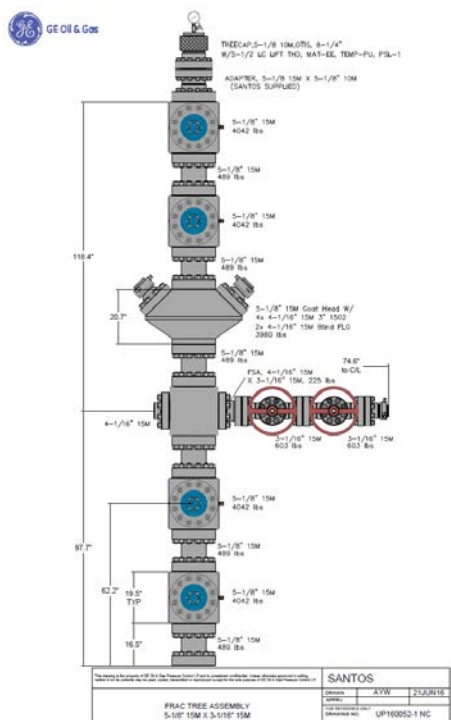
Figure: Typical hydraulic stimulation wellhead used for shale stimulation operations

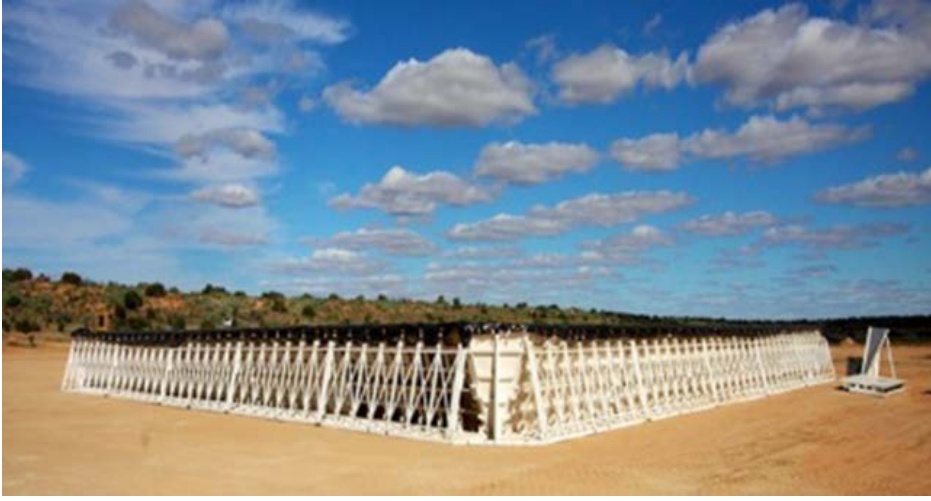
Figure: Above ground storage ponds used for frac make up water storage and frac flowback water storage in the Cooper Basin, (Santos 2013)

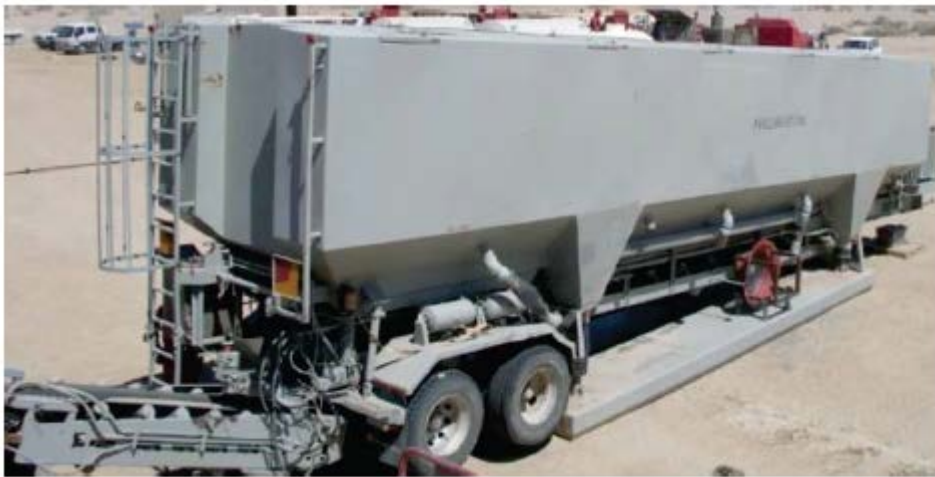
Sand Trailer Unit – a large, multi-compartment trailer that holds proppant (sand or ceramic material) required for the treatment. When proppant is required, a conveyor system distributes proppant from the compartments to the blender unit.

Figure: Sand trailer unit. (Halliburton 2012)

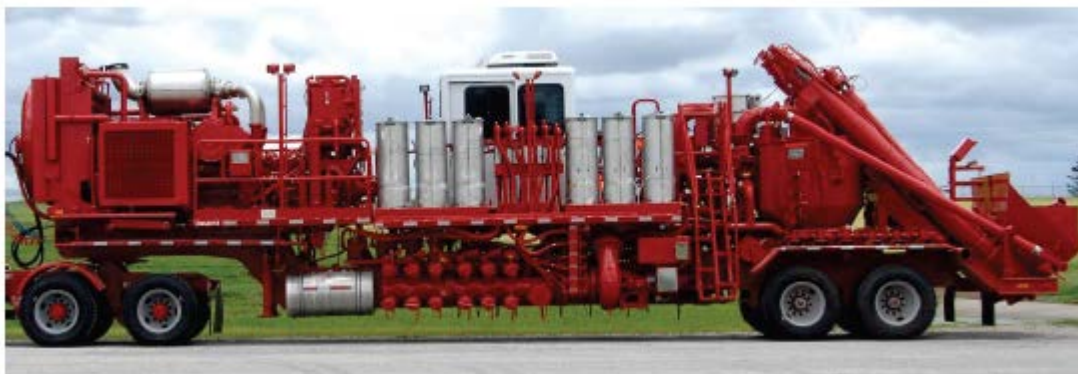
Figure: Blender unit. (Halliburton 2012)

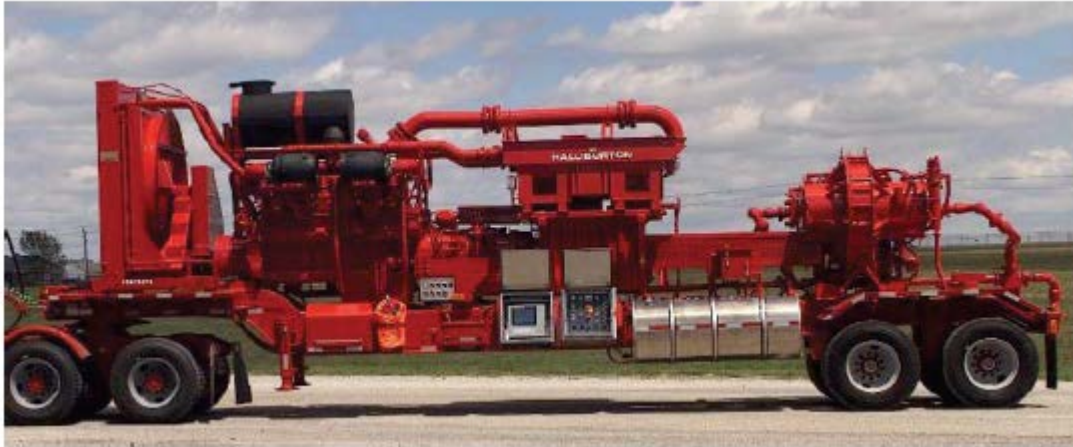
Figure: High pressure pump. (Halliburton 2012)

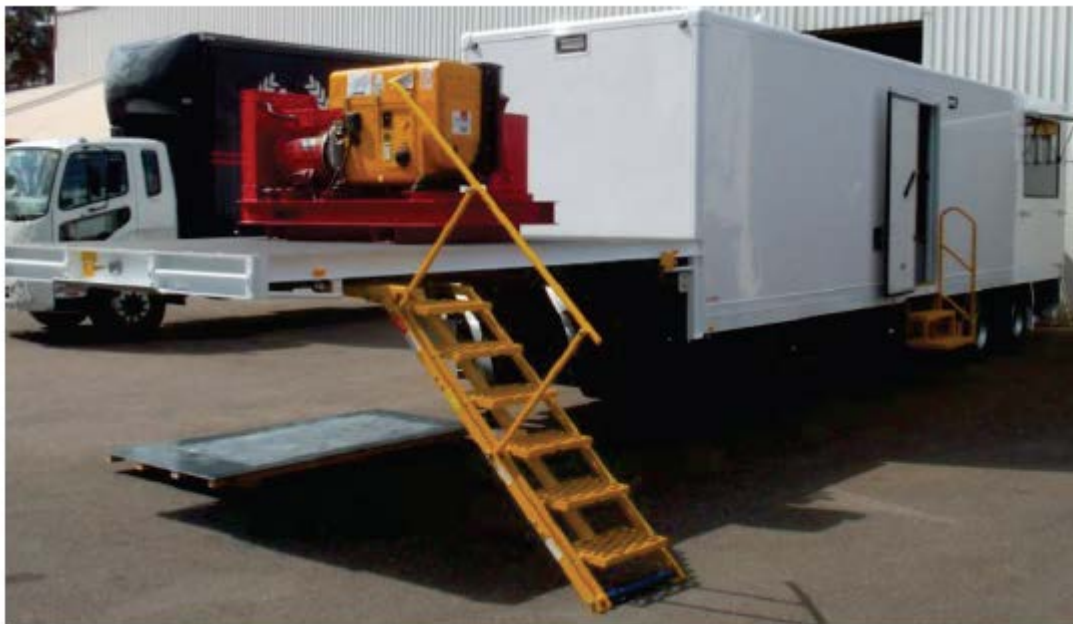
Figure: Control unit. (Halliburton 2012)

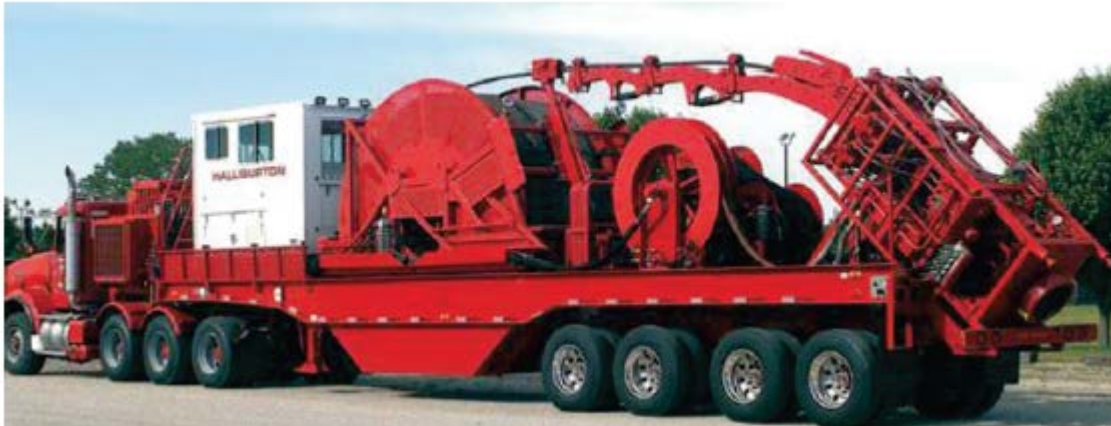
Figure 3.19: Coiled tubing unit. (Halliburton 2012)

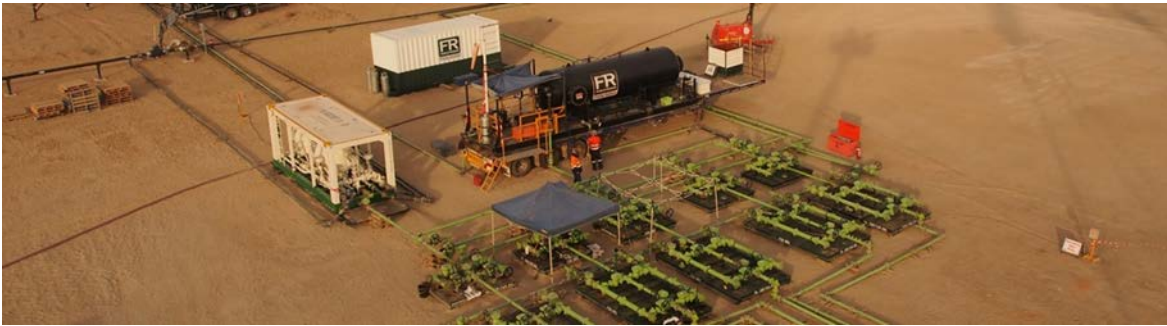
Figure 3.20: Flow testing separator rig up on a pad location. (Farley Riggs 2014)

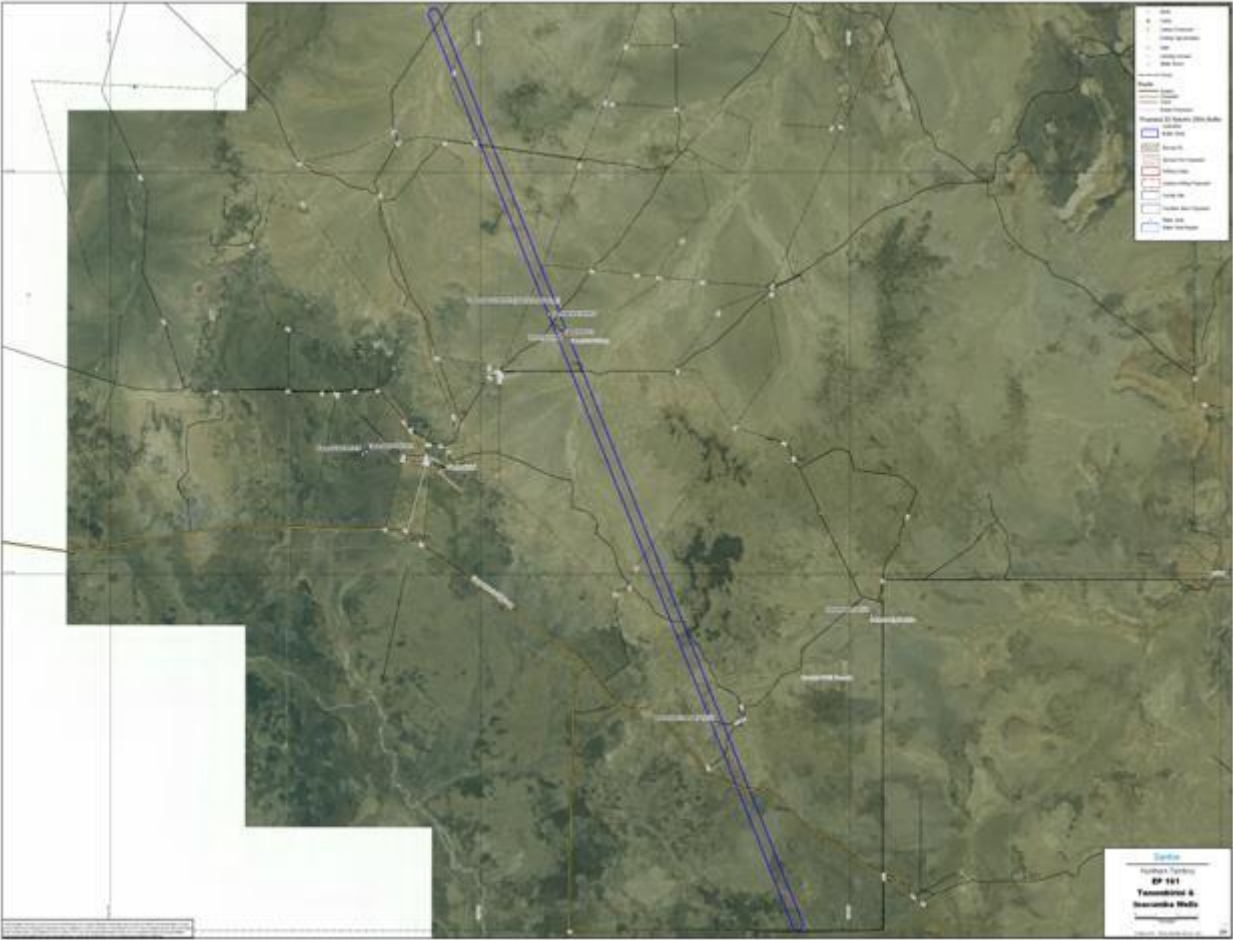
2D seismic line between Tanumbirini #2 and Inacumba South #1
