Darwin - Palmerston report card 2009

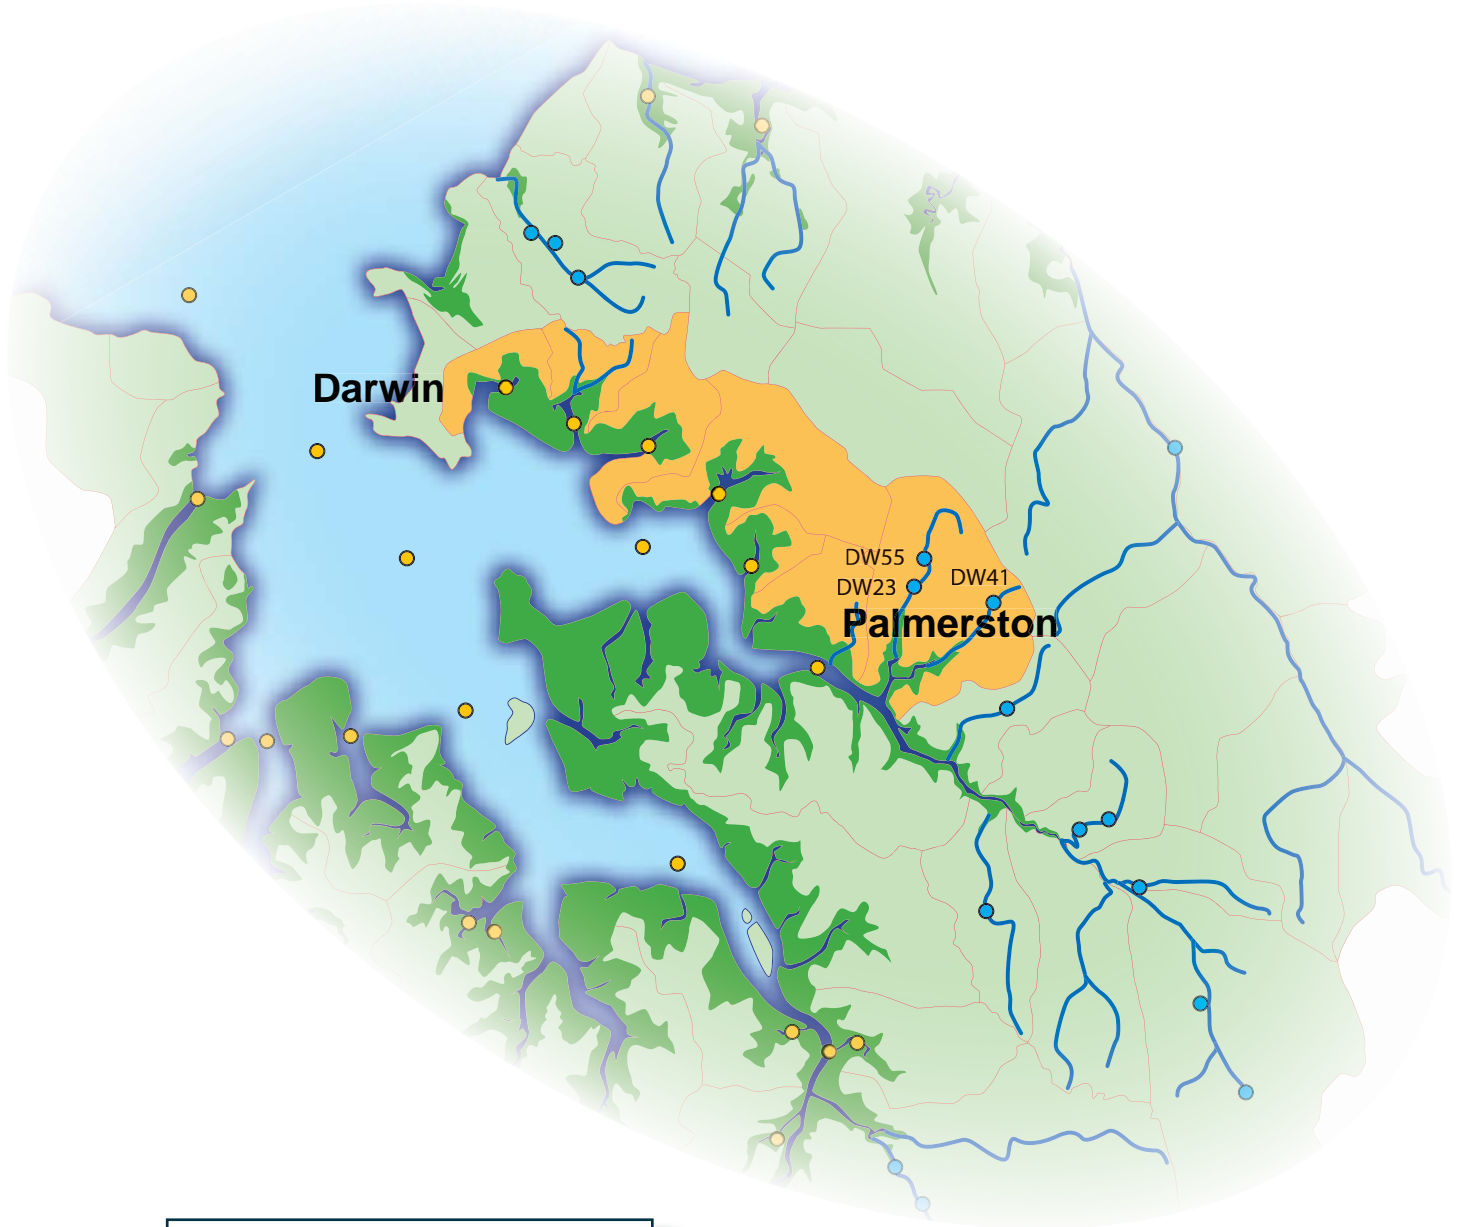
Darwin-Palmerston area catchment showing subcatchments, features and monitoring sites.
