# Darwin Harbour Region Report Cards 2011

This report was prepared by John Drewry, Julia Fortune, Matt Majid, Julia Schult, Gisela Lamche, Simon Townsend and Stephen Cusack of the Aquatic Health Unit, Department of Natural Resources, Environment, The Arts and Sport, Palmerston NT 0831.

Report No 17/2011D

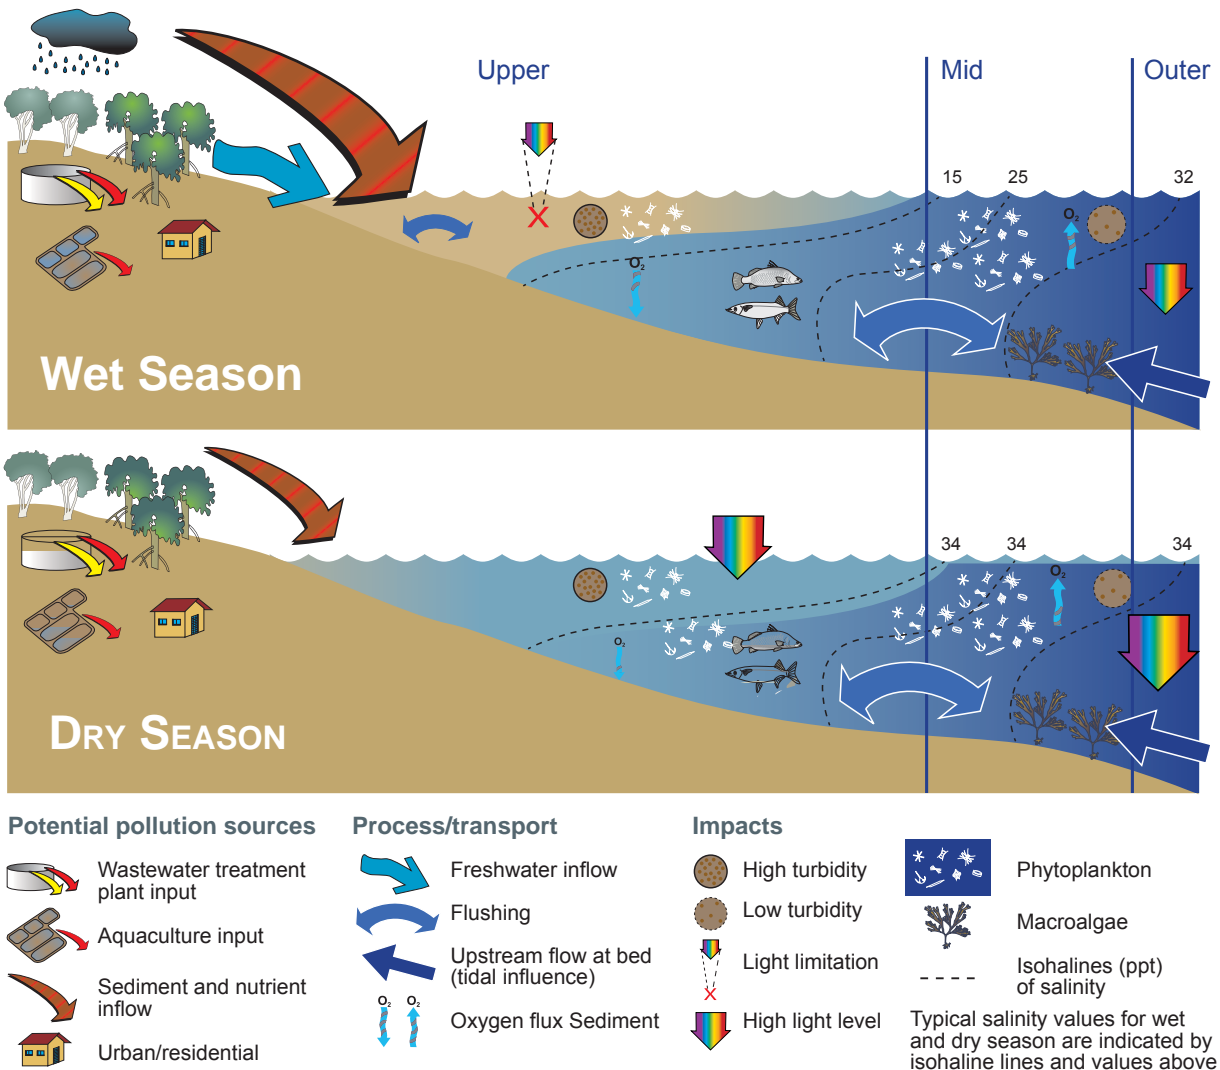
Environmental goals shown in the diagram include:

- Maintaining or improving water quality;
- Protecting or restoring marine and freshwater habitats;
- Protecting marine and freshwater biodiversity;
- Minimising algal blooms; and
- Minimising nutrients, sediment and other pollutants to waterways.

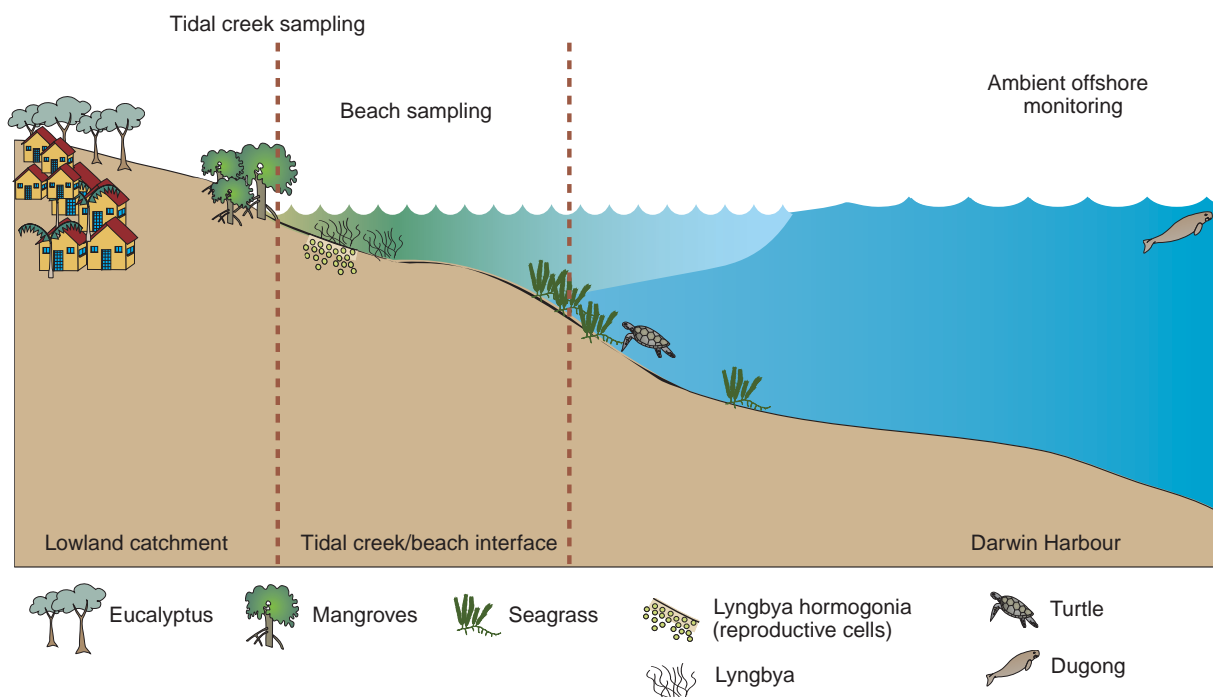
## Conceptual diagram of sampling effort to inform report cards.

The diagram below demonstrates sampling undertaken by NRETAS at tidal creeks and beaches. Outer harbour sampling is also undertaken as part of a broader monitoring program to inform water quality condition. Water quality measurements are taken at these sites quarterly to inform the Report Card grading for catchments.

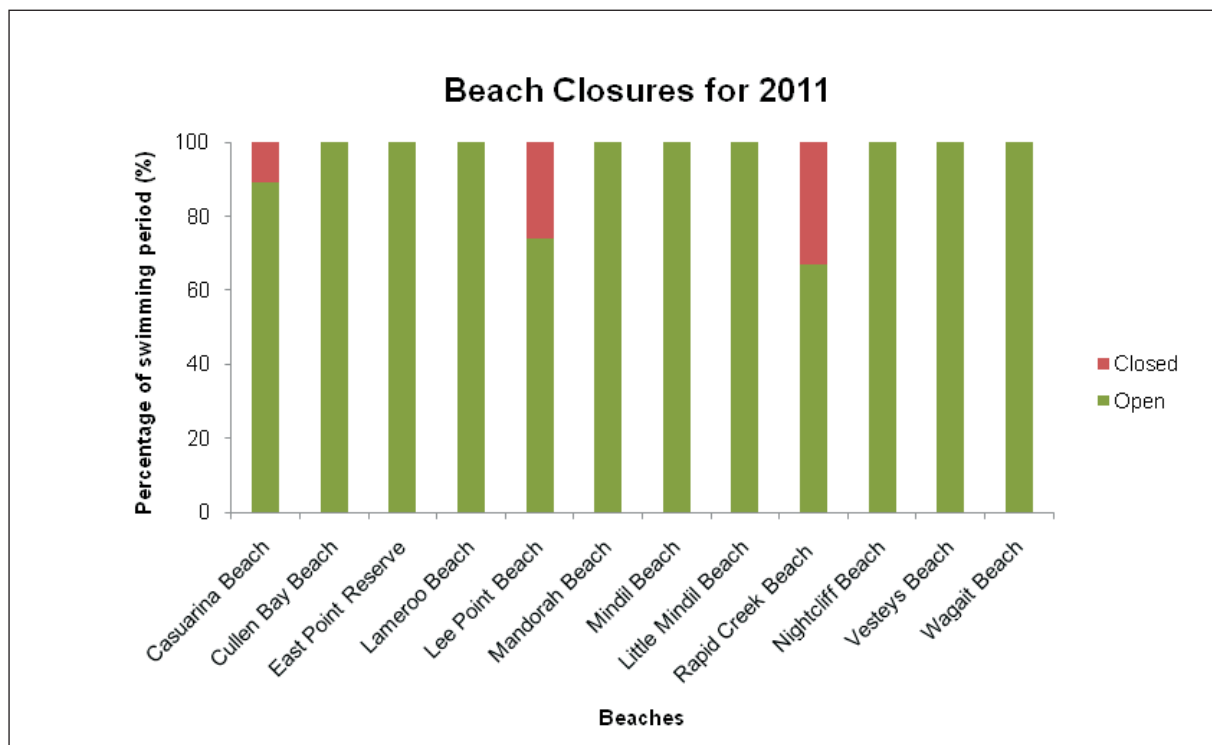
The figure below provides a summary of the closure results between 3 May and 24 October 2011. Most beaches are sampled weekly with the exception of Mandorah and Wagait which are sampled monthly.

Between 3 May and 24 October 2011, Casuarina Beach and Lee Point Beach were closed once to swimming and Rapid Creek Beach was closed on two occasions. Other beaches remained open.

Although individual sampling results in red mode occurred more frequently, two consecutive red mode samplings are required for a beach closure.
