Seismic Environment Management Plan Appendix A - B

EP136 - Beetaloo Sub-Basin, NT

Cover Photo: Southwards view of Line 10 from its intersection of Line 3, Beetaloo Station, November 2019

Land Condition Assessment

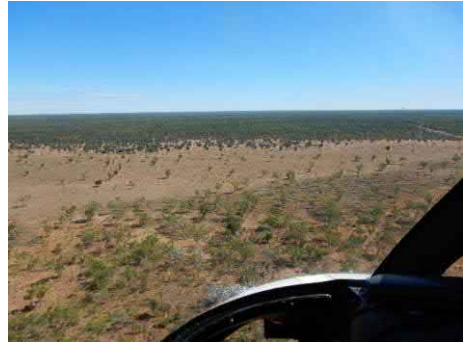
<p>Plate 1 NC01 - Line 9</p>
NC2 Line 9 (E-W) Tanumbirini Station	-16.518087°	134.638753°	Not assigned	Overland flow path following rainfall. No clearing of vegetation necessary for vehicle access during seismic survey.

Creek Reference Line Number Station	Location		Stream Order	Condition Description	Plate
	Latitude	Longitude			
Northern Survey Area					
NC1 Line 9 (E-W) Tanumbirini Station	-16.517940°	134.602306°	Intermittent Stream (1)	Overland flow following rainfall. No clearing of vegetation necessary for vehicle access during seismic survey.

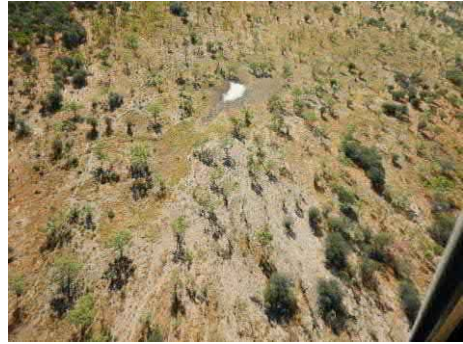
Creek Reference Line Number Station	Location		Stream Order	Condition Description	Plate
	Latitude	Longitude			
NC3 Line 10 (N-S) Tanumbirini Station	-16.529349°	134.515187°	Not assigned	Shallow depression holding water following 2019-2021 wet season. Generally considered an overland flow path following rainfall. No clearing of vegetation necessary for vehicle access during seismic survey.

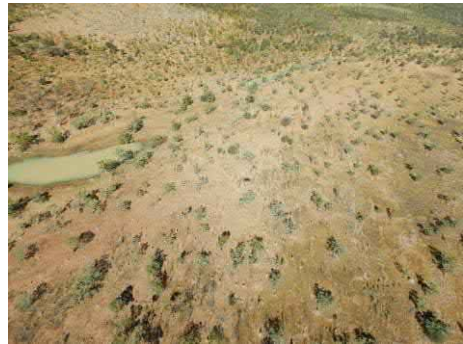
<p>Plate 4 NC04 – Line 11</p>

<p>Plate 3 NC03 – Line 10</p>
NC4 Line 11 (N-S) Tanumbirini Station	-16.535721°	134.558630°	Intermittent Stream (1)	Shallow depression holding water following 2019-2021 wet season. Generally considered an overland flow path following rainfall. No clearing of vegetation necessary for vehicle access during seismic survey.

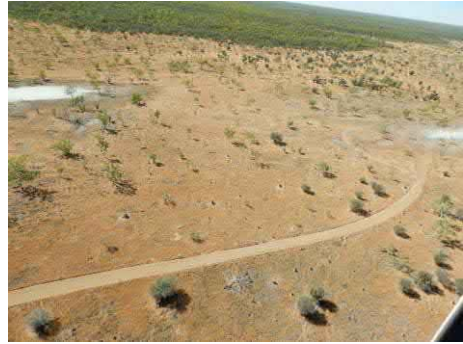
<p>Plate 5 NC05 – Line 12</p>
NC6 Line 9 (E-W) Tanumbirini Station	-16.553430°	134.606736°	Intermittent Stream (1) Newcastle Creek	Shallow depression holding water following 2019-2021 wet season. No clearing of vegetation necessary for vehicle access during seismic survey.

Creek Reference Line Number Station	Location		Stream Order	Condition Description	Plate
	Latitude	Longitude			
NC5 Line 12 (N-S) Tanumbirini Station	-16.532457°	134.606784°	Intermittent Stream (1) Newcastle Creek	Overland flow with some shallow depressions holding water following 2019-2021 wet season. Pastoral activity in area with existing tracks. No clearing of vegetation necessary for vehicle access during seismic survey.

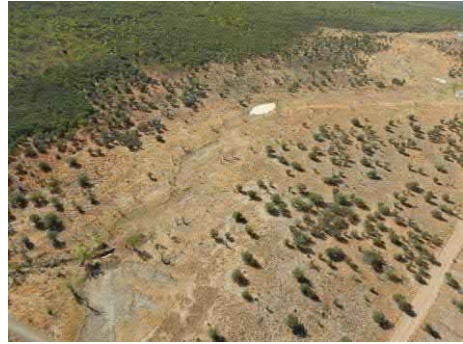
<p>Plate 7 NC07 – Line 8</p>
NC8 Line 8 (E-W) Tanumbirini Station	-16.556558°	134.667130°	Intermittent Stream (1)	Shallow channel evident with shallow depression holding water following wet season. Trafficable with no vegetation clearance necessary.

Creek Reference Line Number Station	Location		Stream Order	Condition Description	Plate
	Latitude	Longitude			
NC7 Line 8 (E-W) Tanumbirini Station	-16.556496°	134.621824°	Intermittent Stream (2) Newcastle Creek	Shallow channel evident with shallow depression holding water following wet season. Trafficable with no vegetation clearance necessary.

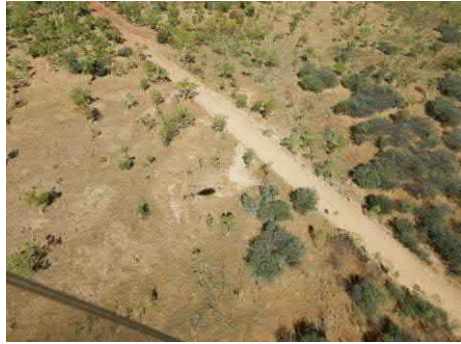
Plate 9 NC09 – Line 14
NC10 Line 13 (N-S) Tanumbirini Station	-16.580307°	134.654208°	Intermittent Stream (1)	Seismic line passes parallel nearby to the drainage channel. The channel will be avoided. Crossing is not required

Creek Reference Line Number Station	Location		Stream Order	Condition Description	Plate
	Latitude	Longitude			
NC9 Line 14 (N-S) Tanumbirini Station	-16.573355°	134.708028°	Not assigned	Shallow channel evident with shallow depression holding water following wet season. Trafficable with no vegetation clearance necessary.

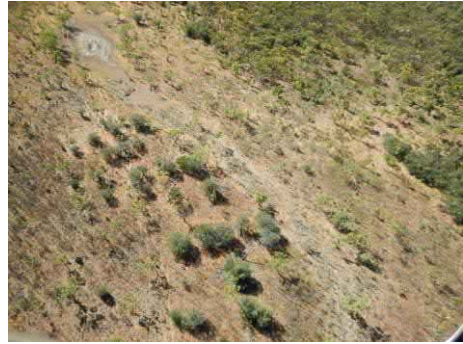
<p>Plate 11 NC11 – Line 13</p>
NC12 Line 7 (E-W) Tanumbirini Station	-16.601016°	134.645299°	Creek (3) Newcastle Creek	Shallow depression holding water following 2019-2021 wet season. No clearing of vegetation necessary for vehicle access during seismic survey.

Creek Reference Line Number Station	Location		Stream Order	Condition Description	Plate
	Latitude	Longitude			
NC11 Line 13 (N-S) Tanumbirini Station	-16.585358°	134.654190°	Intermittent Stream (1)	Shallow channel evident with shallow depression holding water following wet season. Trafficable with no vegetation clearance necessary.

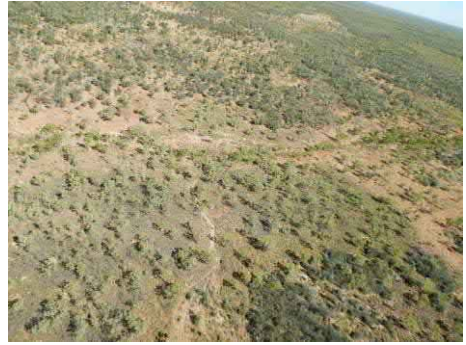
<p>Plate 13 NC13 – Line 7</p>

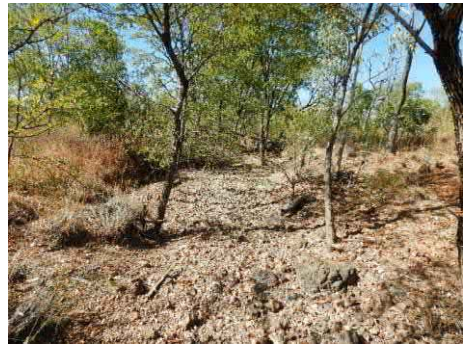
<p>Plate 14 NC13 – Line 7, ground</p>

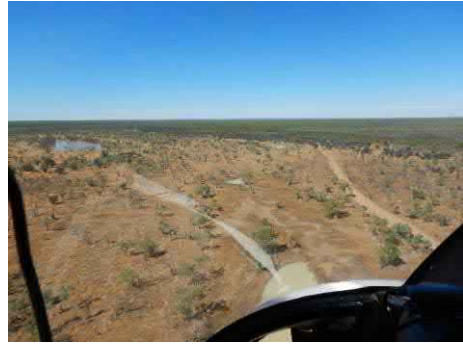
Creek Reference Line Number Station	Location		Stream Order	Condition Description	Plate
	Latitude	Longitude			
NC14 Line 13 (N-S) Tanumbirini Station	-16.611534°	134.654097°	Creek (3) Newcastle Creek	Overland flow with some shallow depressions holding water following 2019-2021 wet season. Pastoral activity in area with existing tracks. No clearing of vegetation necessary for vehicle access during seismic survey.

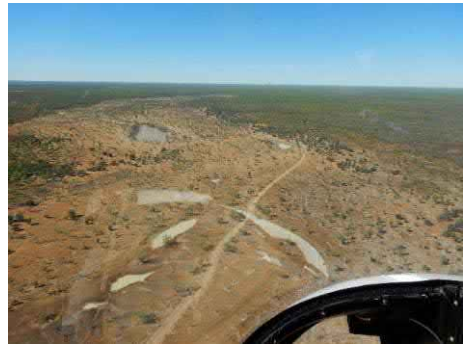
<p>Plate 16 NC15 – Line 13</p>

<p>Plate 15 NC14 – Line 13</p>
NC15 Line 13 (N-S) Tanumbirini Station	-16.620775°	134.654064°	Creek (3) Newcastle Creek	Overland flow with some shallow depressions holding water following 2019-2021 wet season. Pastoral activity in area with existing tracks. No clearing of vegetation necessary for vehicle access during seismic survey.

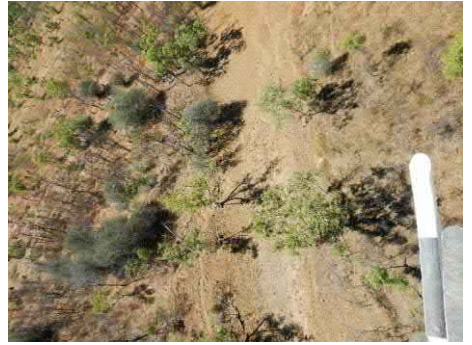
<p>Plate 17 NC16 – Line 12</p>

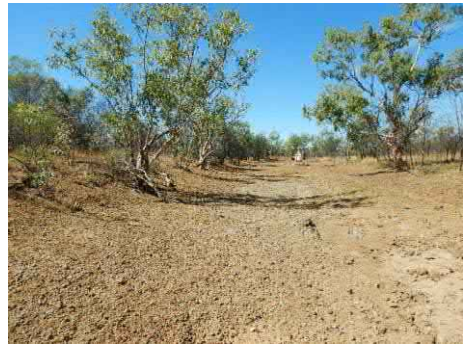
<p>Plate 18 NC16 – Line 12, ground</p>

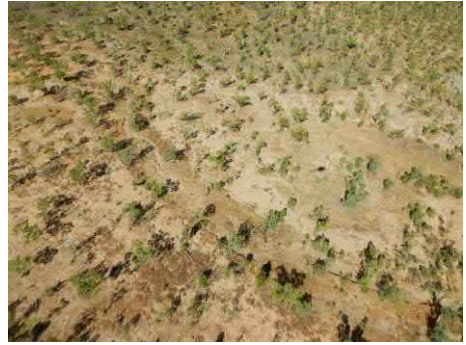
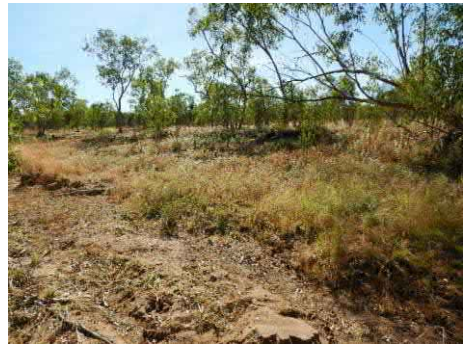
<p>Plate 19 NC17 – Line 10</p>

Creek Reference Line Number Station	Location		Stream Order	Condition Description	Plate
	Latitude	Longitude			
NC17 Line 10 (N-S) Tanumbirini Station	-16.635308°	134.515523°	Intermittent Stream (1)	Shallow channel evident with shallow depression holding water following wet season. Trafficable with no vegetation clearance necessary.

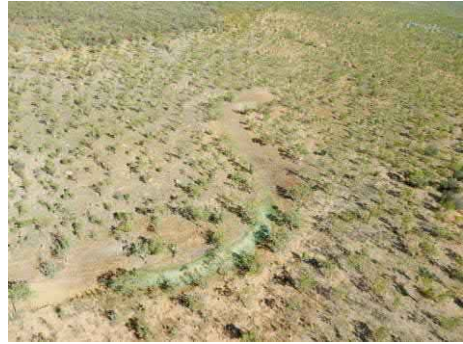
<p>Plate 21 NC18 – Line 6</p>
NC19 Line 11 (N-S) Tanumbirini Station	-16.634210°	134.558580°	Intermittent Stream (2)	Shallow channel evident with shallow depression holding water following the 2019 – 2020 wet season. Trafficable with no vegetation clearance necessary.

Creek Reference Line Number Station	Location		Stream Order	Condition Description	Plate
	Latitude	Longitude			
NC18 Line 6 (E-W) Tanumbirini Station	-16.639638°	134.526308°	Intermittent Stream (1)	Shallow channel evident with shallow depression holding water following the 2019 – 2020 wet season. Trafficable with no vegetation clearance necessary.

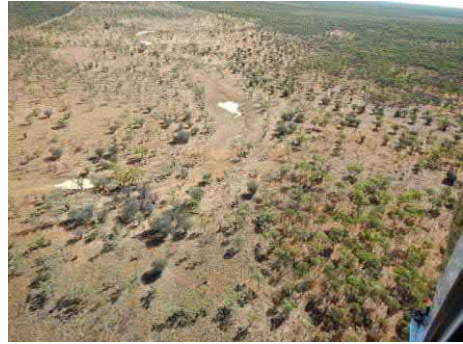
Creek Reference Line Number Station	Location		Stream Order	Condition Description	Plate
	Latitude	Longitude			
NC20 Line 6 (E-W) Tanumbirini Station	-16.640301°	134.666486°	Creek (3) Newcastle Creek	Overland flow with some shallow depressions holding water following 2019-2021 wet season. No clearing of vegetation necessary for vehicle access during seismic survey.

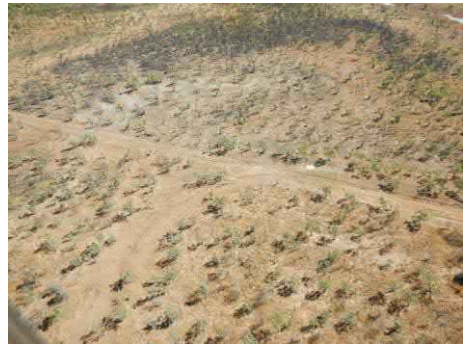
<p>Plate 24 NC21 – Line 5</p>

<p>Plate 23 NC20 – Line 6</p>
NC21 Line 5 (E-W) Beetaloo Station	-16.671021°	134.658055°	Creek (3) Newcastle Creek	Overland flow with some shallow depressions holding water following the wet season. Pastoral activity in area with existing tracks. No clearing of vegetation necessary for vehicle access during seismic survey.

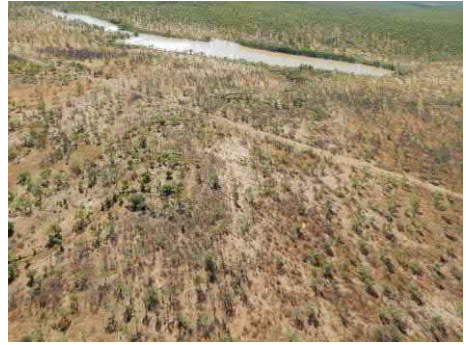
<p>Plate 25 NC22 – Line 13</p>

Creek Reference Line Number Station	Location		Stream Order	Condition Description	Plate
	Latitude	Longitude			
NC22 Line 13 (E-W) Beetaloo Station	-16.687064°	134.653983°	Intermittent Stream (1)	Existing pastoral track crossing a minor watercourse that flows into nearby Newcastle Creek. No clearing of vegetation necessary for vehicle access during seismic survey.

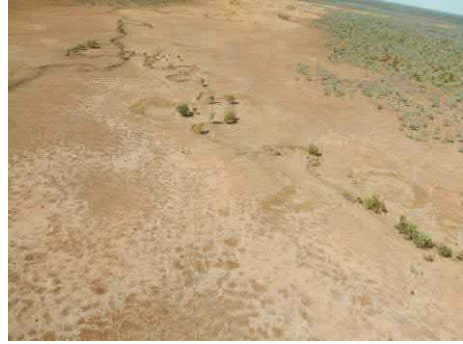
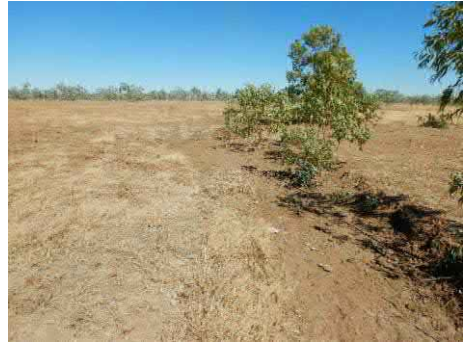
Plate 26 NC23 – Line 10

Creek Reference Line Number Station	Location		Stream Order	Condition Description	Plate
	Latitude	Longitude			
NC23 Line 10 (E-W) Beetaloo Station	-16.685810°	134.512589°	Intermittent Stream (1)	Shallow channel evident with shallow depression holding water following wet season. Trafficable with no vegetation clearance necessary.

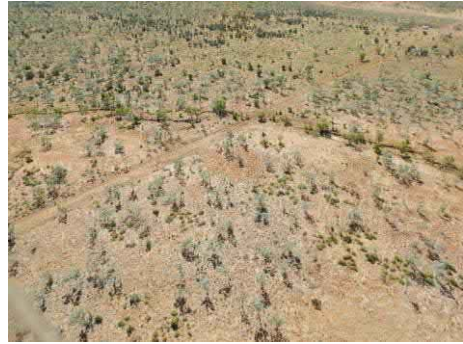
<p>Plate 28 NC24 – Line 4</p>
NC25 Line 10 (E-W) Beetaloo Station	-16.713949°	134.509250°	Intermittent Stream (1)	Existing pastoral track crossing a minor watercourse. No clearing of vegetation necessary for vehicle access during seismic survey.

Creek Reference Line Number Station	Location		Stream Order	Condition Description	Plate
	Latitude	Longitude			
NC24 Line 4 (E-W) Beetaloo Station	-16.710781°	134.504429°	Intermittent Stream (1)	Existing pastoral track crossing a minor watercourse. No clearing of vegetation necessary for vehicle access during seismic survey.

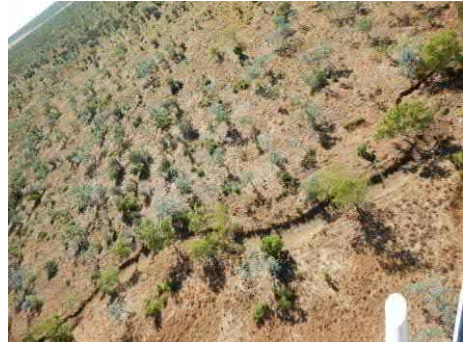
Creek Reference Line Number Station	Location		Stream Order	Condition Description	Plate
	Latitude	Longitude			
NC26 Line 10 (E-W) Beetaloo Station	-16.710784°	134.512664°	Intermittent Stream (2)	Existing pastoral track crossing a minor watercourse. No clearing of vegetation necessary for vehicle access during seismic survey.

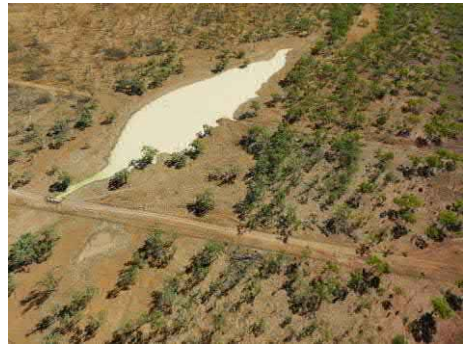
<p>Plate 31 NC27 – Line 4</p>

<p>Plate 30 NC26 – Line 10</p>
NC27 Line 4 (E-N) Beetaloo Station	-16.710810°	134.663682°	Creek (3) Newcastle Creek	Existing pastoral track crossing major watercourse. Overland flow with some shallow depressions holding water following 2019-2021 wet season. No clearing of vegetation necessary for vehicle access during seismic survey.

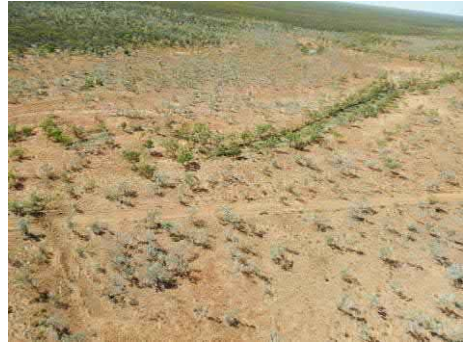
Creek Reference Line Number Station	Location		Stream Order	Condition Description	Plate
	Latitude	Longitude			
NC28 Line 10 (E-W) Beetaloo Station	-16.727088°	134.509267°	Intermittent Stream (2) Yaroo Creek	Existing pastoral track crossing a minor watercourse. No clearing of vegetation necessary for vehicle access during seismic survey.

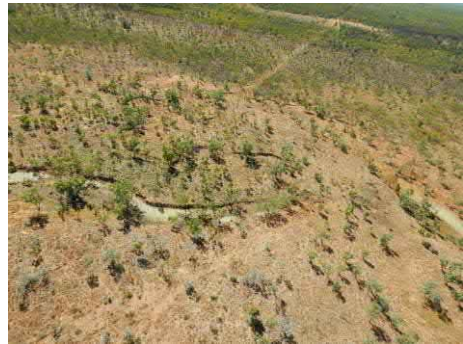
<p>Plate 33 NC29 – Line 3</p>

<p>Plate 32 NC28 – Line 10</p>
NC29 Line 3 (E-W) Beetaloo Station	-16.758336°	134.531569°	Intermittent Stream (2) Yaroo Creek	Existing pastoral track crossing a minor watercourse. Detour in place around depression holding water from the 2019-2020 wet season. No clearing of vegetation necessary for vehicle access during seismic survey.

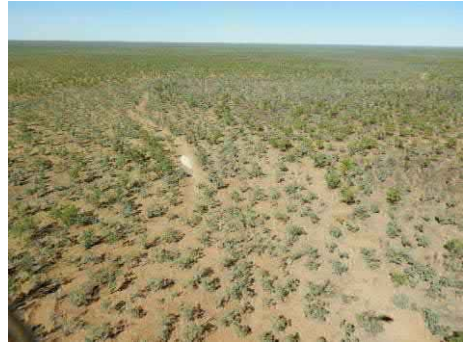
Creek Reference Line Number Station	Location		Stream Order	Condition Description	Plate
	Latitude	Longitude			
NC30 Line 3 (E-W) Beetaloo Station	-16.758387°	134.667117°	Creek (3) Newcastle Creek	Existing pastoral track crossing major watercourse. Overland flow with some shallow depressions holding water following 2019-2021 wet season. No clearing of vegetation necessary for vehicle access during seismic survey.

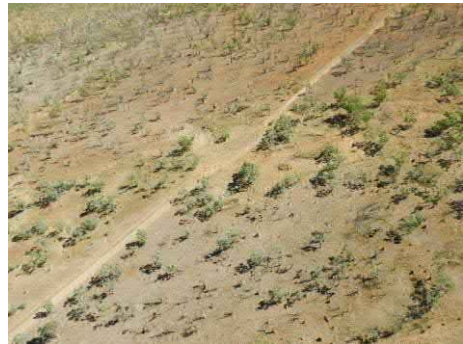
<p>Plate 35 NC31 – Line 13</p>

<p>Plate 34 NC30 – Line 3</p>
NC31 Line 13 (N-S) Beetaloo Station	-16.782209°	134.653958°	Creek (3) Newcastle Creek	Existing pastoral track crossing major watercourse. Overland flow with some shallow depressions holding water following 2019-2021 wet season. No clearing of vegetation necessary for vehicle access during seismic survey.

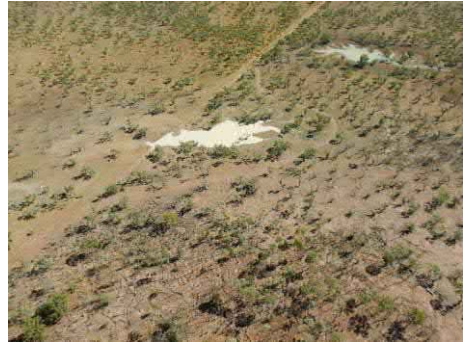
<p>Plate 36 NC32 – Line 13</p>

Creek Reference Line Number Station	Location		Stream Order	Condition Description	Plate
	Latitude	Longitude			
NC32 Line 13 (N-S) Beetaloo Station	-16.797492°	134.653953°	Extent of Creek (3) Newcastle Creek	Existing pastoral track crossing a minor watercourse. Detour in place around depression holding water from the 2019-2020 wet season. No clearing of vegetation necessary for vehicle access during seismic survey.

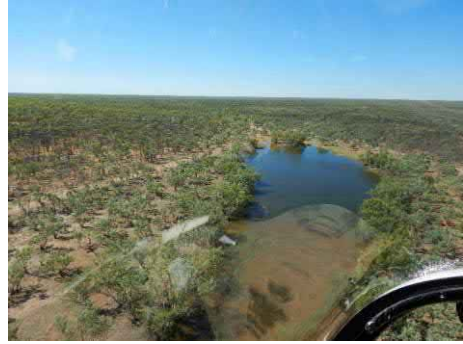
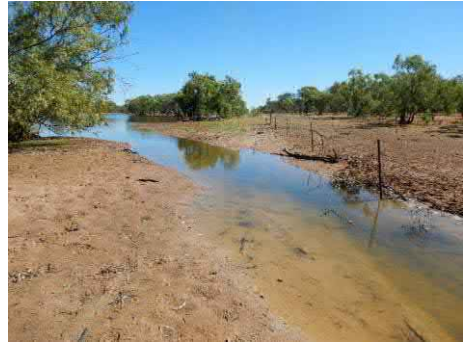
<p>Plate 37 NC33 - Line 2</p>

Creek Reference Line Number Station	Location		Stream Order	Condition Description	Plate
	Latitude	Longitude			
NC33 Line 2 (E-W) Beetaloo Station	-16.811604°	134.622306°	Creek (3) Newcastle Creek	Existing pastoral track crossing a major watercourse. Detour in place around depression holding water from the 2019-2020 wet season. No clearing of vegetation necessary for vehicle access during seismic survey.

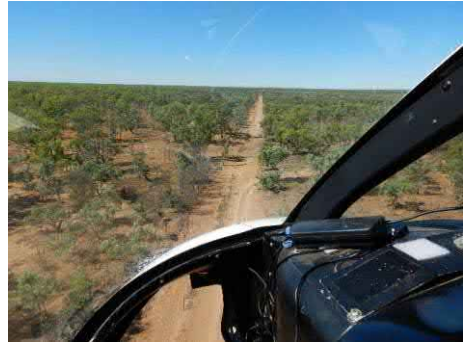
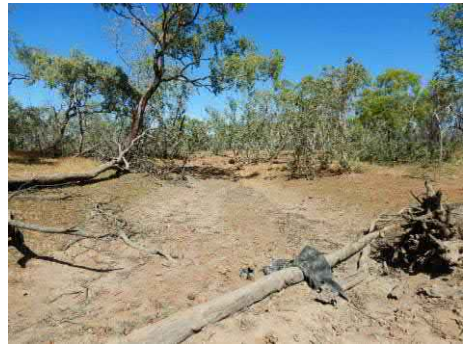
<p>Plate 39 NC34 – Line 2</p>

Creek Reference Line Number Station	Location		Stream Order	Condition Description	Plate
	Latitude	Longitude			
NC34 Line 2 (E-W) Beetaloo Station	-16.811613°	134.609790°	Creek (3) Newcastle Creek	Existing pastoral track crossing a major watercourse. Detour in place around depression holding water from the 2019-2020 wet season. No clearing of vegetation necessary for vehicle access during seismic survey.

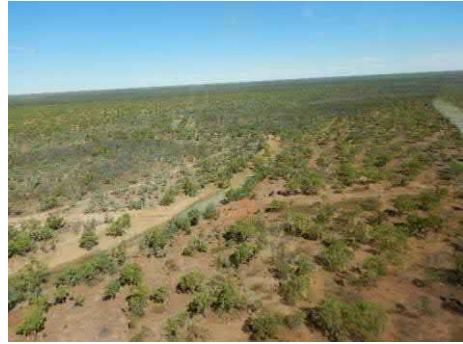
<p>Plate 41 NC35 – Line 2</p>

Creek Reference Line Number Station	Location		Stream Order	Condition Description	Plate
	Latitude	Longitude			
NC35 Line 2 (E-W) Beetaloo Station	-16.811608°	134.601864°	Creek (3) Newcastle Creek	Existing pastoral track crossing a minor watercourse. Detour in place around depression holding water from the 2019-2020 wet season. No clearing of vegetation necessary for vehicle access during seismic survey.

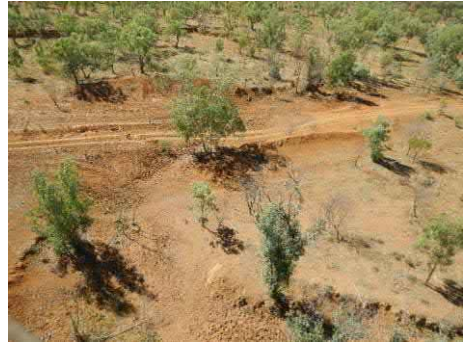
<p>Plate 43 NC36 – Line 2</p>

Creek Reference Line Number Station	Location		Stream Order	Condition Description	Plate
	Latitude	Longitude			
NC36 Line 2 (E-W) Beetaloo Station	-16.811560°	134.554040°	Intermittent Stream (2) Yaroo Creek	Existing pastoral track crossing a minor watercourse. No clearing of vegetation necessary for vehicle access during seismic survey.

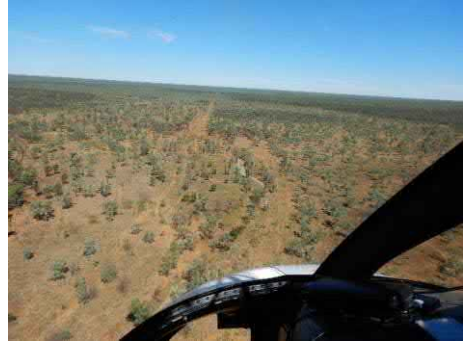
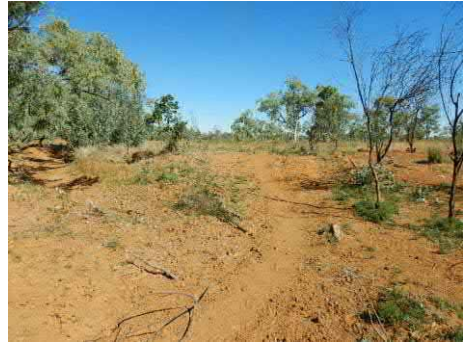
<p>Plate 44 NC37 - Line 11</p>

Creek Reference Line Number Station	Location		Stream Order	Condition Description	Plate
	Latitude	Longitude			
NC37 Line 11 (N-S) Beetaloo Station	-16.822944°	134.558535°	Intermittent Stream (2) Yaroo Creek	Existing pastoral track crossing a minor watercourse. No clearing of vegetation necessary for vehicle access during seismic survey.

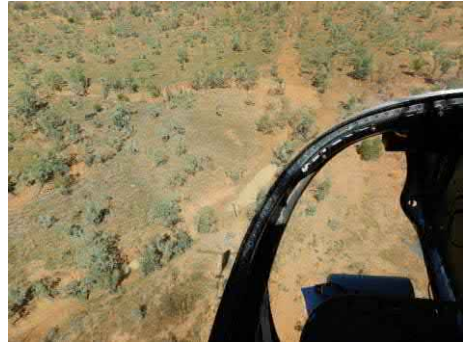
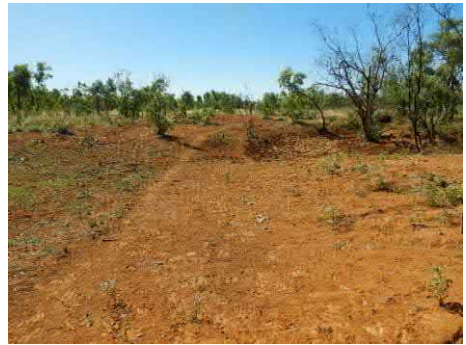
<p>Plate 46 NC38 – Line 11</p>

Creek Reference Line Number Station	Location		Stream Order	Condition Description	Plate
	Latitude	Longitude			
NC38 Line 11 (N-S) Beetaloo Station	-16.836419°	134.558530°	Intermittent Stream (2) Yaroo Creek	Existing pastoral track crossing a minor watercourse. No clearing of vegetation necessary for vehicle access during seismic survey.

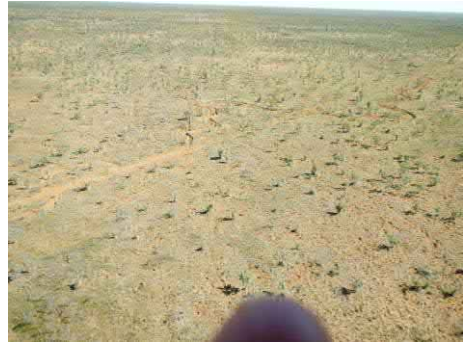
Creek Reference Line Number Station	Location		Stream Order	Condition Description	Plate
	Latitude	Longitude			
NC39 Line 11 (N-S) Beetaloo Station	-16.853759°	134.558524°	Intermittent Stream (2) Yaroo Creek	Existing pastoral track crossing a minor watercourse. No clearing of vegetation necessary for vehicle access during seismic survey.

<p>Plate 48 NC39 – Line 11</p>
NC40 Line 1 (E-W) Beetaloo Station	-16.866681°	134.562520°	Creek (3) Newcastle Creek	Existing pastoral track crossing a watercourse. Detour in place around depression holding water from the 2019-2020 wet season. No clearing of vegetation necessary for vehicle access during seismic survey.

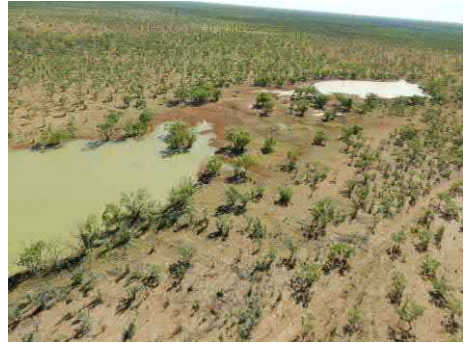
<p>Plate 50 NC41 – Line 11</p>

Creek Reference Line Number Station	Location		Stream Order	Condition Description	Plate
	Latitude	Longitude			
NC41 Line 11 (N-S) Beetaloo Station	-16.869353°	134.558519°	Creek (3) Newcastle Creek	Existing pastoral track crossing a watercourse. Detour in place around depression holding water from the 2019-2020 wet season. No clearing of vegetation necessary for vehicle access during seismic survey.

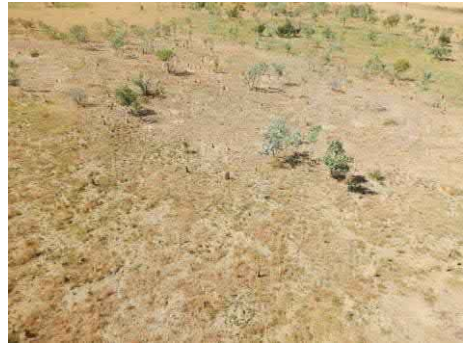
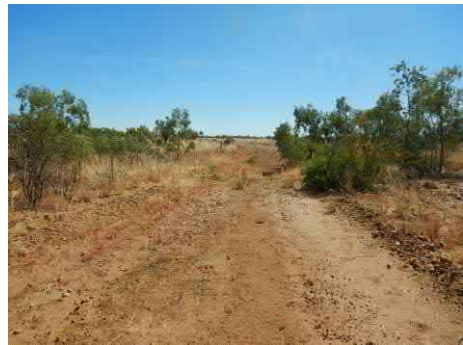
Plate 51 SC01 – Line 10 (south)

Creek Reference Line Number Station	Location		Stream Order	Condition Description	Plate
	Latitude	Longitude			
Southern Creek Crossings					
SC1 Line 10 (south) Anthony Lagoon Station	-17.727180°	134.701408°	Intermittent Stream (1)	Existing pastoral track crossing a major watercourse. No clearing of vegetation necessary for vehicle access during seismic survey.

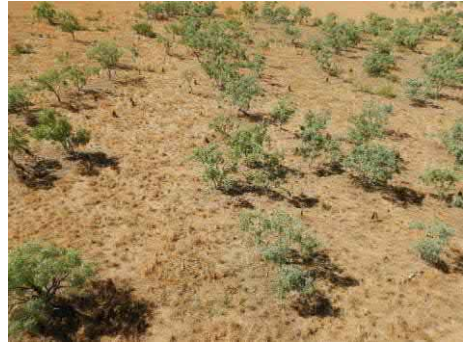
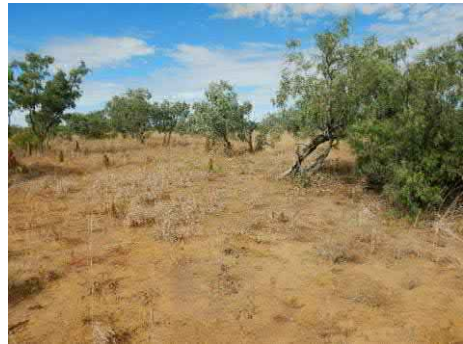
<p>Plate 53 SC02 - Line 10 (south)</p>

Creek Reference Line Number Station	Location		Stream Order	Condition Description	Plate
	Latitude	Longitude			
SC2 Line 10 (south) Anthony Lagoon	-17.692102°	134.702228°	Intermittent Stream (2)	Existing pastoral track crossing a major watercourse. No clearing of vegetation necessary for vehicle access during seismic survey.

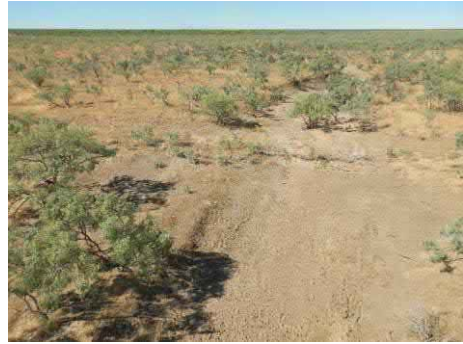
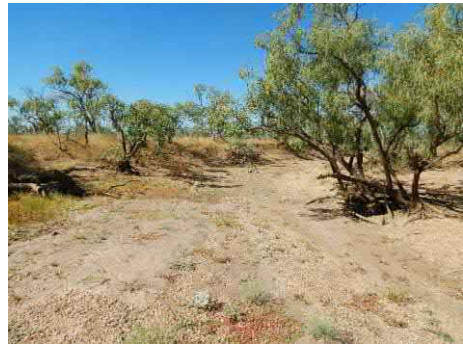
<p>Plate 55 SC03 – Line 10 (south)</p>

Creek Reference Line Number Station	Location		Stream Order	Condition Description	Plate
	Latitude	Longitude			
SC3 Line 10 (south) Anthony Lagoon Station	-17.842060°	134.699065°	Creek (3) Broad Creek	Existing pastoral track crossing a major watercourse. No clearing of vegetation necessary for vehicle access during seismic survey.

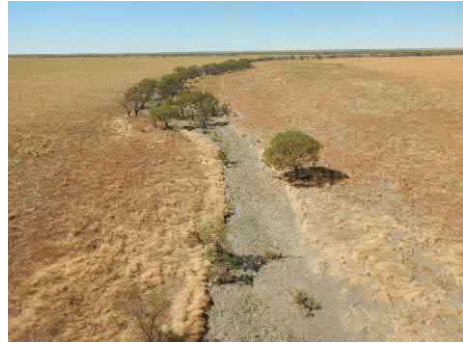
Creek Reference Line Number Station	Location		Stream Order	Condition Description	Plate
	Latitude	Longitude			
SC4 Line 10 (south) Eva Downs Station/Barkly Stock Route	-17.943113°	134.692035°	Creek (2) Billycan Creek	Existing pastoral track crossing a minor watercourse. No clearing of vegetation necessary for vehicle access during seismic survey.

<p>Plate 57 SC04 – Line 10 (south)</p>
SC5 Line 10 (south) Eva Downs Station/Barkly Stock Route	-17.964019°	134.709447°	Creek (3) Billycan Creek	Existing Barkly Stock Route track crossing a major watercourse. No clearing of vegetation necessary for vehicle access during seismic survey.

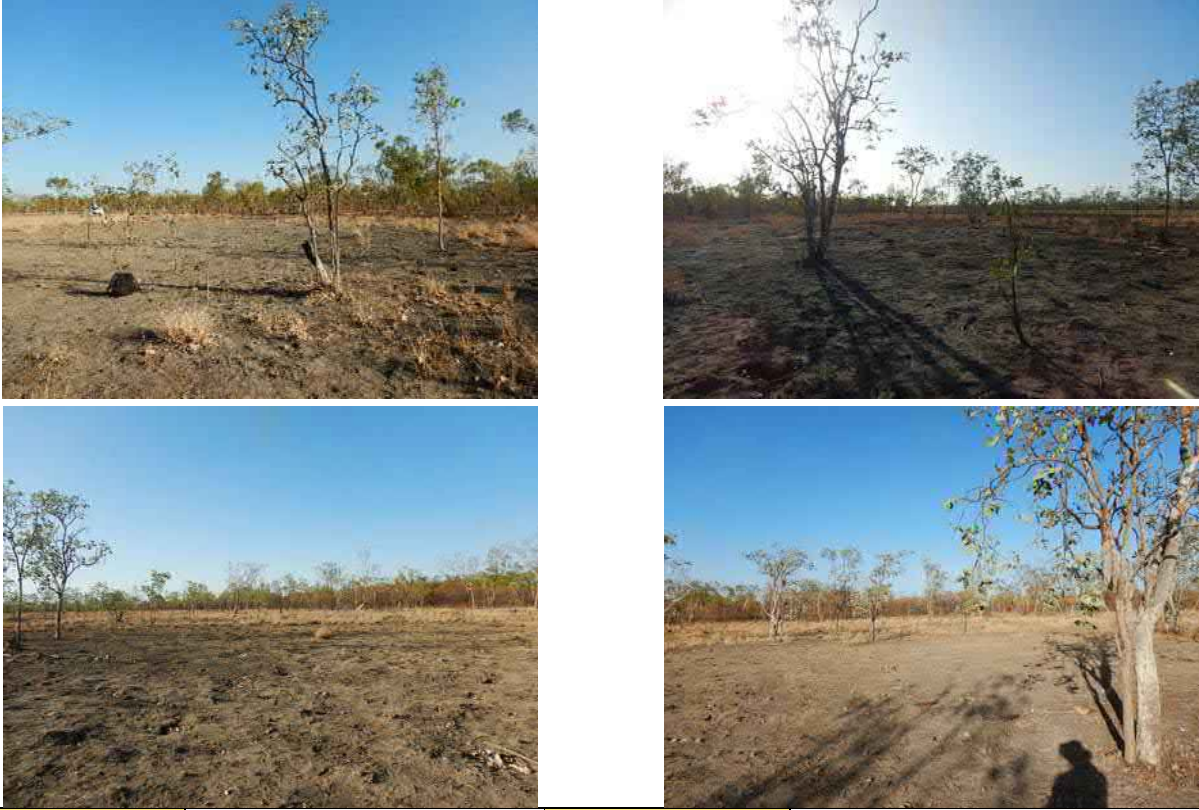
Northern Site 1 (NL1)				
Location	-16.865807°, 134.562257°		Veg. community	<i>Eucalyptus pruinosa</i> open woodland
Landform	Alluvial Plain		Soil	Poorly drained clays (Vertosol)

Obstruction cover	Insignificant (<1%)		Crust broken-ness	Moderately broken
Perennial basal cover	Low (1-10%)		Deposited material	Insignificant (0-5%), sand
Litter cover	<10%		Microtopography	Deep formations, with visible base (25-100mm)
Cryptogram cover	Insignificant (<1%)		Surface nature	Brittle, breaking into amorphous fragments or powder
Soil	A1:	0-0.05m, Sandy clay loam, colour: 2.5Y 3/1 Very dark grey, pH 6.5		
	B1:	0.05-0.1m, Medium clay, colour: 10YR 5/1 Grey, pH 6.5		
Vegetation description	Upper storey:	<i>Eucalyptus pruinosa</i> (3-5m)		
	Mid-storey:	<i>Eucalyptus pruinosa</i>		
	Understorey:	<i>Dichanthium</i> sp.		
Disturbance	Grazing in current season: approximately 25% of area, 25-50% vegetation impacted. No fire damage. Sheet water erosion across 50-75% of area. Minor rill erosion.

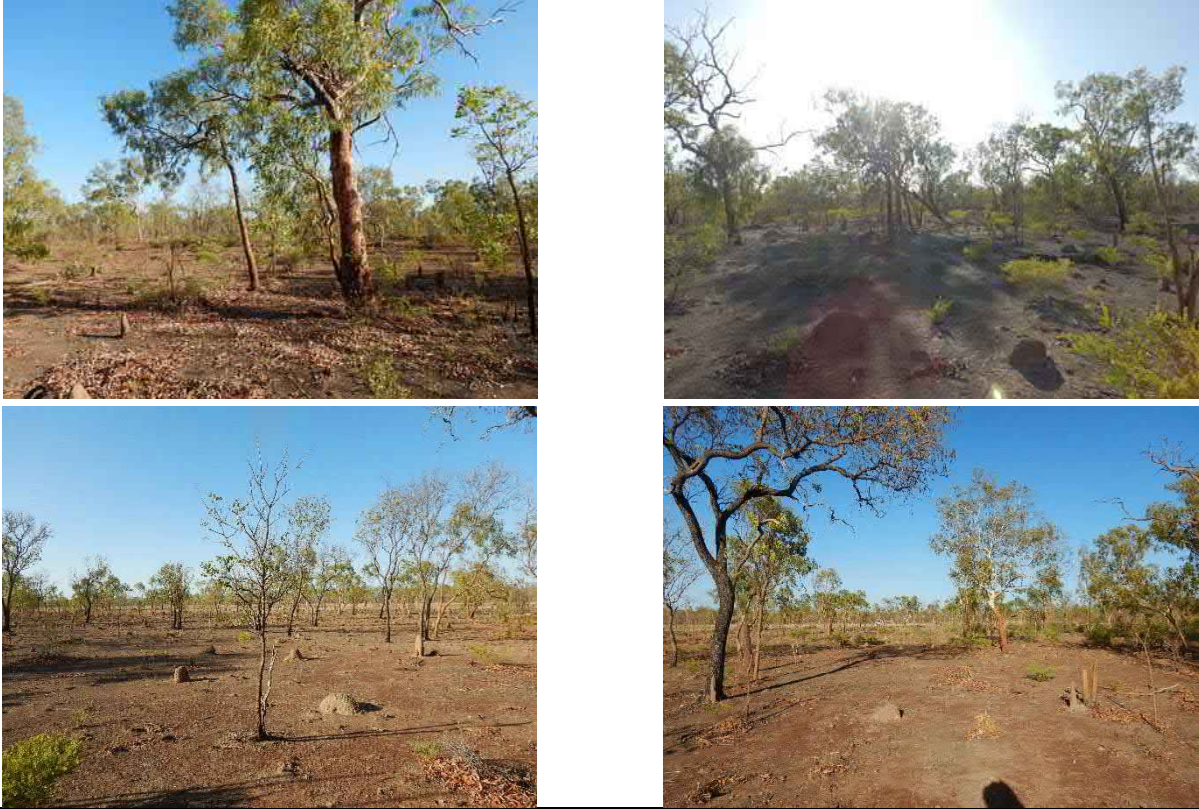
Obstruction cover	Moderate (15-30%)		Crust broken-ness	NA
Perennial basal cover	Low (1-10%)		Deposited material	Insignificant (0-5%), sand
Litter cover	10-25%, local, slight		Microtopography	Smooth, insignificant retention
Cryptogram cover	Insignificant (<1%)		Surface nature	Crust moderately hard
Soil	A1:	0-0.05m, Sandy clay loam, colour: 7.5 YR 3/2 dark brown, 50% sub-rounded, 3mm ironstone gravels, slake score 4, pH 6.5		
	B1:	0.05-0.1m, Sandy clay loam, colour: 7.5 YR 4/3 Brown, 50% sub-rounded 3-10mm ironstone gravels, slake score 4, pH 6.5		
Vegetation description	Upper storey:	<i>Corymbia dichromophloia</i> (dominant), <i>Corymbia terminalis</i> , <i>Eucalyptus chlorophylla</i> and <i>Erythrophleum chlorostachys</i> (scattered). (5-10m)

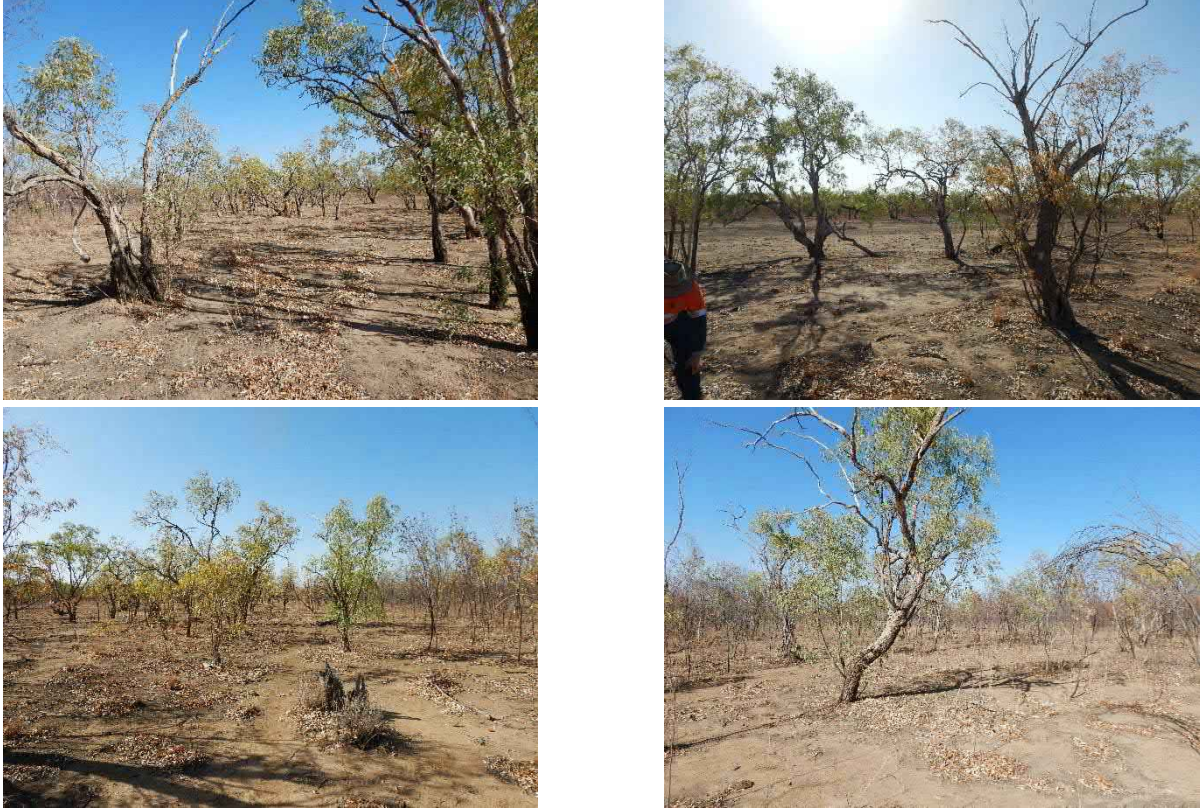
Obstruction cover	Low (1-15%)	Crust broken-ness	NA
Perennial basal cover	Moderate (10-20%)	Deposited material	Slight (5-20%), sand
Litter cover	10-25%, local, slight	Microtopography	Shallow depressions, low retention (3-8mm)
Cryptogram cover	Insignificant (<1%)	Surface nature	Crust moderately hard
Soil	A1:	0-0.05m, Sandy clay loam, colour: 7.5YR 4/3 brown, 50% 1mm orange mottles, slake score 3, pH 6	
	B1:	0.05-0.1m, Light clay, colour: 7.5YR 5/3 brown, 50% sub-rounded 3-10mm ironstone gravels, slake score 1, pH 6.	
Vegetation description	Upper storey:	<i>Eucalyptus chlorophylla</i> (3-5m)	
	Mid-storey:	<i>Eucalyptus chlorophylla</i>	
	Understorey:	<i>Dichanthium</i> sp., <i>Eragrostis</i> sp., <i>Chrysopogon fallax</i> (sparse), <i>Carissa lanceolata</i>

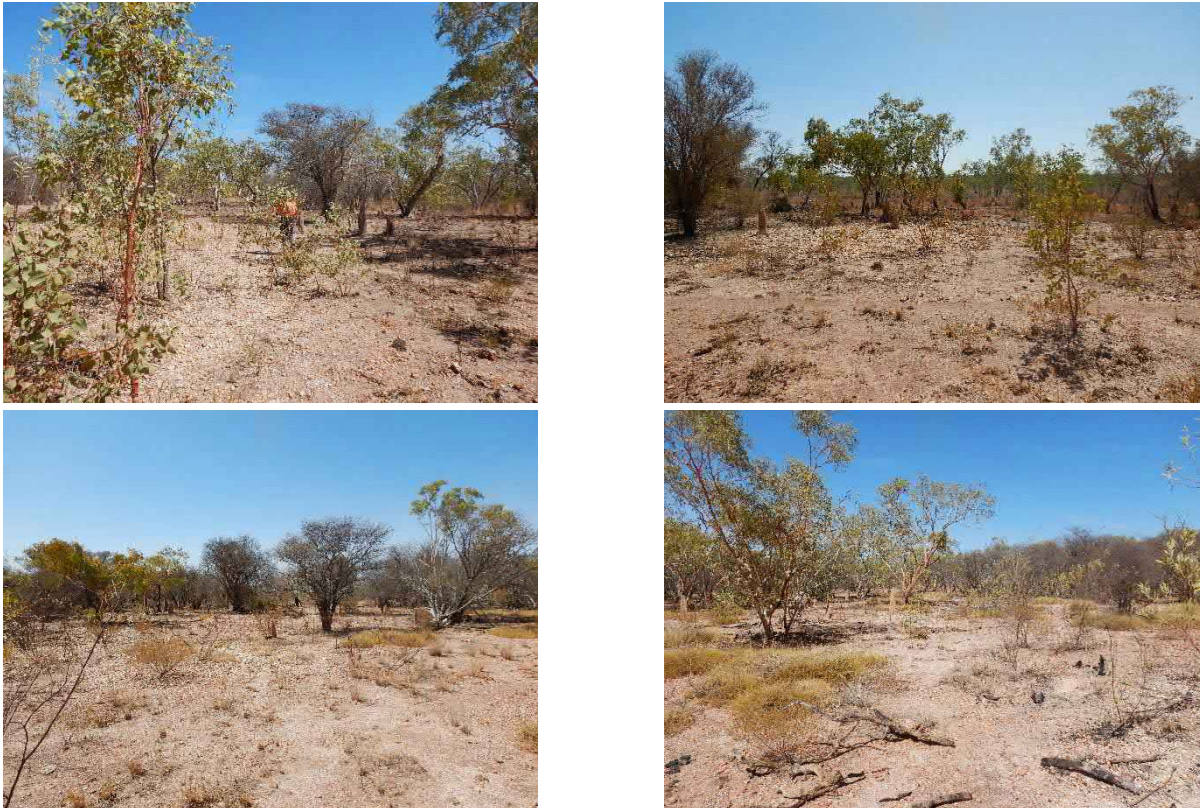
Obstruction cover	Moderate (15-30%)		Crust broken-ness NA
Perennial basal cover	High (>20%)		Deposited material Slight (5-20%), sand
Litter cover	<10%, local, slight		Microtopography Smooth, insignificant retention
Cryptogram cover	Insignificant (<1%)		Surface nature Crust moderately hard
Soil	A1:	0-0.05m, Silty clay loam, colour: 7.5YR 4/3 brown, 10% 10-50mm sub-angular fragments, slake score 2, pH 5.	
	A3:	0.05-0.1m, Light clay, colour: 7.5YR 5/3 brown, 80% sub-angular 10-100mm fragments, slake score 2, pH 6.5.	
Vegetation description	Upper storey:	<i>Eucalyptus leucophloia</i> subsp. <i>euroa</i> (dominant), <i>Macropteranthes keckwickii</i> (5-10m)	
	Mid-storey:	<i>Acacia</i> sp., <i>Macropteranthes keckwickii</i> , <i>Eucalyptus leucophloia</i> subsp. <i>euroa</i>

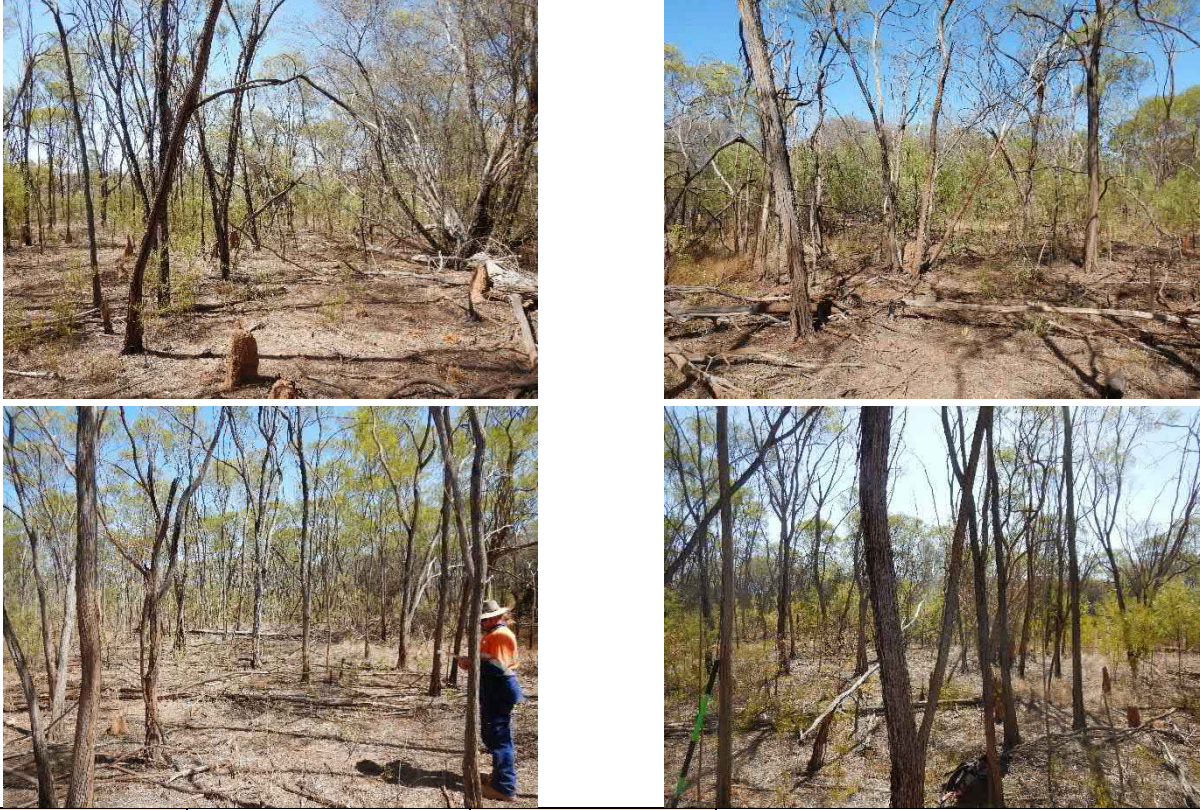
Obstruction cover	Very high (>50%)		Crust broken-ness	NA
Perennial basal cover	Moderate (10-20%)		Deposited material	Insignificant (0-5%), sand
Litter cover	75-100%		Microtopography	Shallow depressions, low retention (3-8mm)
Cryptogram cover	NA		Surface nature	Crust very hard and brittle
Soil	A1:	0-0.05m, Sandy loam (heavy), colour: 5YR 3/3 dark reddish brown, 75% sub-rounded and sub-angular 10-30mm ironstone fragments		
Vegetation description	Upper storey:	<i>Acacia shirleyi</i> (dominant) and <i>Macropteranthes kekwickii</i> (8-10m)		
	Mid-storey:	<i>Acacia shirleyi</i> (dominant) and <i>Macropteranthes kekwickii</i>		
	Understorey:	<i>Chrysopogon fallax</i> , <i>Eriachne</i> sp., <i>Carissa lanceolata</i> (all sparse)		
Disturbance	Grazing in current season: approximately 5% of area, <5% ground vegetation impacted. Fire damage in previous 1-2 years, minor scars 1-4m on most trees/shrubs

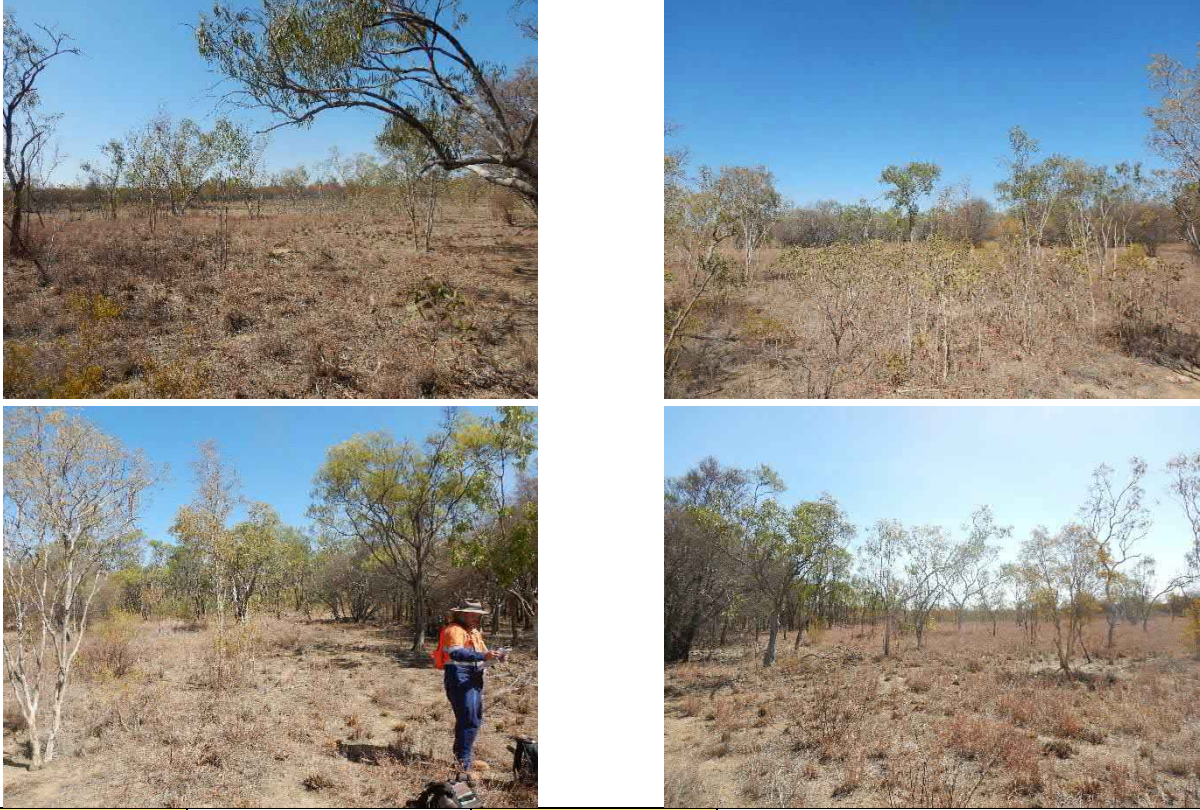
Obstruction cover	Low (1-15%)	Crust broken-ness	NA
Perennial basal cover	Low (1-10%)	Deposited material	Insignificant (0-5%), sand
Litter cover	75-100%	Microtopography	Smooth, insignificant retention
Cryptogram cover	Insignificant (<1%)	Surface nature	Crust very hard
Vegetation description	Upper storey:	<i>Eucalyptus chlorophylla</i> , <i>Eucalyptus camaldulensis</i> var. <i>obtusa</i> (5-6)	
	Mid-storey:	<i>Melaleuca nervosa</i> , <i>Melaleuca citrolens</i> , <i>Macropteranthes kekwickii</i>	
	Understorey:	<i>Dichanthium</i> sp., <i>Chrysopogon fallax</i> (sparse), <i>Melaleuca citrolens</i>	
Disturbance	Grazing in current season: approximately 5% of area, <5% ground vegetation impacted. No evident fire damage. Sheet water erosion across 25-50% of area.

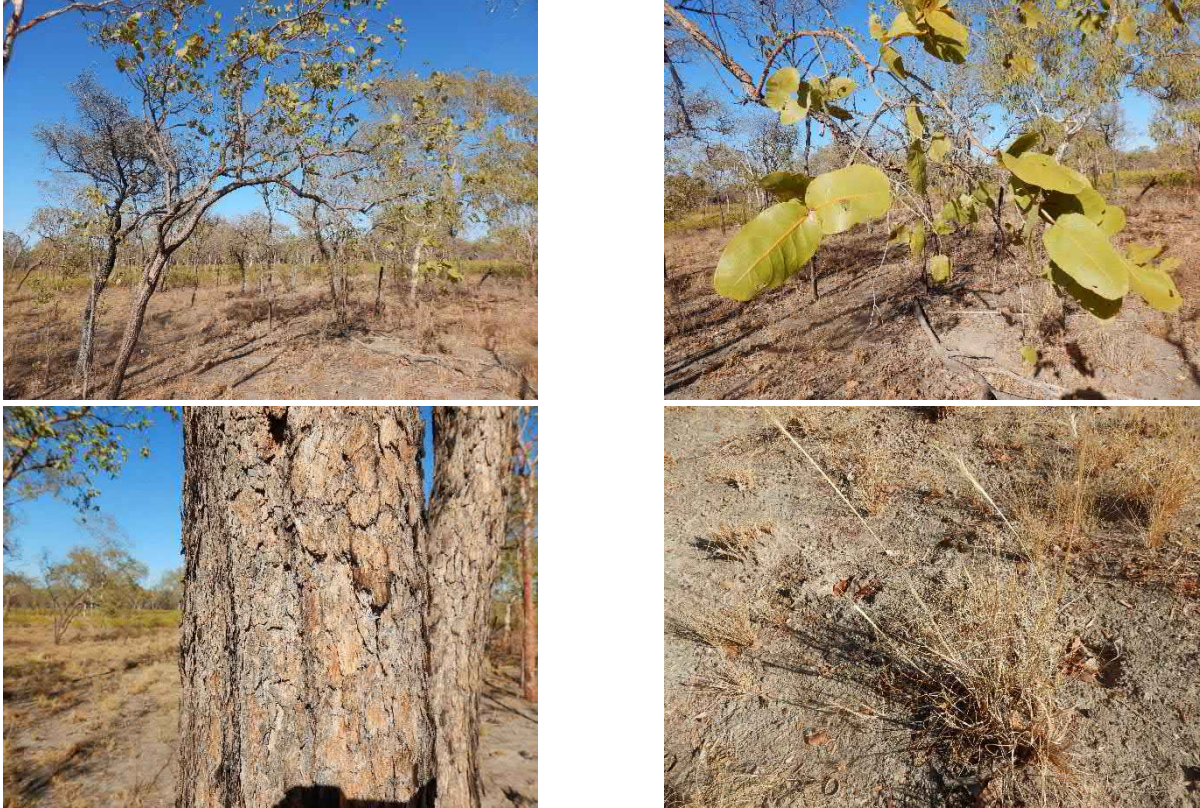
Northern Site 14 (NL14)				
Location	-16.629052°, 134.55792°		Veg. community	Corymbia (mixed) open woodland
Landform	Gently undulating plain		Soil	Brown earths

Obstruction cover	Moderate (15-30%)	Crust broken-ness	Intact	
Perennial basal cover	High (>20%)	Deposited material	Insignificant (0-5%), sand	
Litter cover	25-50%, local, slight	Microtopography	Shallow depressions, low retention (3-8mm)	
Cryptogram cover	Insignificant (<1%)	Surface nature	Crust easily broken with finger pressure	
Soil	A1:	0-0.05m, Sandy loam (heavy), colour: 7.5YR 3/4 dark brown, well graded uniform fines, slaking score 4, pH 5.5		
	B1:	0.05-0.15m, Sandy clay loam, 7.5YR 4/3 brown, well graded uniform fines, organics, slaking score 4, pH 6.5		
Vegetation description	Upper storey:	<i>Corymbia dichromophloia</i> (dominant), <i>Petalostigma pubescens</i> , <i>Terminalia canescens</i> , <i>Erythrophleum chlorostachys</i> , <i>Corymbia ferruginea</i>

Mid-storey:	<i>Terminalia canescens</i> (dominant), <i>Corymbia dichromophloia</i> , <i>Erythrophleum chlorostachys</i>		
	Ground storey:	<i>Triodia bitextura</i> (dominant), <i>Chrysopogon fallax</i> (sparse), <i>Eriachne sp.</i> , <i>Terminalia canescens</i> , <i>Grewia retusifolia</i>		
Disturbance	Grazing in previous 1-2 years: approximately 2% of area, <5% ground vegetation impacted. Fire damage in previous 1-2 years, some trees/shrubs killed.			
Habitat	Hollows scattered, small fallen branches common and large logs scattered, small surface rocks and mistletoe scattered. Average habitat for hollow and log dependent fauna. Good habitat for small birds.			
Fauna	Observed fauna included Weebill (<i>Smicrornis brevirostris</i>), Grey-crowned Babbler (<i>Pomatostomus temporalis</i>) and Apostlebird. Potential habitat for threatened species such as Yellow-spotted Monitor, Crested (Northern) Shrike-tit and Grey Falcon.

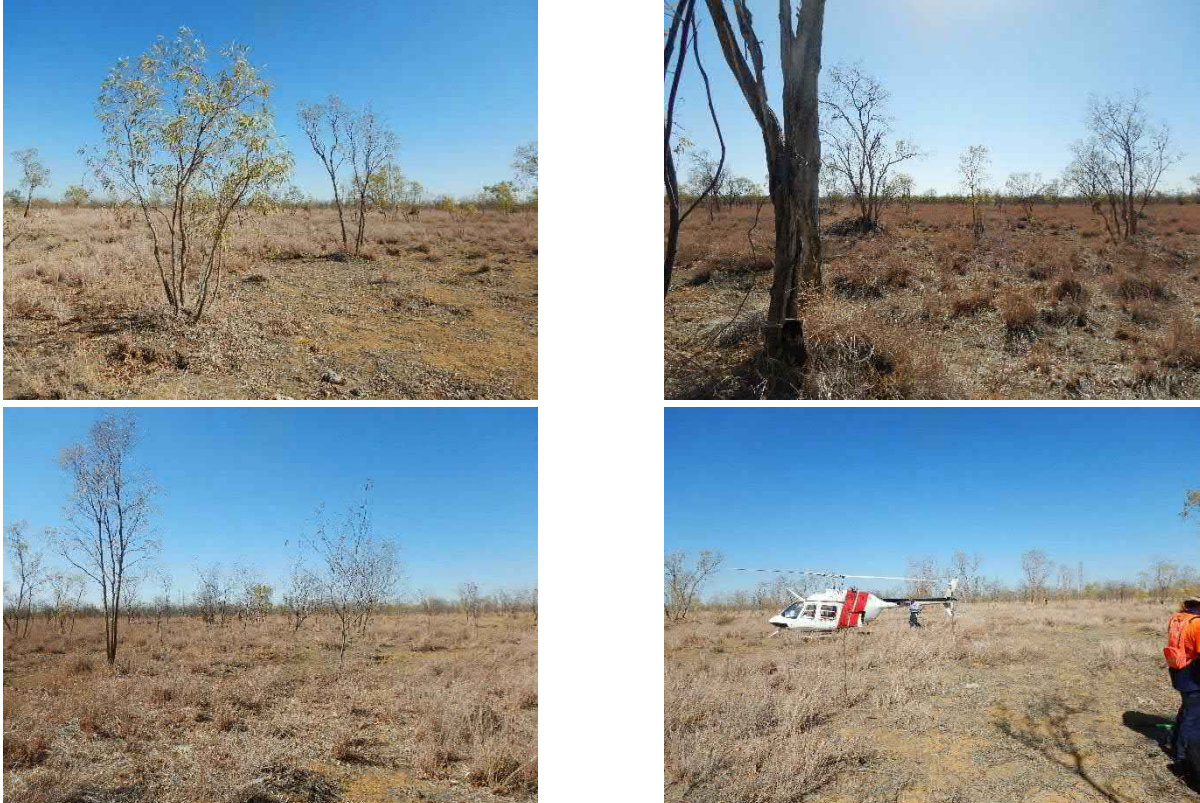
Northern Site 15 (NL15)					
Location	-16.856204°, 134.558891°		Veg. community	<i>Eucalyptus microtheca</i> isolated trees	
Landform	Alluvial plain		Soil	Mottled brown earths

Obstruction cover	Low (1-15%)		Crust broken-ness	Intact	Cryptogram cover Insignificant (<1%)
Perennial basal cover	Moderate (10-20%)		Deposited material	Extensive (>50%), sand	
Litter cover	50-75%, local, slight		Microtopography	Deep formations with visible base (25-100mm)	
Soil	A1:	0-0.05m, Sandy loam, colour: 7.5YR 3/4 dark brown, 30% sub-rounded 3-5mm ironstone gravels, slaking score 4, pH 4.5			
	B1:	0.05-0.10m, Sandy loam, 10YR 4/4 dark yellowish brown, orange 1mm mottles, slaking score 3, pH 5			
	B2	0.1-0.35, sandy clay loam, 10YR 3/6, dark yellowish brown, orange 1mm mottles, slaking score 2, pH 6.5			
Vegetation description	Upper storey:	<i>Eucalyptus microtheca</i> (dominant) and <i>Acacia holosericea</i>

Mid-storey:	<i>Eucalyptus microtheca</i> (dominant) and <i>Acacia holosericea</i>			
	Understorey:	<i>Dichanthium fecundum</i> (dominant), <i>Chrysopogon fallax</i> (sparse)			
Disturbance	Grazing in previous 1-2 years: approximately 15% of area, 5-25% ground vegetation impacted. Fire damage in previous 2-3 years, minor <1m scars on some trees/shrubs				
Habitat	Scattered hollows and fallen branches, small surface rocks and mistletoe scattered. Poor habitat for hollow and log dependent fauna. Average habitat for small birds.				
Fauna	Potential habitat for threatened species such as Yellow-spotted Monitor, Plains Death Adder and Grey Falcon.
