Seismic Environment Management Plan Appendix A - B

EP136 - Beetaloo Sub-Basin, NT

Cover Photo: Southwards view of Line 10 from its intersection of Line 3, Beetaloo Station, November 2019

Land Condition Assessment

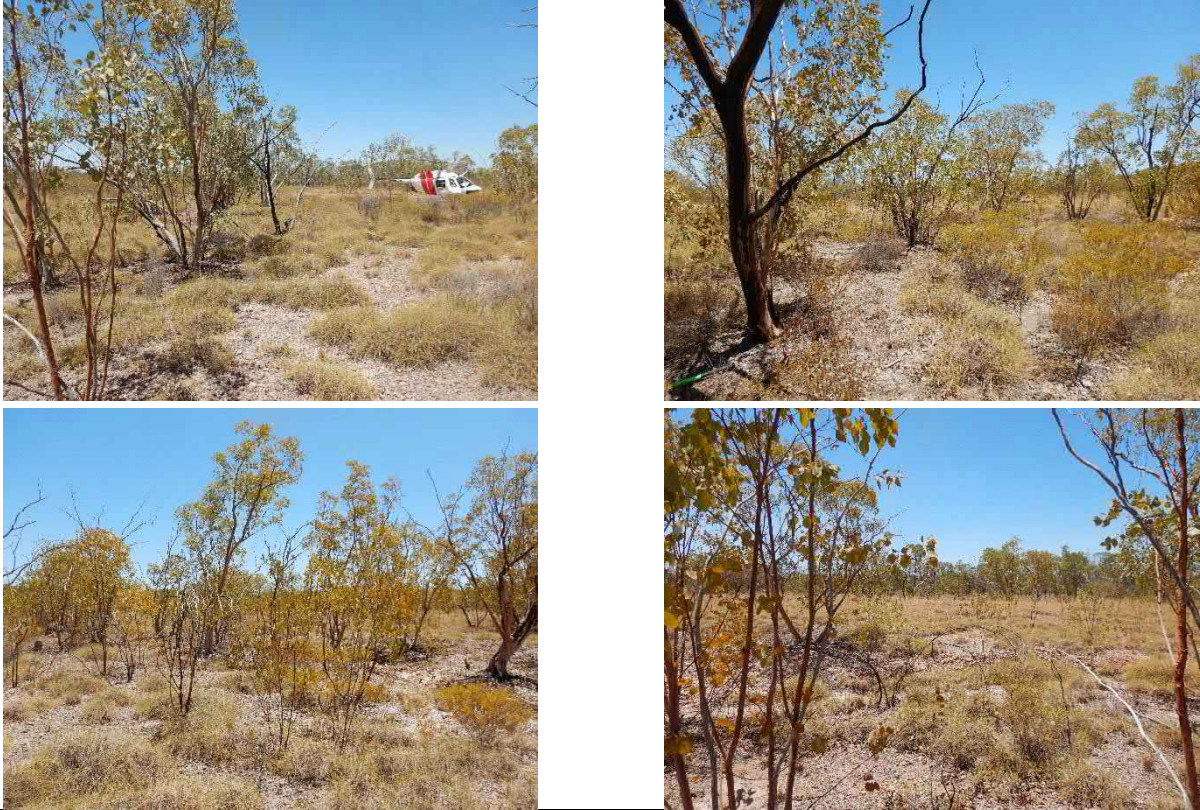
Northern Site 18 (NL18)			
Location	-16.667105°, 134.509016°		Veg. community <i>Eucalyptus leucophloia</i> open woodland
Landform	Plain		Soil Rudosol

Obstruction cover	Low (1-15%)		Crust broken-ness NA
Perennial basal cover	Moderate (10-20%)		Deposited material Insignificant (0-5%)
Litter cover	10-25%, local, slight		Cryptogram cover Insignificant (<1%)
Soil	A1:	0-0.05m, Loamy sand, 95% gravel cover on surface - Rudosol	
Vegetation description	Upper storey:	<i>Eucalyptus leucophloia</i> subsp. <i>europa</i> (3-5m)	
	Mid-storey	<i>Acacia wickhamii</i> , <i>Acacia</i> sp.	
	Understorey:	<i>Triodia bitextura</i> , <i>Dichanthium fecundum</i>	
Disturbance	No evidence of grazing impacts. Fire damage 2-3 years previous, minor scars <1m on some trees/shrubs. Gully erosion across 10% of area.		
Habitat	Hollows common. Small and large fallen branches scattered. Small surface rocks abundant and large rocks common. Mistletoe absent. Good habitat for hollow dependent fauna. Average habitat for log and rock dependent fauna, and small birds.

Fauna	Potential habitat for threatened species such as Gouldian Finch and Grey Falcon.

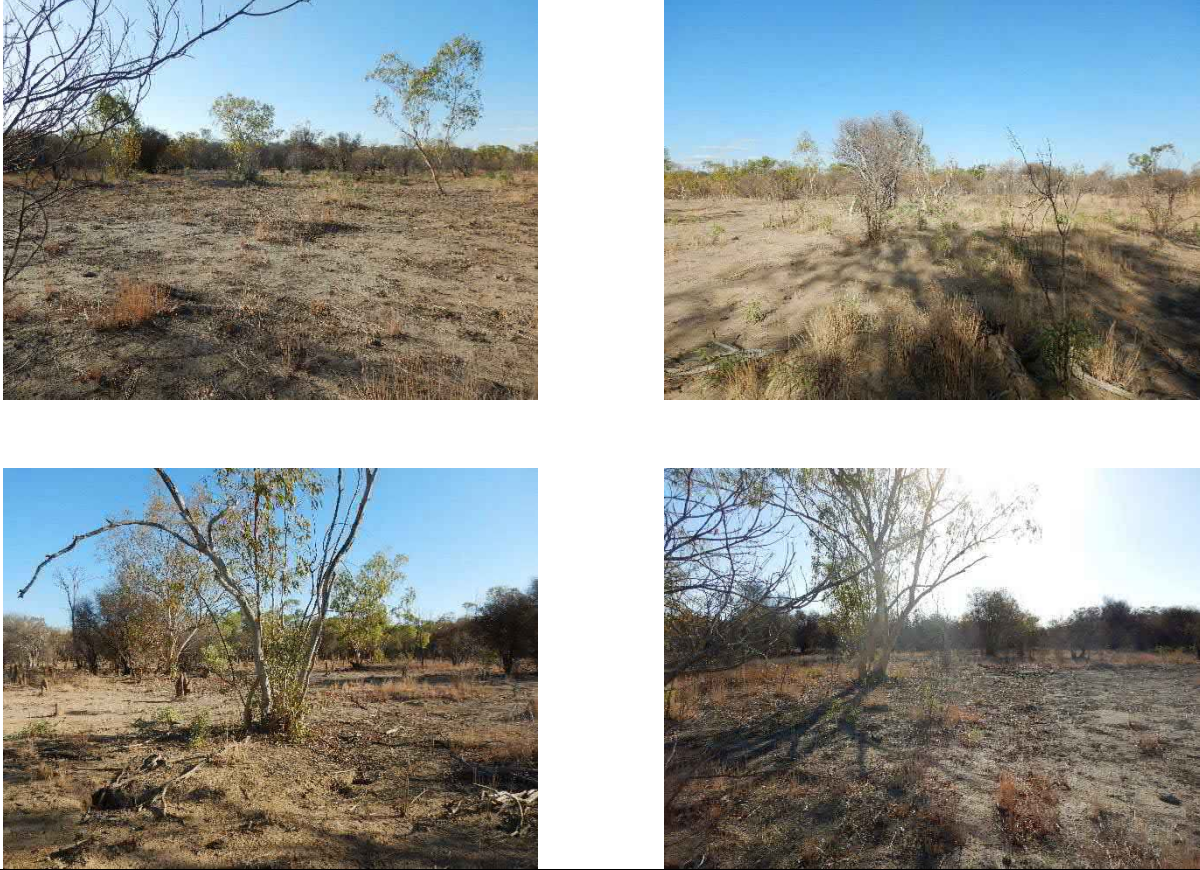
Northern Site 20 (NL20)			
Location	-16.710284°, 134.739562°	Veg. community	<i>Eucalyptus camaldulensis</i> isolated trees
Landform	Gently Undulating Plain	Soil	Poorly drained clays (Vertosol)

Obstruction cover	Low (1-15%)	Crust broken-ness	Slightly broken
Perennial basal cover	Low (1-10%)	Deposited material	Insignificant (0-5%), sand
Litter cover	10-25%, local, slight	Surface nature	Crust is easily broken with finger pressure
Cryptogram cover	Insignificant (<1%)	Erosion	Pedastal erosion, >30cm, moderate
Soil	A1: 0-0.03m, sandy clay loam (heavy), colour: 7.5YR 3/1 very dark grey, slaking score 2, pH 6 B1: 0.03-0.35, light clay, colour: 7.5YR 4/4 brown, slaking score 4, pH 7		
Vegetation description	Upper storey:	<i>Eucalyptus camaldulensis</i> var. <i>obtusa</i> (dominant), <i>Macropteranthes kekwickii</i> (sparse)	
	Mid-storey	<i>Atalaya hemiglauca</i>	
	Understorey:	<i>Dichanthium fecundum</i>

Disturbance	Grazing impacts in present season, approximately 30% of area, 5-25% of ground vegetation impacted. Fire damage 2-3 years previous, minor scars <1m on some trees/shrubs. Sheet and gully erosion, >75% of area eroded		
Habitat	Hollows scattered. Small fallen branches common, large logs scattered. Surface rocks and mistletoe absent. Average habitat for log and hollow dependent fauna, and small birds.		
Fauna	Potential habitat for threatened species such as Yellow-spotted Monitor, Plains Death Adder and Grey Falcon.

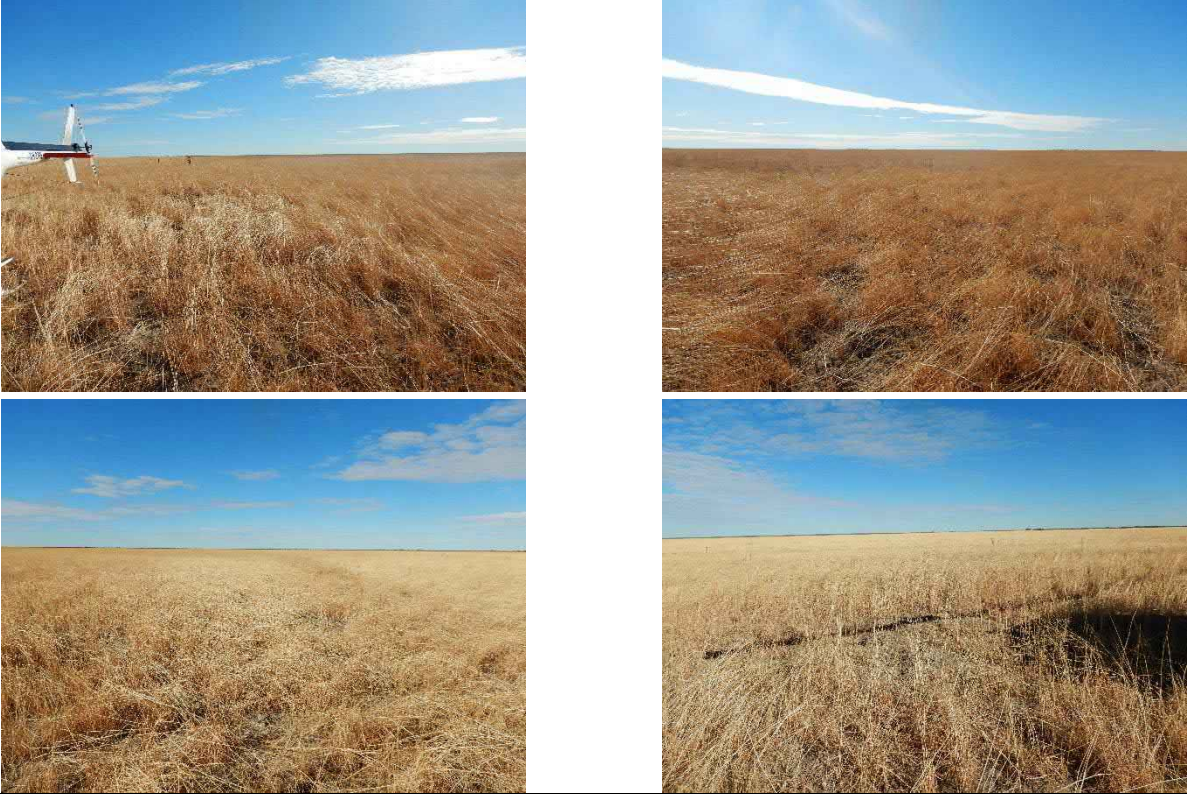
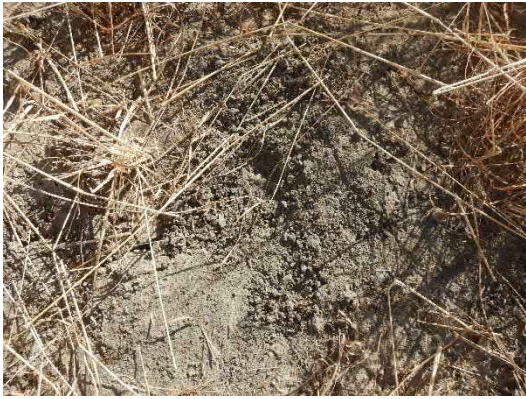
Southern Site 1 (SL1)			
Location	-17.630595°, 134.704395°	Veg. community	<i>Sorghum timorense</i> open tussock grassland
Landform	Alluvial Plain

Slope	<1%

Soil drainage	Very poorly drained (seasonal waterlogging and inundation)		
Soil texture	Light clay		
Soil colour	Black		
Termite mounds	Absent		
Ground cover	Vegetation 30%, litter cover 10%, bare soil 60%		
Surface rocks	Siltstone		
Vegetation description	Ground storey: 0-1 m	<i>Sorghum timorense</i> (22%), <i>Iseilema vaginiflorum</i> (3%), <i>Sesbania muelleri</i> (3%)	
Disturbance	No fire, weeds or feral animal disturbance evident.		
Habitat	Poor fauna habitat. Fallen logs, tree hollows, mistletoe, flowering plants and leaf litter all absent.

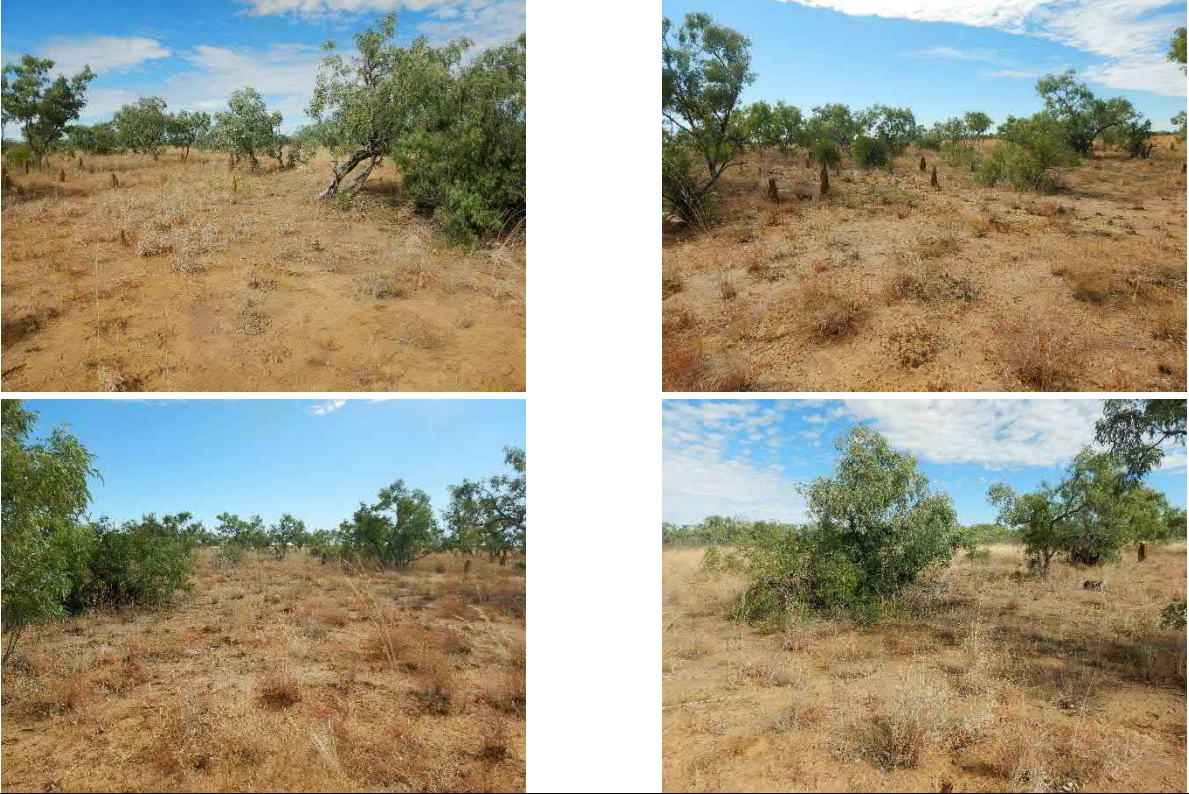
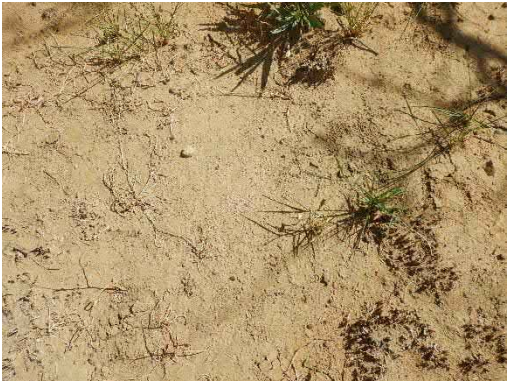
Southern Site 3 (SL3)			
Location	-17.692947°, 134.702798°	Veg. community	<i>Eucalyptus microtheca</i> open woodland
Landform	Floodplain

Slope	<1%

Soil drainage	Very poorly drained (seasonal waterlogging and inundation)		
Soil texture	Sandy loam		
Soil colour	Yellowish brown		
Termite mounds	Common		
Ground cover	Vegetation 15%, litter cover 5%, bare soil 75%, gravel 5%		
Vegetation description	Upper storey: 4-7 m	<i>Eucalyptus microtheca</i> (10%),	
	Mid-storey: 1-4 m	<i>Ventilago viminalis</i> (4%), <i>Carissa lanceolata</i> (3%), <i>Ehretia saligna</i> (1%)	
	Understorey: 0-1 m	<i>Eulalia aurea</i> (8%), <i>Chrysopogon pallidus</i> (3%), <i>Eriachne armitii</i> (2%)	
Disturbance	No fire, weeds or feral animal disturbance evident.		
Habitat	Scattered fallen logs and tree hollows. Mistletoe, flowering plants and leaf litter absent.

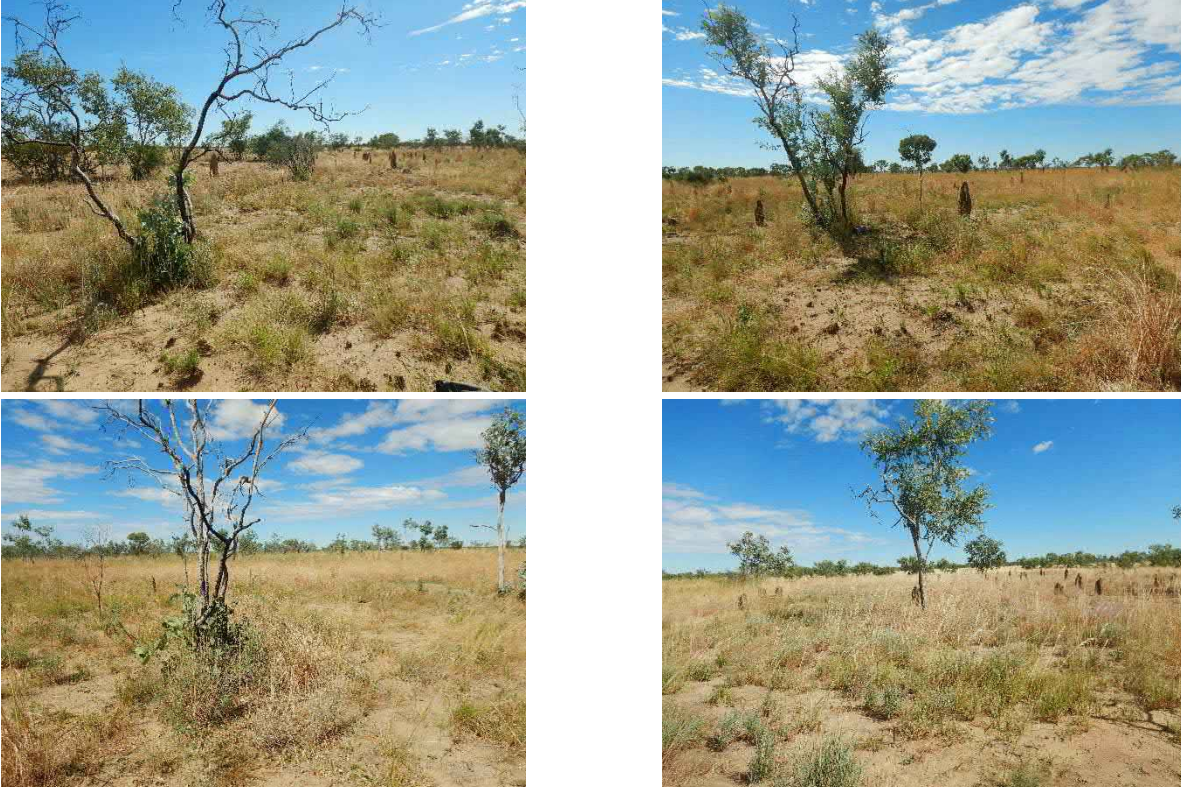
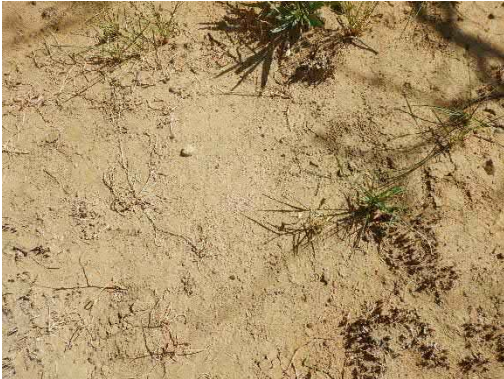
Southern Site 4 (SL4)							
Location	-17.727650°, 134.702120°	Veg. community <i>Eucalyptus pruinosa</i> open woodland					
Landform	Alluvial Plain

Slope	<1%

Soil drainage	Very poorly drained (seasonal waterlogging and inundation)						
Soil texture	Sandy clay loam						
Soil colour	Yellowish brown						
Termite mounds	Common						
Ground cover	Vegetation 30%, bare soil 68%, gravel 2%						
Vegetation description

<table><tr> <td style="background-color: yellow;">Upper storey: 4-6 m</td> <td><i>Eucalyptus pruinosa</i> (7%)</td> </tr><tr> <td style="background-color: yellow;">Mid-storey: 1-4 m</td> <td><i>Eucalyptus pruinosa</i> (2%), <i>Carissa lanceolata</i> (2%)</td> </tr></table>

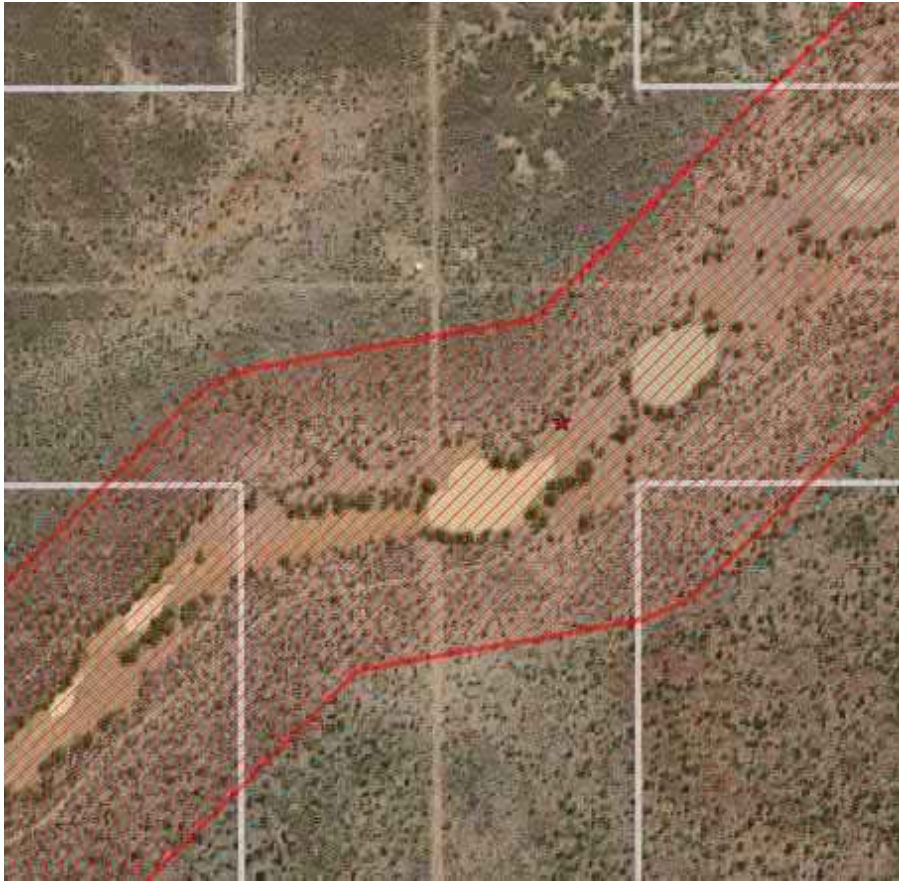
- AAPA sacred site 5864-18 is located approximately 150 m east of the proposed northern seismic line 10, is described as two large waterholes in a flood out area (see Figure 7). Based on the available point data of the sacred site, the seismic line 10 intersects one of the waterholes described in this site, although is an existing pastoral access track.
- Another AAPA recorded sites is known to be located approximately 150 m south of the proposed southern seismic line 1, and is described in the 2012 NLC report as a spring and cave. This site is associated with EP136 RWA6 and is bisected by the Barkly Stock Route (Figure 8).

Figure 7 Seismic line study area intersecting waterhole associated with AAPA recorded sacred site 5864-18 (red star) within EP136 RWA1 (red hatching)
