Northern Territory
**Cabomba Eradication
Program 2005/06**

March 2008

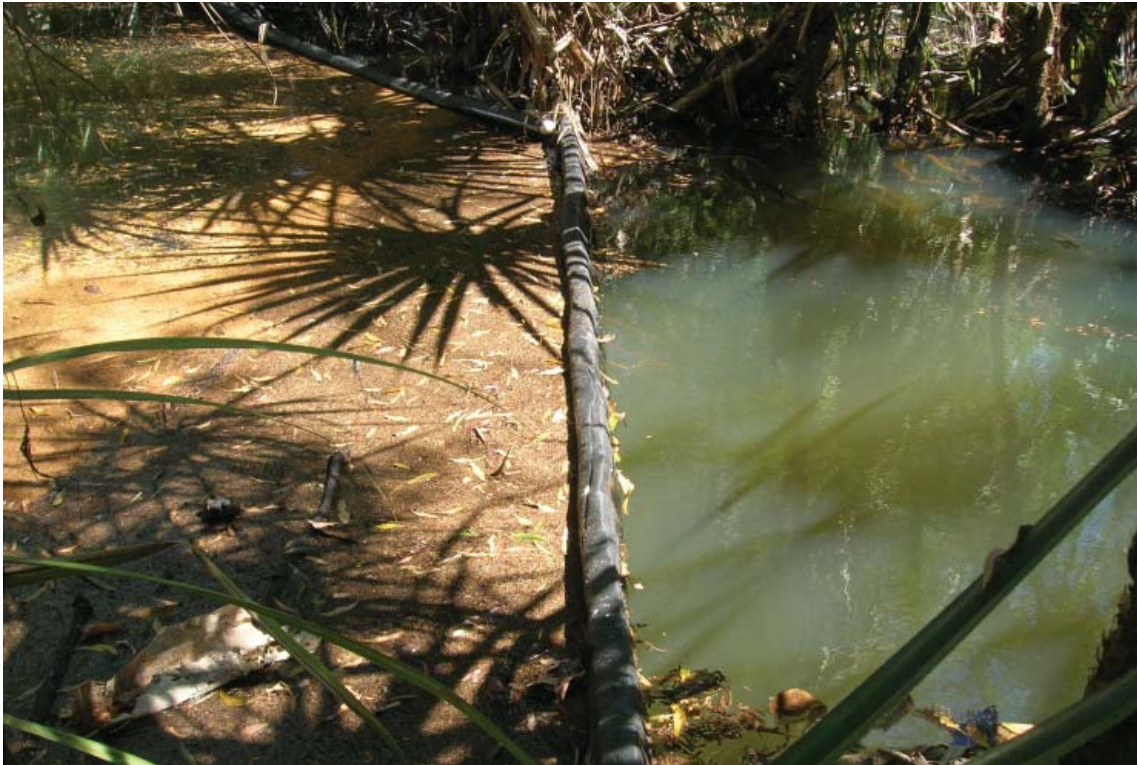
Plate 2: Floating boom constructed to prevent spread of viable fragments

NRETA Weed Management Officers also constructed floating 'booms' to prevent viable fragments moving downstream into unaffected areas. These structures are essentially a floating net extending 30 cm below the water surface supported by a length of poly pipe.

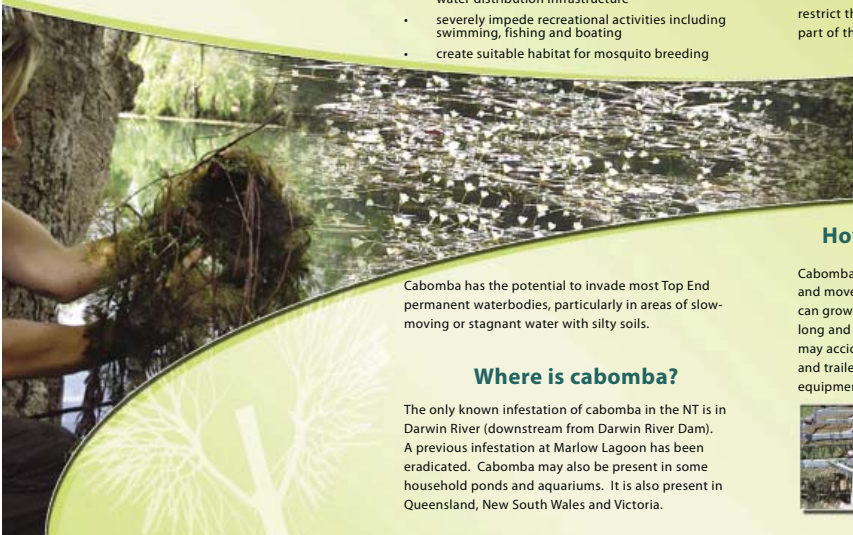
Cabomba is a submerged water plant with emergent white flowers introduced into Australia by the aquarium industry. It is usually rooted to soil but can survive free-floating for 6-8 weeks. It is an aggressive invader of shallow and deep, permanent freshwater bodies where it grows quickly to produce dense and often tall stands (e.g. 3 m) of underwater vegetation.

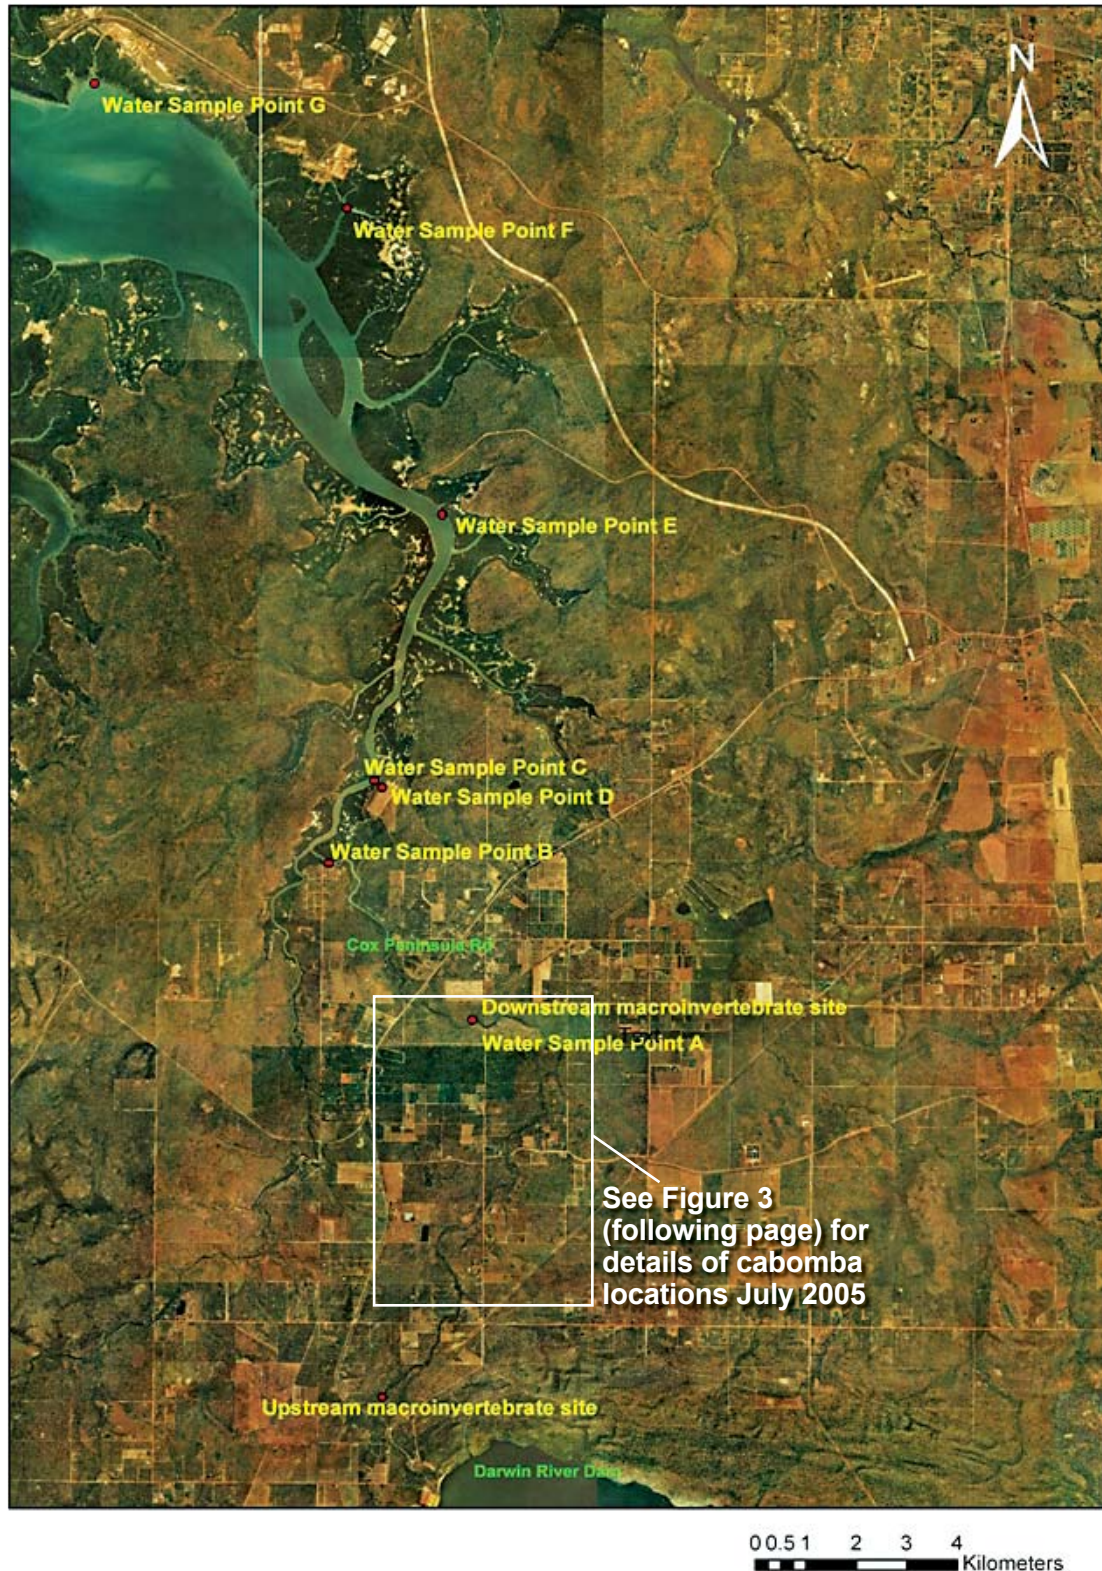
Figure 2: 2006 Water quality monitoring sites in Darwin River Catchment

Lok Landji Billabong is a 2.2 km long section of Darwin River that is located 1.5 – 3.7 km upstream of the Cox Peninsula road and 0.5 – 2.7 km up stream of site A.

Prior to the application of 2,4-D-n-butyl ester in 2004, bores along Darwin River were selected for monitoring. Samples from these bores were tested before treatment with 2,4-D-n-butyl ester (November 2004) and in February 2005. All samples were sent to Sydney for low level analysis of 2,4-D-n-butyl ester and the break down products, 4-chlorophenol and 2,4-dichlorophenol. In every sample, concentrations of all compounds were below detectable limits, meaning that the water was safe for drinking and use.

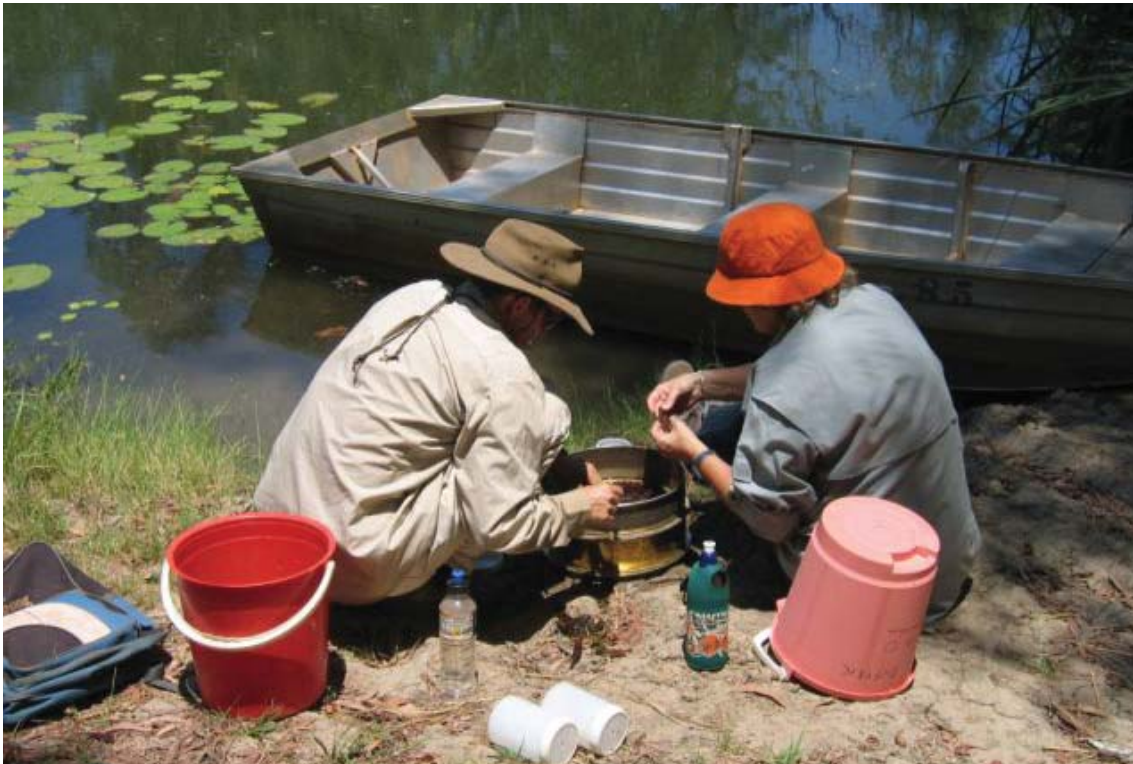
Plate 4 - Macroinvertebrate sampling. G. Lamche and R. Spry, Aquatic Health Unit, NRETA.

The results of the early dry season sampling analysed with the Darwin-Daly family level AUSRIVAS* model revealed no significant change to the macroinvertebrate community at the monitoring site from 2002 to 2006. The sampling confirmed that the macroinvertebrate community of Darwin River had remained similar to other regional rivers and streams in the early dry season.
