CABOMBA ERADICATION PROGRAM REPORT FOR 2004/05

Northern Territory Government

Department of Natural Resources, Environment and the Arts

CABOMBA REPORT

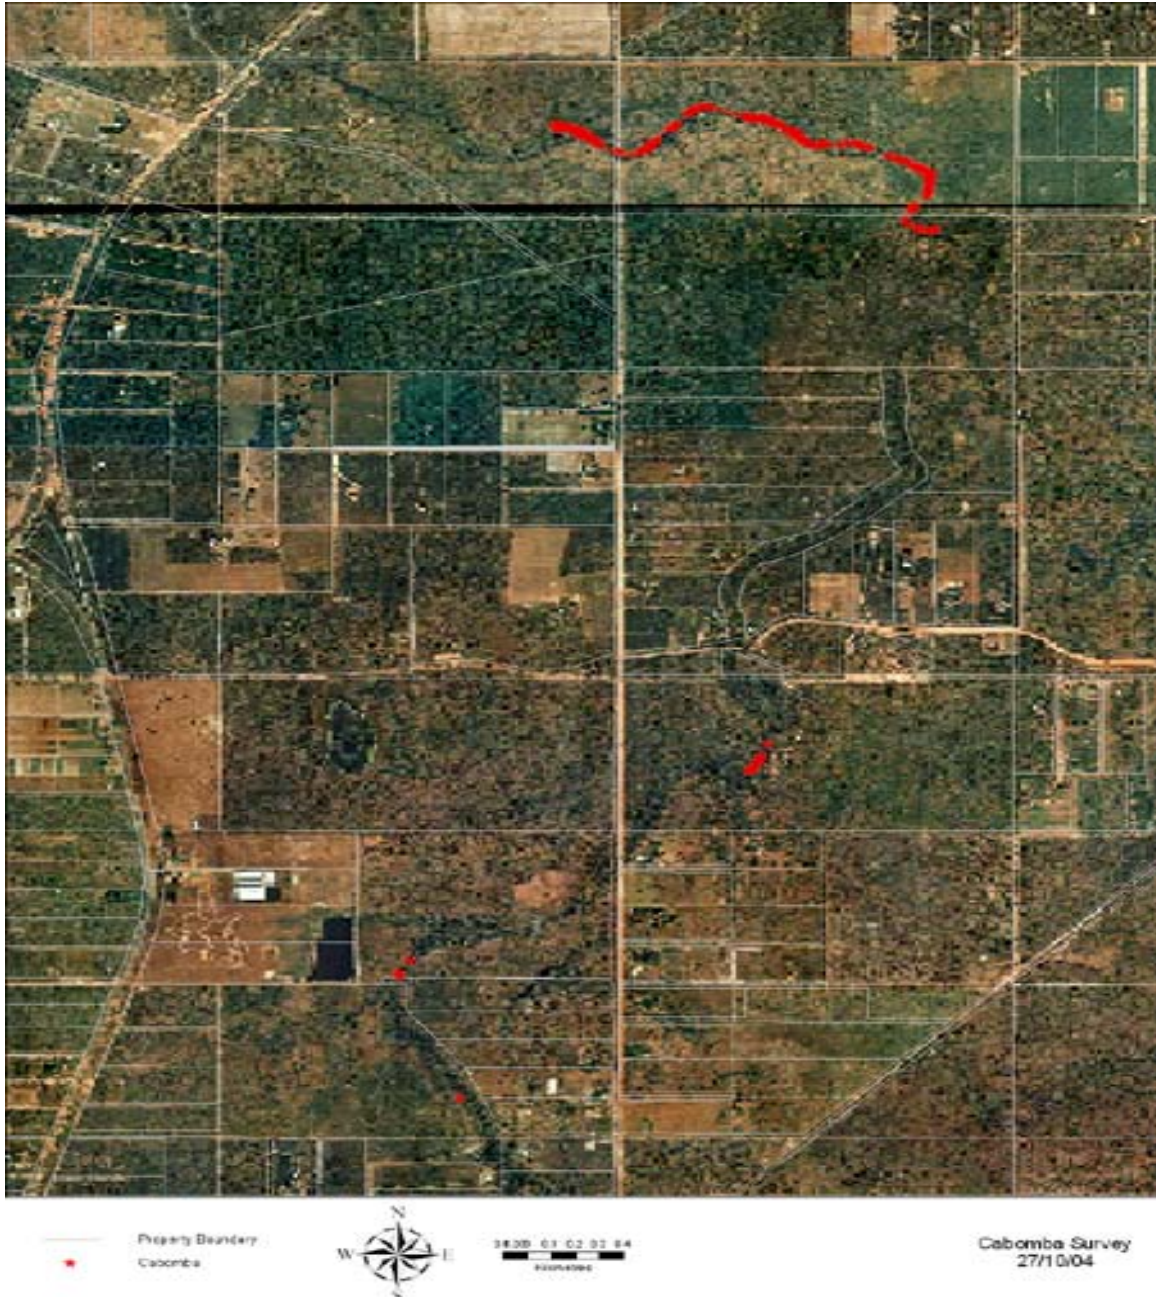
(Figure 1: Distribution of cabomba, Darwin River, October 2004. Infestation indicated in red)

On October 21 2004 cabomba was reported and subsequently positively identified in the Darwin River area. This is the second recording for the Northern Territory. Cabomba was found at several locations along an 11 km stretch of the river

Subsequent to the report in October 2004, and formal identification by the NT Herbarium, a comprehensive riverbank and aerial survey of the freshwater section of Darwin River, its tributaries and two adjacent catchments was conducted to ascertain the exact distribution of the plant in the immediate area. In addition to this an airboat survey of Darwin River and Manton dam was conducted. The result of this survey was that Cabomba was only found at four discrete locations along Darwin River between Leonino Road and Cox Peninsula Road.

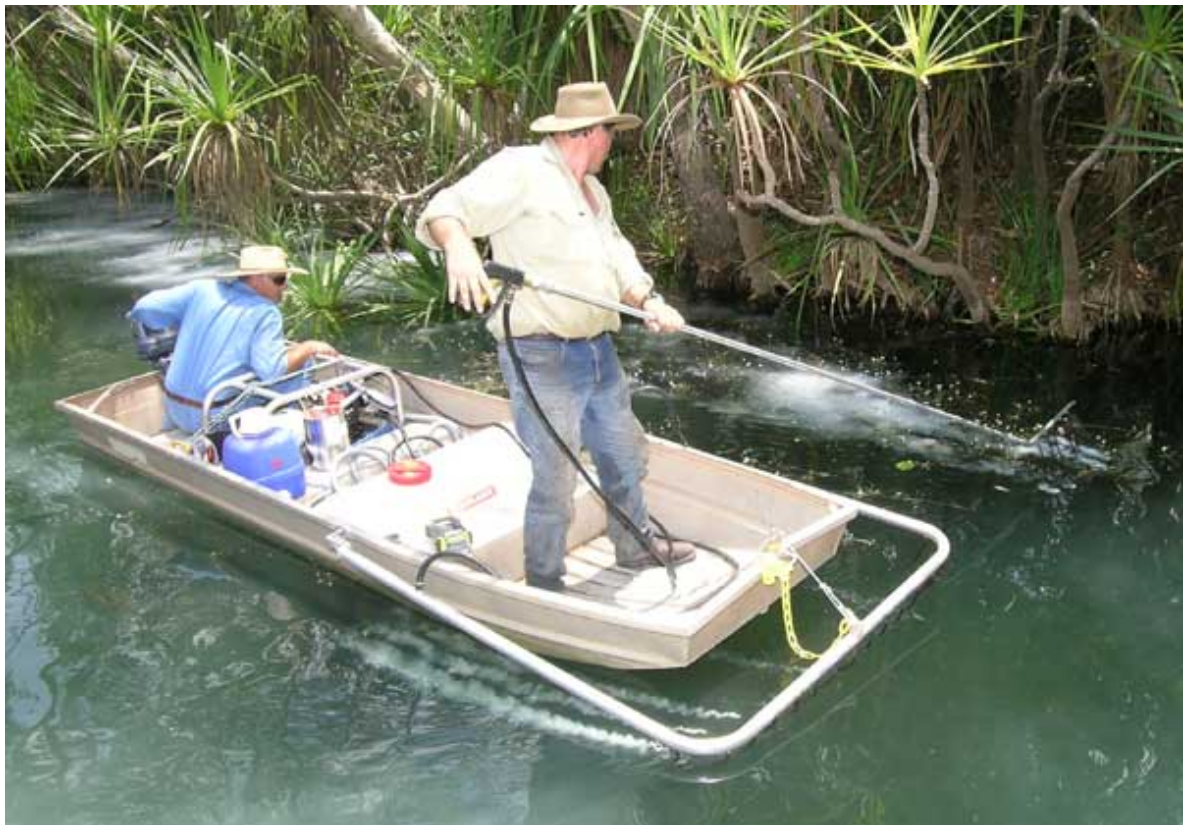
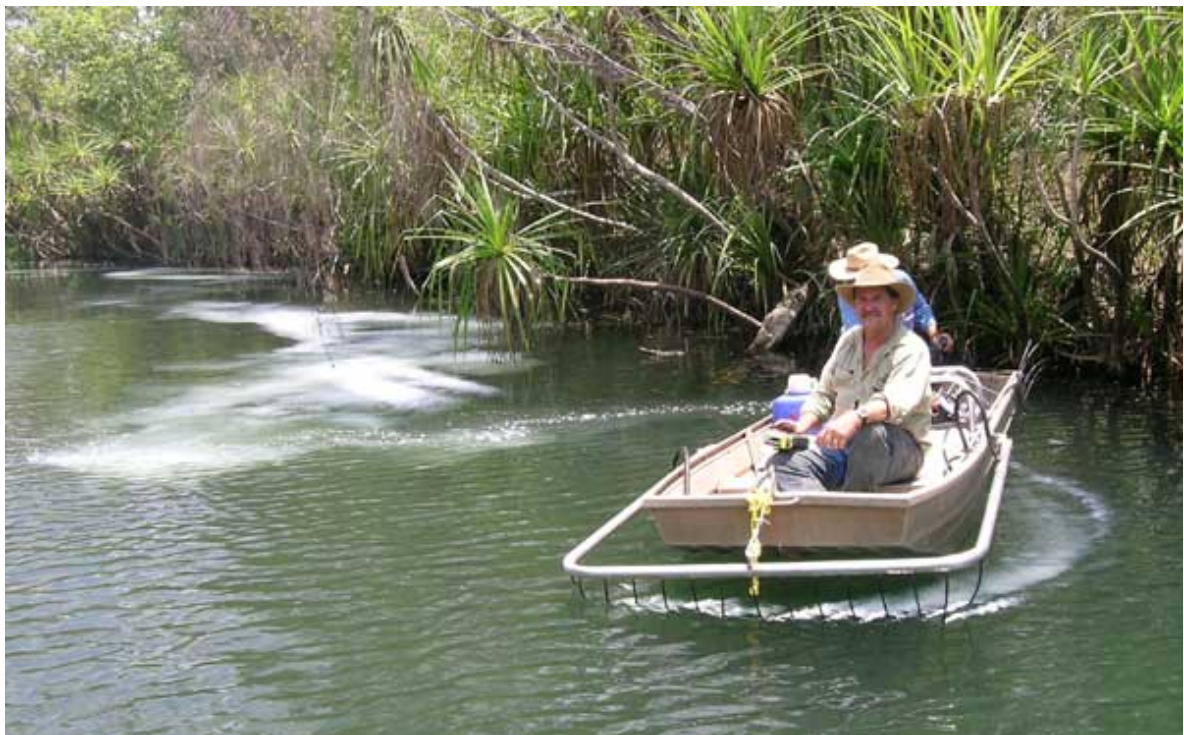
Figure: Images above and below illustrating Cabomba control operations on Darwin River November 2004.

The (2) control crews comprised of two Weed Management Officers, one a boat operator and the other a herbicide applicator. Each boat was a punt approximately 12 ' in length powered by a three horsepower outboard. Each boat was fitted with a 100 litre tank and a petrol pump used to source river water and apply herbicide.

The front of each boat was fitted with a boom used for application in more open water situations and also a hand held “wand” to be used in more confined situations. Herbicide, fuel, safety equipment and diatomaceous earth were also carried in each boat in order to increase the level of efficiency of control operations. Booms were calibrated in order to allow the application of herbicide to the three dimensional waterbody in an effort to facilitate the application of herbicide to within label recommendations.

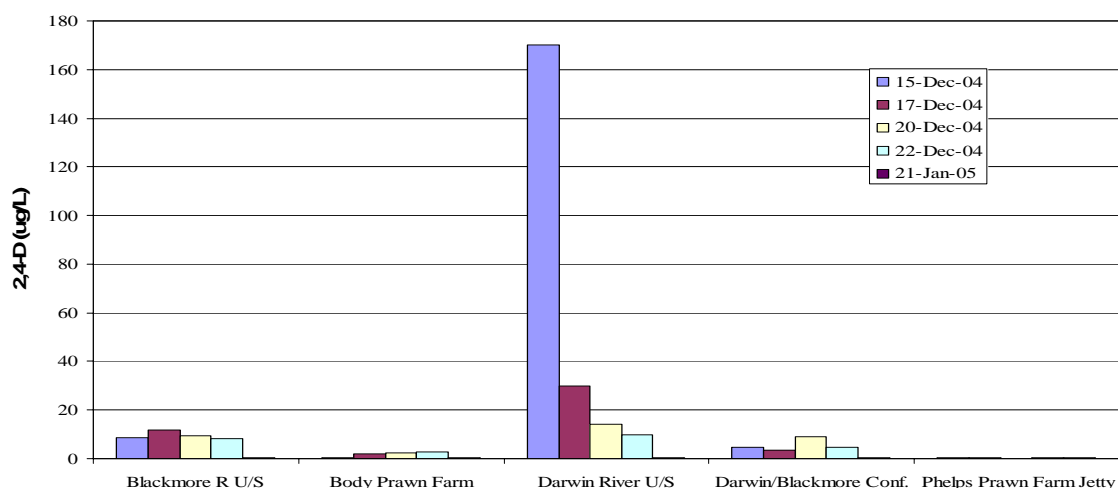
Figure 8 summarises concentrations of 2,4-D measured at the five sites. The main finding is that concentrations of 2,4-D rapidly decreased after release of bund water to levels below those recommended in the ANZECC Water Quality Guidelines of 140 ug/L (the most stringent level). The breakdown product 4-chlorophenol was not detected in the estuary, and traces of 2,4-dichlorophenol were found. This shows that there was virtually no degradation of 2,4-D.

Figure 8. Concentrations of 2,4-D at the five estuary monitoring sites on five occasions after the release of bund water.

During the monitoring program there was no evidence of fish kills or detrimental effects on fauna, and there was little or no reduction on dissolved oxygen levels in the estuary.
