CABOMBA ERADICATION PROGRAM REPORT FOR 2004/05

Northern Territory Government

Department of Natural Resources, Environment and the Arts

CABOMBA REPORT

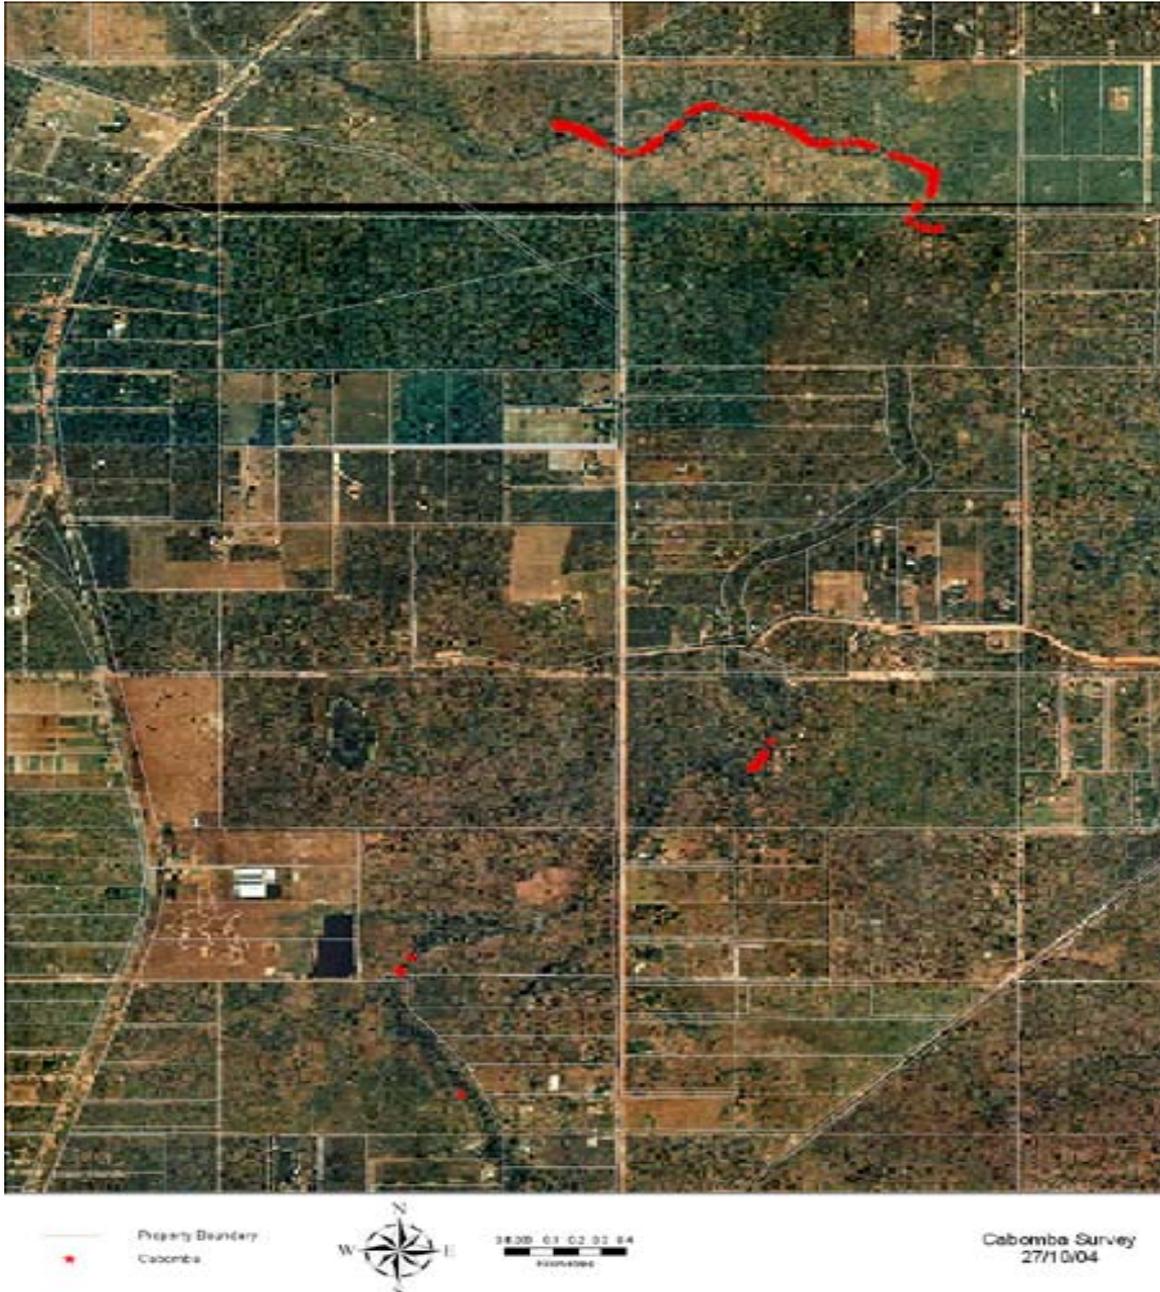
(Figure 1: Distribution of cabomba, Darwin River, October 2004. Infestation indicated in red)

On October 21 2004 cabomba was reported and subsequently positively identified in the Darwin River area. This is the second recording for the Northern Territory. Cabomba was found at several locations along an 11 km stretch of the river

Subsequent to the report in October 2004, and formal identification by the NT Herbarium, a comprehensive riverbank and aerial survey of the freshwater section of Darwin River, its tributaries and two adjacent catchments was conducted to ascertain the exact distribution of the plant in the immediate area. In addition to this an airboat survey of Darwin River and Manton dam was conducted. The result of this survey was that Cabomba was only found at four discrete locations along Darwin River between Leonino Road and Cox Peninsula Road.

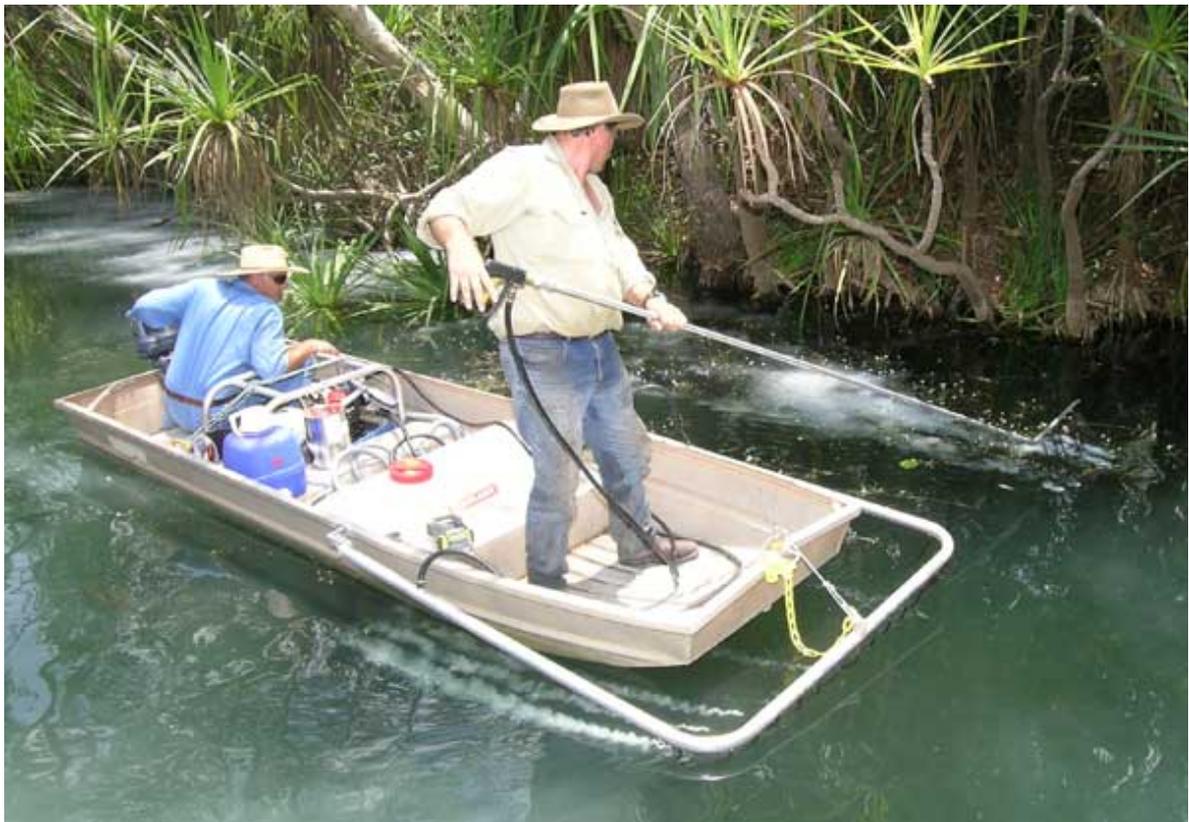
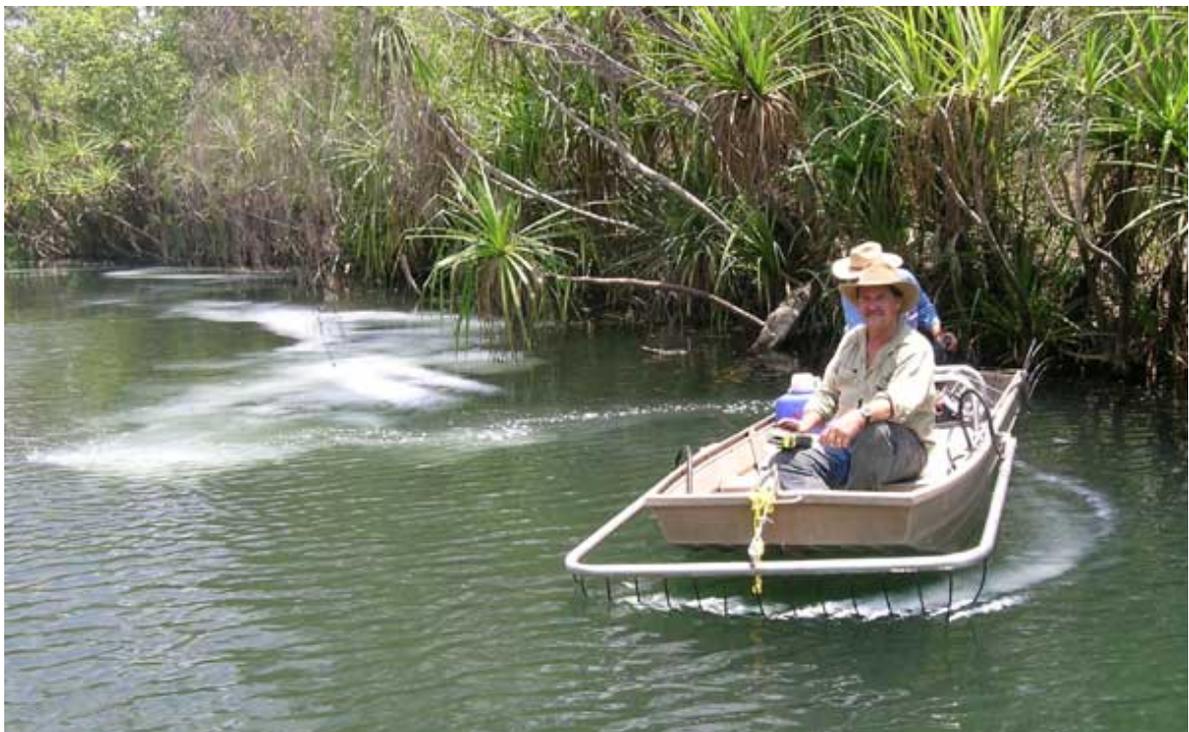
Figure: Images above and below illustrating Cabomba control operations on Darwin River November 2004.

The (2) control crews comprised of two Weed Management Officers, one a boat operator and the other a herbicide applicator. Each boat was a punt approximately 12 ' in length powered by a three horsepower outboard. Each boat was fitted with a 100 litre tank and a petrol pump used to source river water and apply herbicide.

The front of each boat was fitted with a boom used for application in more open water situations and also a hand held “wand” to be used in more confined situations. Herbicide, fuel, safety equipment and diatomaceous earth were also carried in each boat in order to increase the level of efficiency of control operations. Booms were calibrated in order to allow the application of herbicide to the three dimensional waterbody in an effort to facilitate the application of herbicide to within label recommendations.

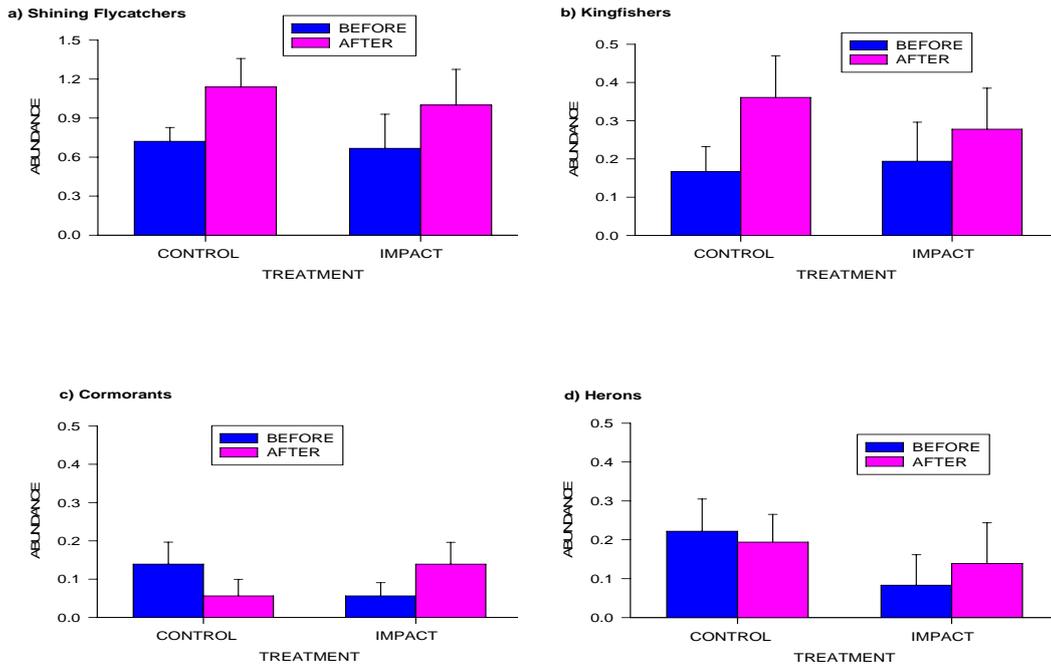
Figure 2: Survey results for four species groups. The abundance measure is the mean number of birds observed per 200 stretch from four repeat observations number of birds observed per 200 stretch from four repeat observations.

All four species groups were recorded in control and impact sites both before and after treatment (Figure 2). This was also the case for pool IMP1, which was the most heavily treated pool. In fact, all four bird groups actually increased slightly in abundance after treatment in the Impact pools. The graphs for each group show that bird abundance is approximately constant across all treatments. For example, the mean number of Shining Flycatchers recorded per section was between 0.7 and 1.2 for all four treatments.

There were no statistically significant effects of the two treatments or of their interaction for any of the four bird groups (Figure 2). However, the interaction terms for Shining Flycatchers and kingfishers were significant when the abundance values for the Impact/After samples were reduced to 10% of their actual values (Figure 2). Thus, this monitoring design would have been capable of statistically demonstrating a 90% decline in these two most common species groups.

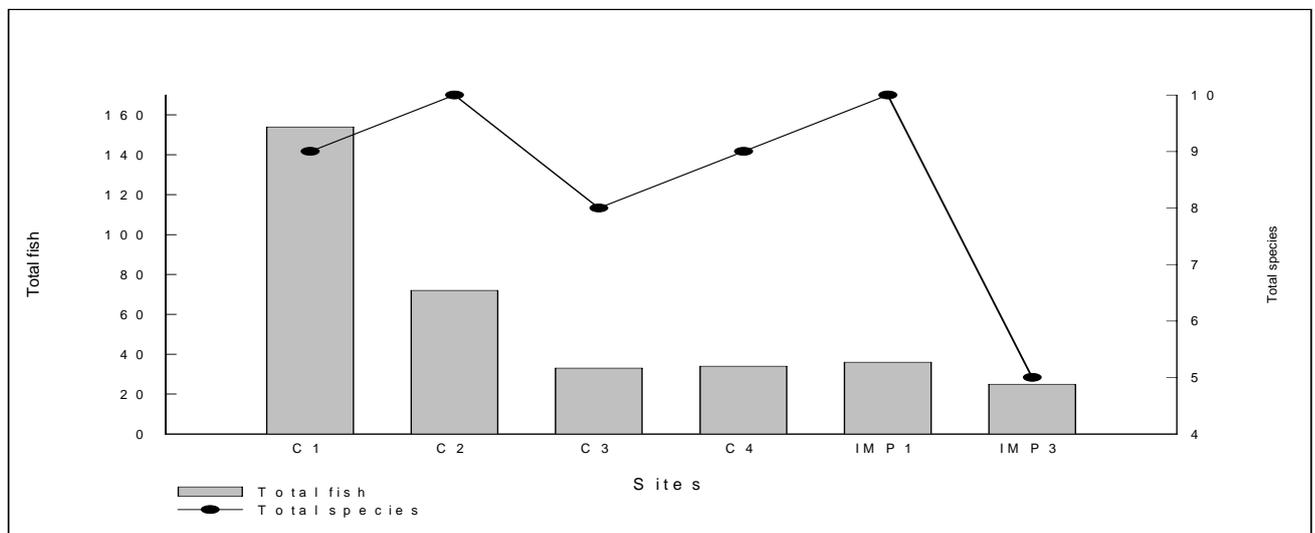
Figure 3 Total numbers of individual fish collected at each site and the number of species recorded from each site sampled

Although the abundance of fish varied from site to site, five of the most abundant fish species were sampled from all the control sites (C1, C2, C3). Four of the same species were sampled in each of the impact sites (IMP1, IMP2, IMP3).

All sites excluding IMP3 had similar species richness. Only 5 species of fish were sampled from IMP3 compared to an average of 10 species from each of the other sites.

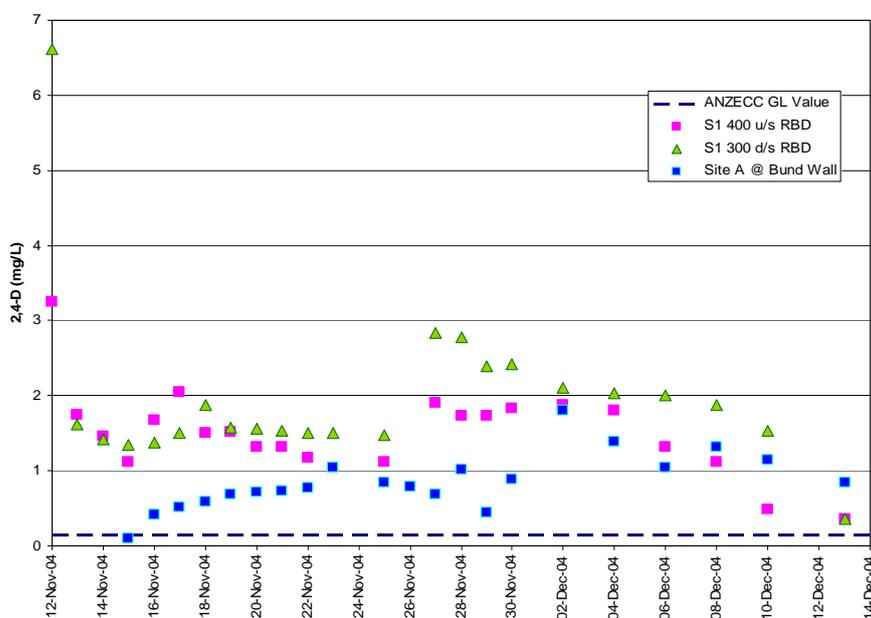
Figure 4

The following figure (figure 4) shows concentrations of 2,4-D measured at two locations on Site 1 and at the Bund Wall.

Concentrations of 2,4-D at Site 1 (S1) were very high on 12 November immediately following the first application of herbicide to the edges of the pool. Levels quickly declined as 2,4-D was mixed in to the main water body through wind action. Levels of 2,4-D rose again on 27-28 November after the second application of herbicide to the pool.

Levels of 2,4-D were well above the ANZECC/ARMCANZ (2000) guideline value of 140 ug/L (0.14 mg/L) indicated by the dashed line. This was the case at all four monitoring sites. The expectation was that concentration of 2,4-D would decline as bacterial and chemical processes degraded 2,4-D to the two breakdown products. This did not occur. Confirmation that 2,4-D was not decomposing was indicated by: very low levels of breakdown products measured during the first week of application (4-dichlorophenol was always below 0.1 ug/L; 2,4-dichlorophenol was less than 10 ug/L); and very low concentrations of breakdown products relative to 2,4-D levels in the estuary following release of bund water.

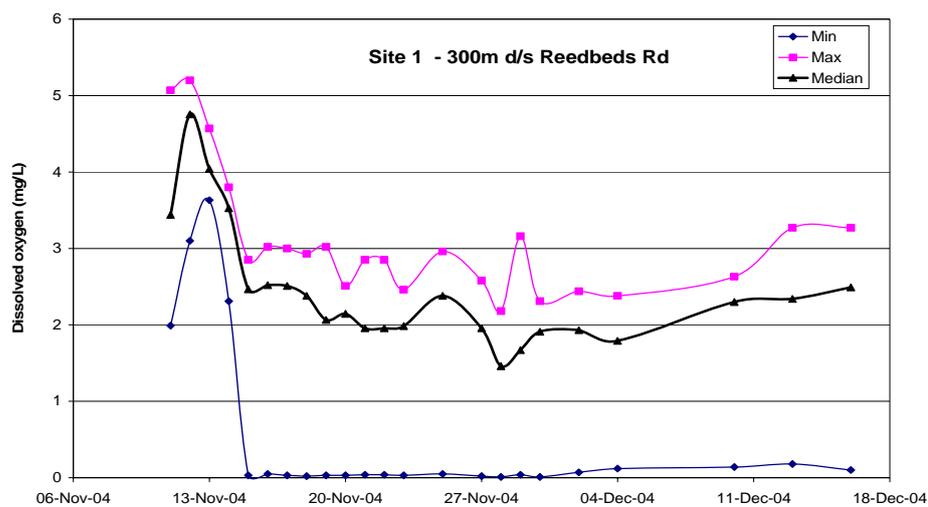
Figure 5

The second main concern surrounding the application of herbicide was the effect this may have on levels of dissolved oxygen (DO). The following figures (Figures 5 and 6) show levels of dissolved oxygen at two locations in Site 1. Following the application of 2,4-D on 12 November 2004 there was an immediate reduction in levels of dissolved oxygen. Median levels of DO declined to around 2 mg/L from a level of approximately 5 mg/L prior to the application of herbicide. Minimum levels of zero were measured at both locations, especially at 300 m downstream of Reedbeds Road. These very low values were measured towards the bottom of the water body.

Following the rapid initial decline in DO levels an aerator was activated on 14 November 2004. Coincident with this, levels of DO at the 300 m downstream site stabilised, with median values at around 2 mg/L. Minimum levels at the bottom remained at or near zero. At the 400 m upstream site DO levels also stabilised to between 2 and 3 mg/L, and minimum levels usually exceeded 1 mg/L.

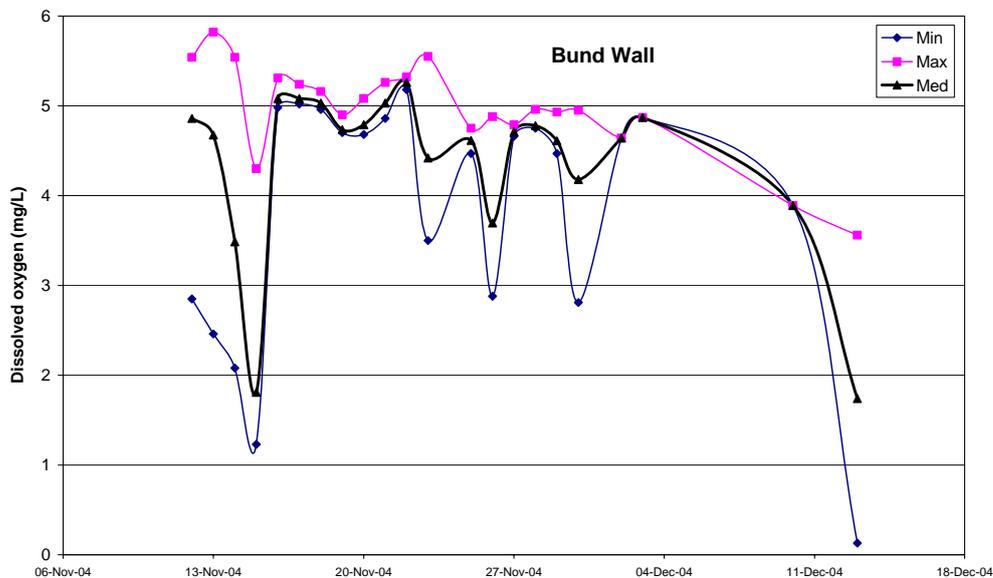
Figure 7

At the bund wall site (see Figure 7) there was a reduction in DO levels coincident with the application of herbicide. Treated water from upstream Site 1 pooled behind the bund wall in an incised location. At this location, saline water from the last high tide was also trapped by the bund wall at the bottom of the pool. This combination of factors resulted in the rapid decline of DO. An aerator was installed at the site and activated on 14 November 2004. There was an immediate increase in DO levels, with minimum values in excess of 3 mg/L, and similar to levels measured before the application of 2,4-D.

It is not clear from these results what the main mechanism for oxygen reduction is as there are many factors that contribute to this process. This includes the direct effect of herbicide on oxygen levels, the decomposition of plant material, the reduction in flow in Darwin River as the release of water from Darwin River Dam was stopped prior to the application of herbicide, and seasonal reductions in

oxygen levels associated with increasing water temperatures. With respect to the latter, it should be noted that oxygen levels at a control site well upstream of where herbicide was applied had measured oxygen levels of 2-3 mg/L, lower than what was measured at Site 1 immediately before the application of herbicide. This low level is not unusual in Top End waterways and is attributed to low flow and high water temperatures.

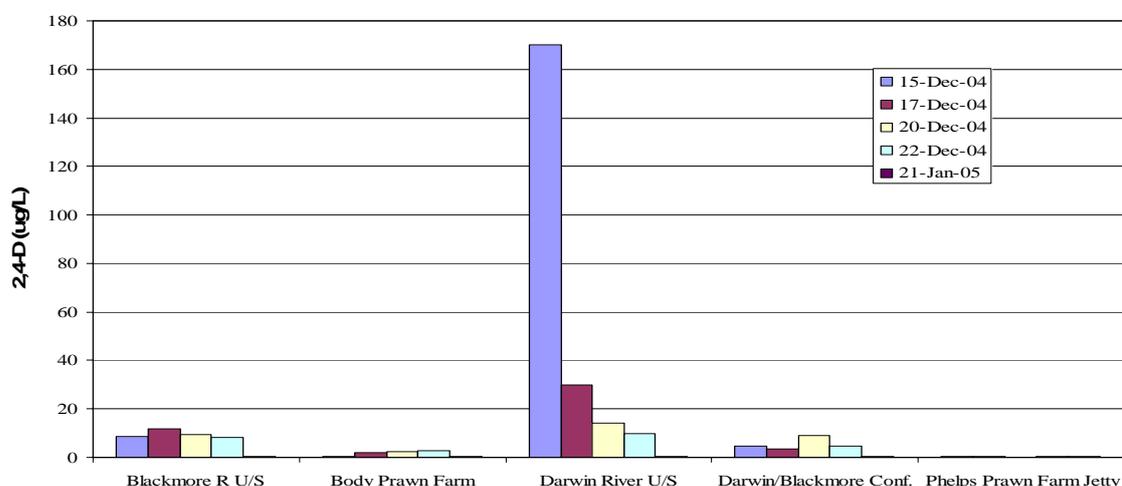
Figure 8 summarises concentrations of 2,4-D measured at the five sites. The main finding is that concentrations of 2,4-D rapidly decreased after release of bund water to levels below those recommended in the ANZECC Water Quality Guidelines of 140 ug/L (the most stringent level). The breakdown product 4-chlorophenol was not detected in the estuary, and traces of 2,4-dichlorophenol were found. This shows that there was virtually no degradation of 2,4-D.

Figure 8. Concentrations of 2,4-D at the five estuary monitoring sites on five occasions after the release of bund water.
