Darwin River Cabomba Eradication Program Summary

FEBRUARY 2017

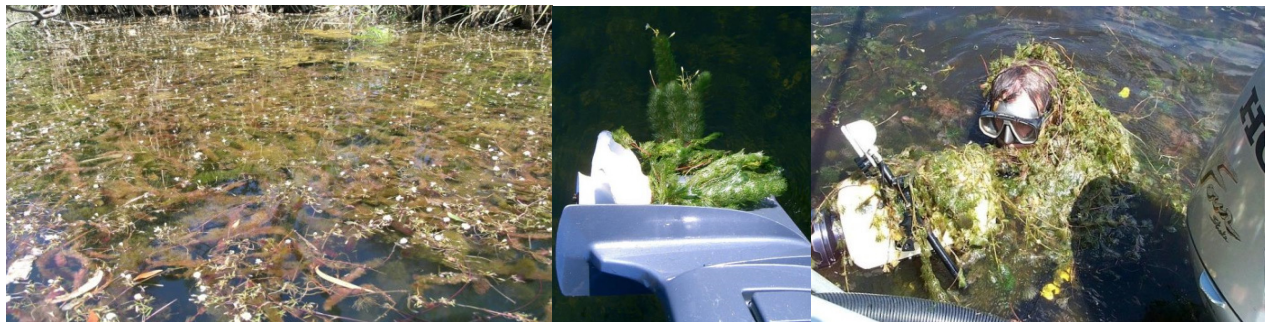
Plate 1: Physical attributes and implications of cabomba

Freshwater rivers and water bodies in the NT are at a significant risk to the adverse effects of cabomba as they provide ideal habitat conditions for its growth. Cabomba could decimate freshwater fishing and other recreational activities if it were to spread from Darwin River (Plate 1).

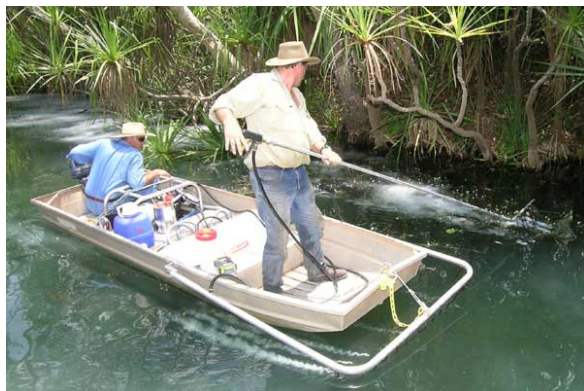
Plate 3: Boat previously used for herbicide application in known salt water crocodile habitat (left)

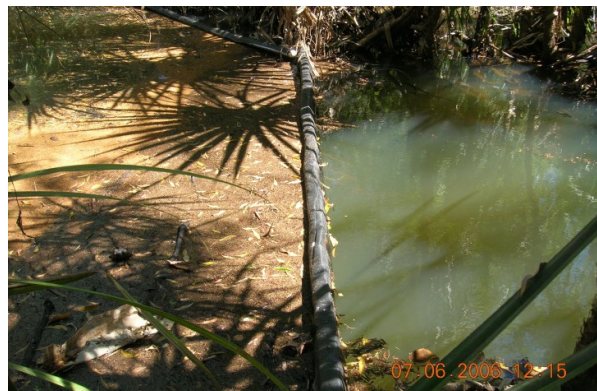
Plate 4: Booms used to catch cabomba fragments (right)

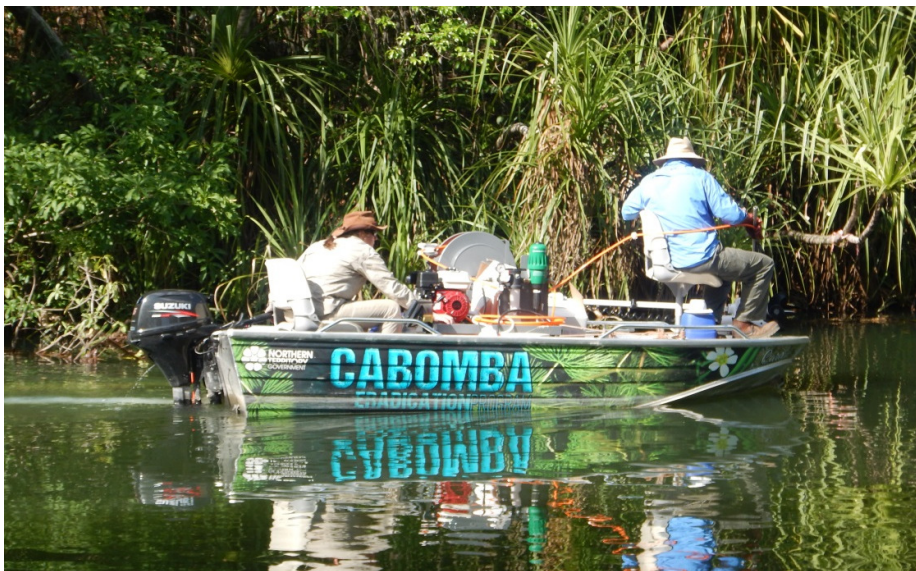
Plate 5: 'Carolyn', the new cabomba eradication program vessel

The additional funding received by the Department allowed the purchase of a more appropriately sized vessel with level floatation for enhanced buoyancy for officer safety and also for better carrying capacity of herbicide and seaworthiness. The new vessel (Plate 5) was also fitted with a GPS enabled trolling motor (Minn Kota®) to allow the vessel to stay stationary for the purposes of survey and monitoring.

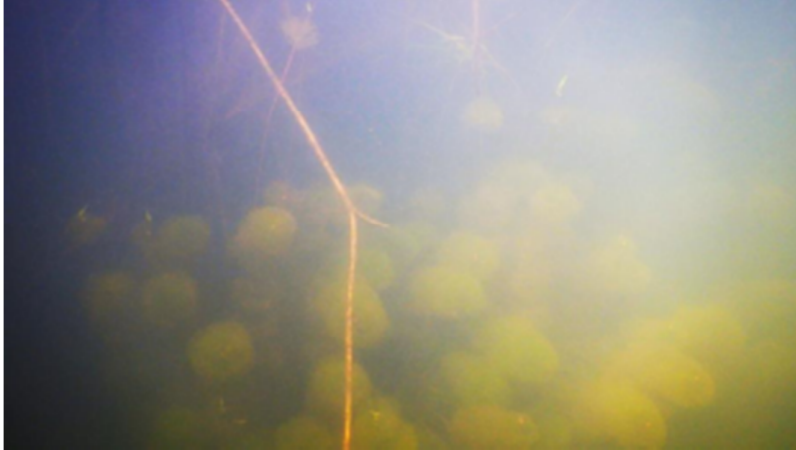
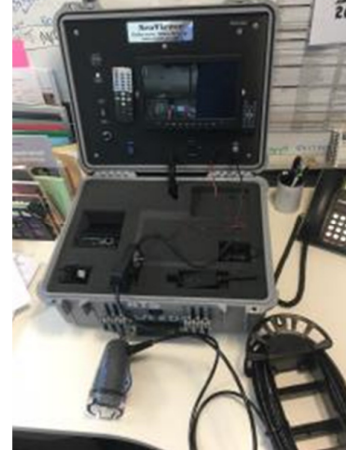
Plate 6: Detection of cabomba using underwater camera

An underwater camera with live feed back to the surface was purchased in December 2015. This camera was used extensively during 2016 to observe the river bed in real-time to identify cabomba. The camera revealed cabomba growing at depths and locations within Lok Landji that it had previously not been known to occur, Plate 6.

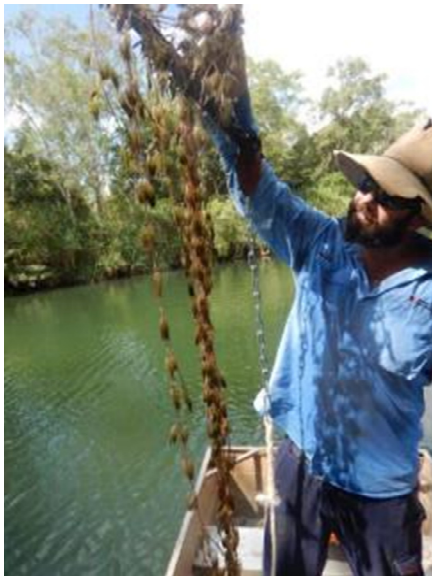
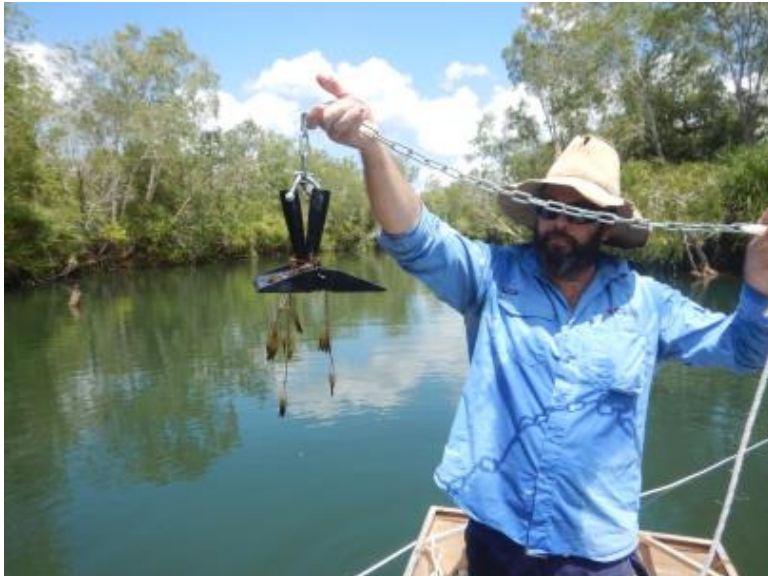
Plate 7: Physical sampling and monitoring of cabomba at depth using the rake set up

Under advice from Dr Dugdale, a simplistic approach was used to get samples of cabomba up from the river bed for assessment. Two rake heads were fastened back to back on a length of chain and rope. This apparatus was able to be thrown into the water, dragged along the bottom then retrieved with cabomba fragments attached. Weed Officers could visually inspect treated cabomba to determine the level of health post herbicide application (Plate 7).

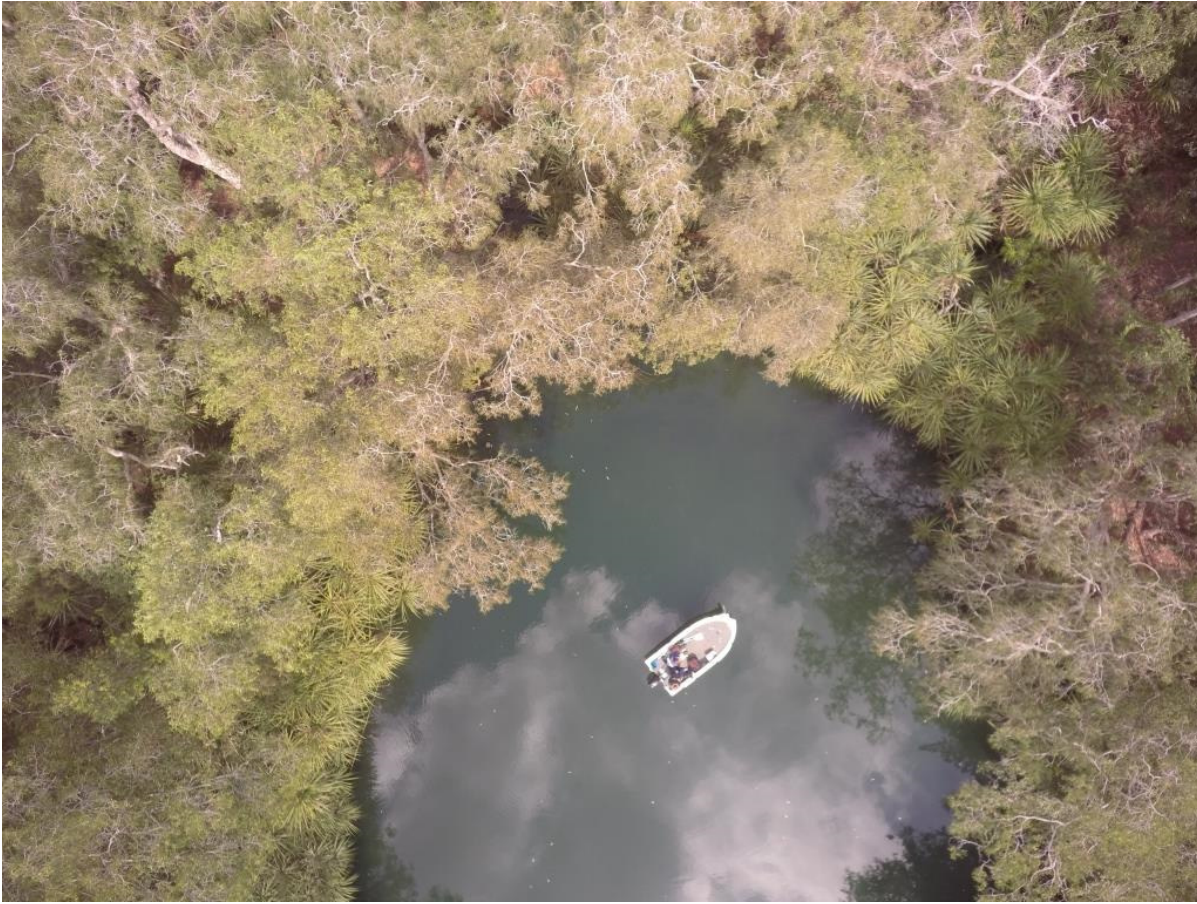
Plate 8: Baseline riparian vegetation survey being undertaken with drone - pre herbicide treatment

- A monitoring program that assesses baseline values and changes on cabomba infestation levels, water quality, fish populations, crocodiles, terrestrial, riparian (Plate 8) and aquatic vegetation was administered.

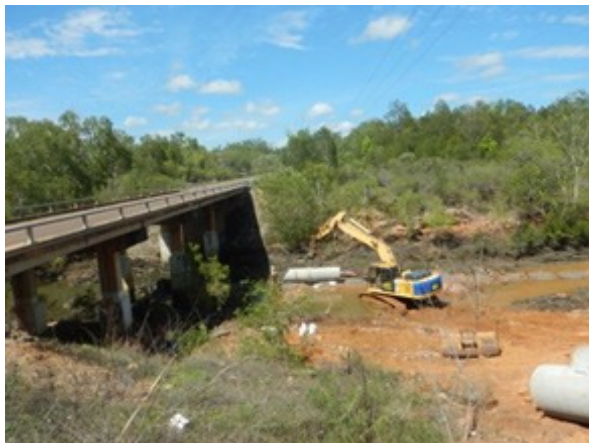
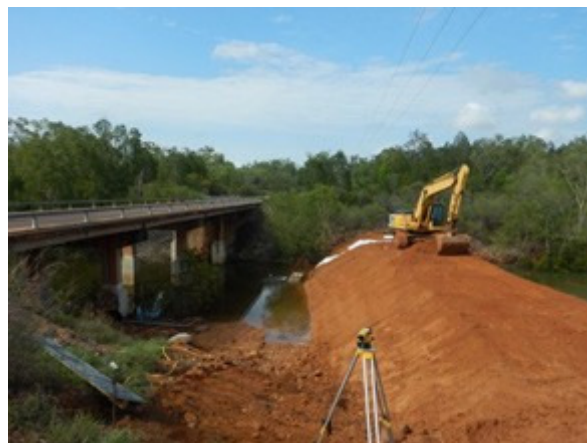
Plate 9: Bund wall construction at Cox Peninsula Bridge

A bund wall was a precautionary measure that recognised the application of Shark™ on this scale was unprecedented in tropical flowing water bodies in Australia (Plate 9). While the break down rates of Shark™ could be estimated, they could not be guaranteed. The construction would also provide members of the public with visible assurance that downstream environments were being protected from herbicide impacts.

To enable limited release of potentially herbicide-contaminated upstream water to avoid overflow (through a 900mm pipe in the bund wall), the Weed Management Branch applied to the Northern Territory Environment Protection Authority (NT EPA) for a Waste Discharge Licence.

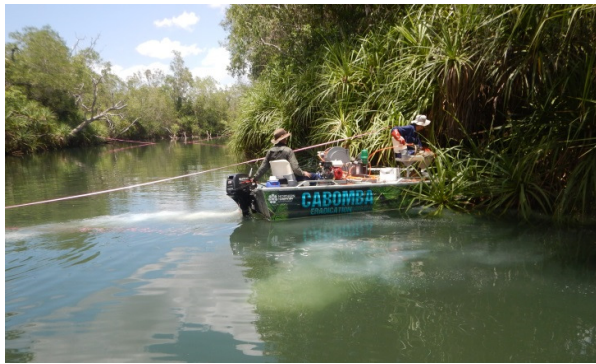
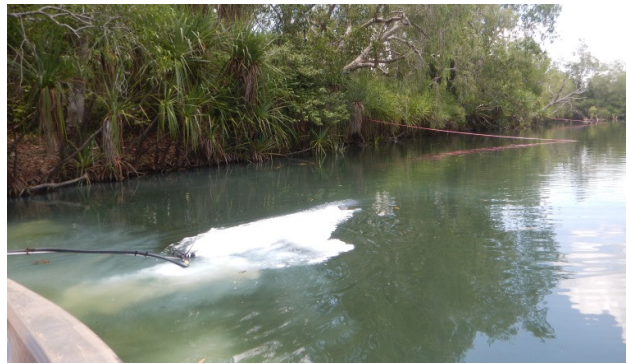
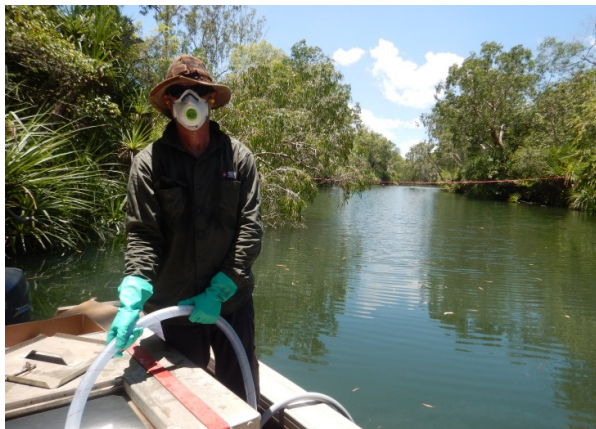
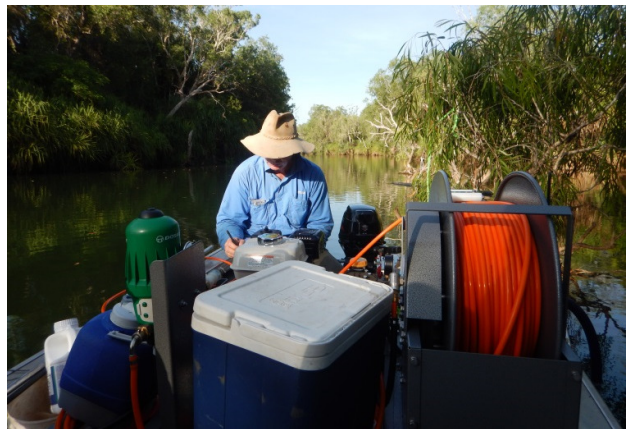
Plate 11: Half billabong treatment and associated monitoring, October 2016

In total, it took four Weed Management Branch Officers six days to treat 85 mega litres of the billabong, using two boats to subsurface inject over 700 litres of herbicide along a linear distance of just over 1 kilometre (refer to Plates 11 and 12 and Map 3).

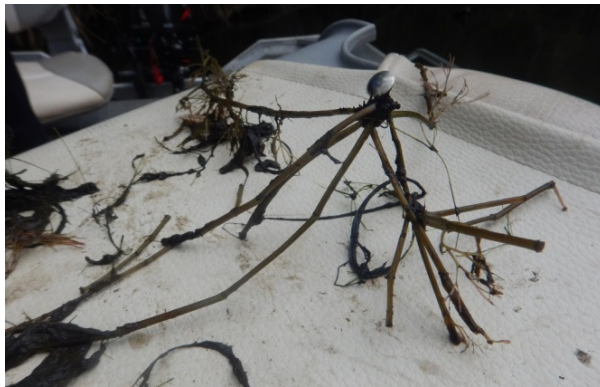
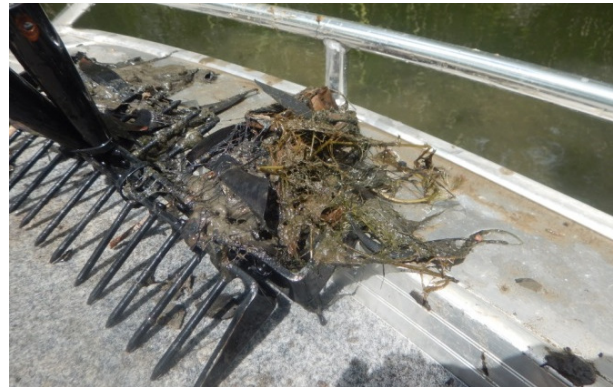
Plate 13: Unhealthy cabomba eight weeks post-treatment

- No floating fragments were found in the treated zone or downstream in the untreated zone.
- No healthy cabomba was able to be found on the river bed in either the treated or untreated zone (Plate 13).

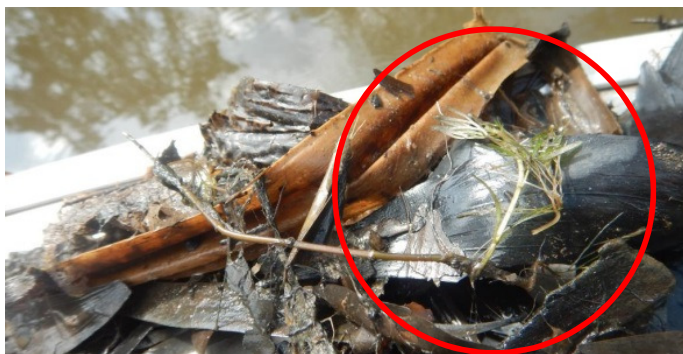
Plate 14: First sign of healthy cabomba three months post treatment – only in untreated zone.

- No floating fragments could be located in either the treated or untreated zone.
- Surveillance techniques used in the treated zone could not locate any cabomba on the river bed in any of the previously known infestation sites.
- In the untreated zone a single small, but healthy fragment was located on the river bed (Plate 14). This healthy stem indicates that while some herbicide effect was observed in the untreated zone, it will require targeted management once the river stops flowing in the coming 2017 Dry season.

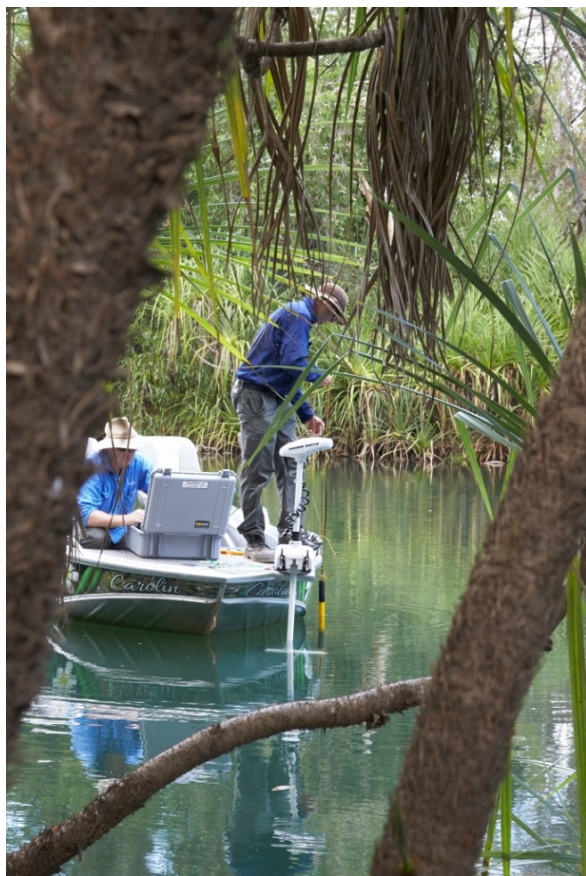
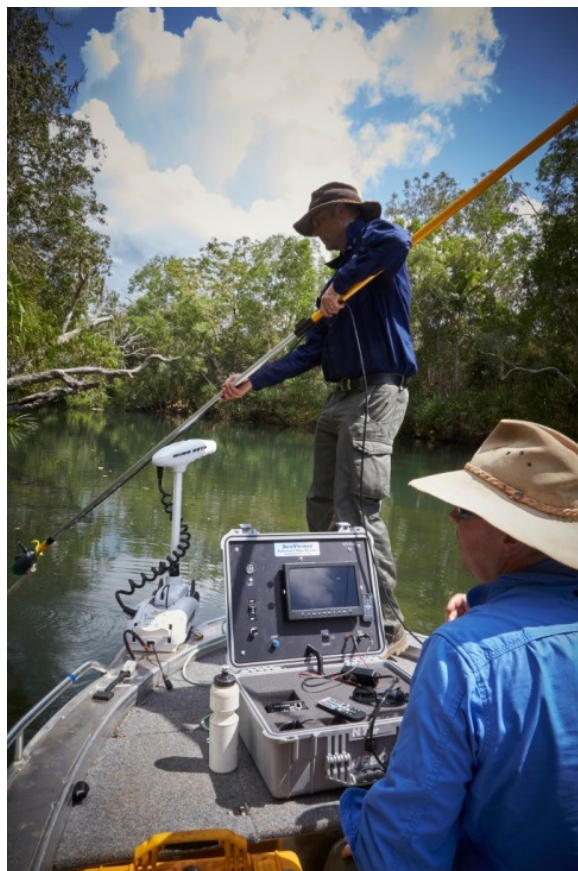
Plate 15: Cabomba survey being undertaken after first half billabong treatment
